## Annual Inspection

Torpoint Town Council

Torpoint Skateboard Park

Inspection Ref: 1610375

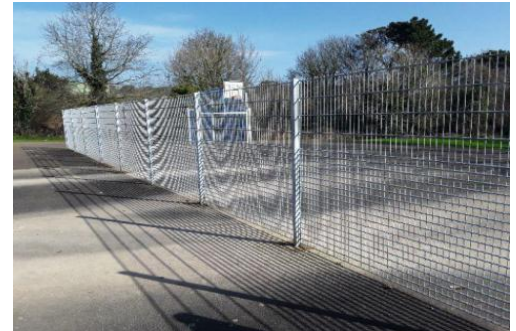
There are post / end caps missing from the item - Replace missing post caps

There are a number of loose posts around the fence - Monitor for any further deterioration and reset as required

There are a number of fixings missing from the fence - Replace missing fixings

There is some damage to the fence sections - Monitor for any further deterioration and repair as required

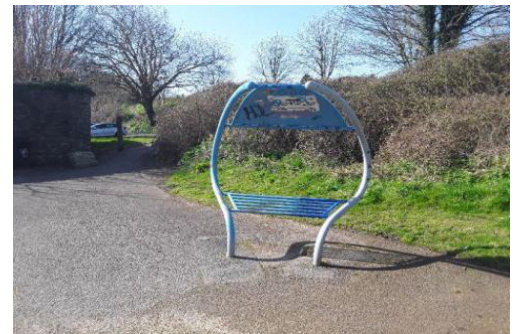
There is some evidence of fire damage to the surfacing - Monitor for any further deterioration and repair as required

There is/are several inserts missing - Replace missing inserts

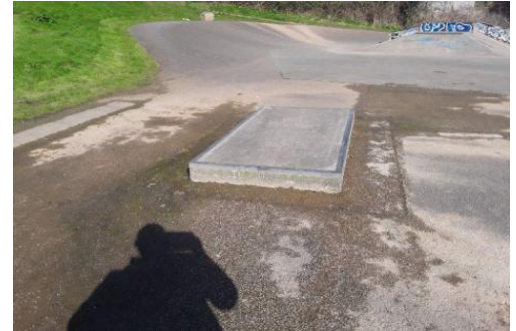
The item has exposed edges and corners with a radius of less than 3mm and fails the requirements of BS EN 14974 - Monitor - no remedial action recommended

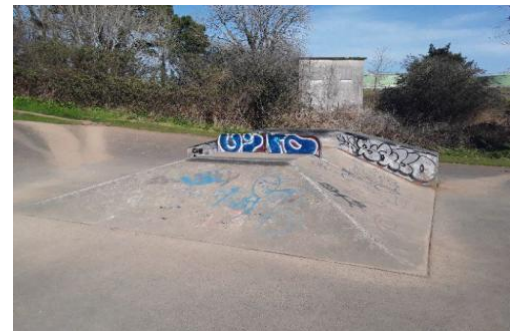
The riding surface of the ramp has some damage apparent - Monitor for any further deterioration and repair as required

The item has exposed edges and corners with a radius of less than 3mm and fails the requirements of BS EN 14974 - Monitor - no remedial action recommended

The concrete has been damaged at the side of the ramp - Monitor for any further deterioration and replace as required

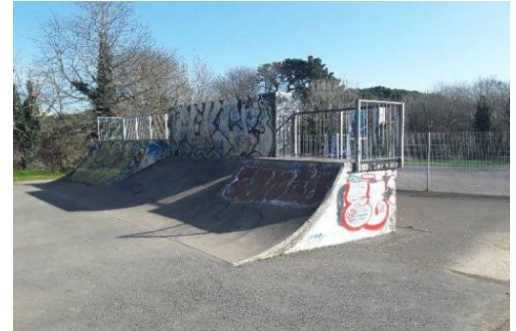
Barrier ends should have a radius of at least 50mm as required by BS EN 14974 - Monitor, no remedial action is recommended

The height of the barrier is less than 1200mm and fails the requirements of BS EN 14974 - Monitor - No remedial work recommended

There is some damage to the barrier sections - Monitor for any further deterioration and repair as required

The horizontal opening in the barrier is in excess of 89mm and fails the requirements of BS EN 14974 - Monitor - No remedial work recommended

The riding surface of the ramp has some damage apparent - Monitor for any further deterioration and repair as required

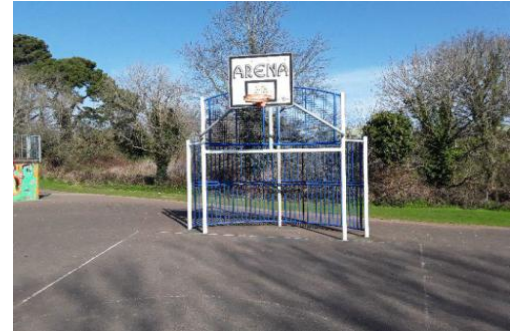
The item fails to meet the requirements of BS EN 15312 4.4.2.1 head and neck entrapment in the frame - Monitor - No remedial work recommended

The bitumen surface is worn or damaged - Repair the bitumen to provide a uniform surface

There is some damage to the netting - Replace

There is minor damage to the adjacent wall resulting in loose rocks on top of the wall and debris on the adjacent surface - Repair as required to remove / secure all loose rocks, remove debris from the surface and maintain

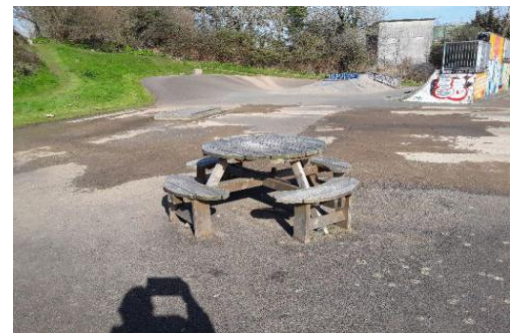
There is some evidence of fire damage to the item - Monitor for any further deterioration and repair as required

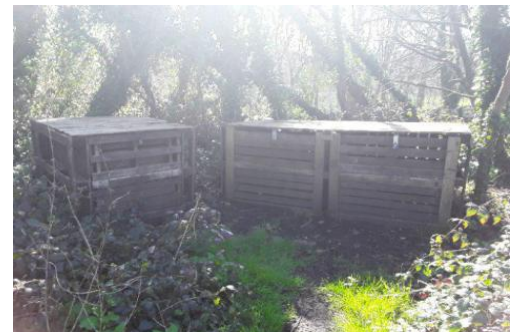
There are projecting nail ends present - Remove and provide more appropriate fixings if required

There are areas or parts of the timber on the structure that have rotted - Replace all affected timbers

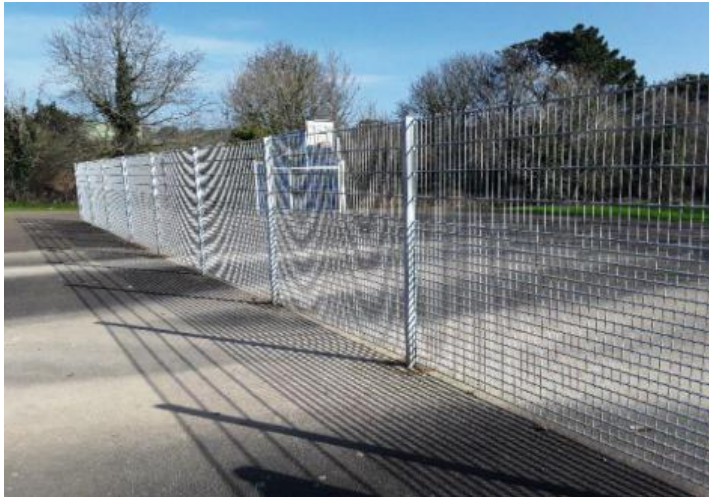
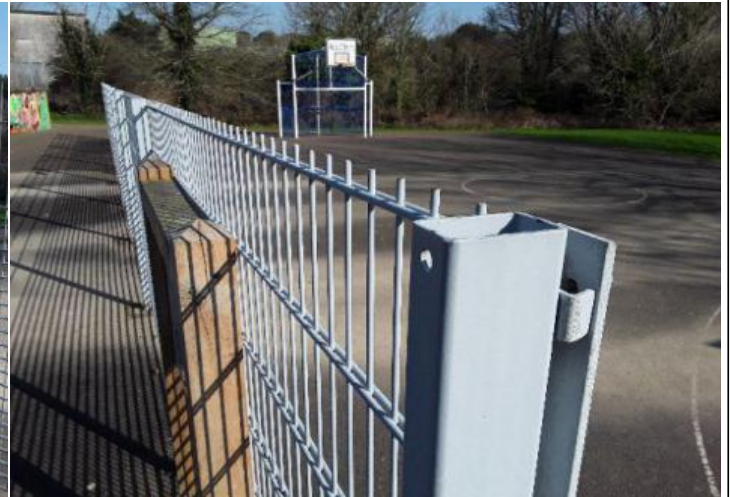
**Finding:** There are post / end caps missing from the item

**Action:** Replace missing post caps

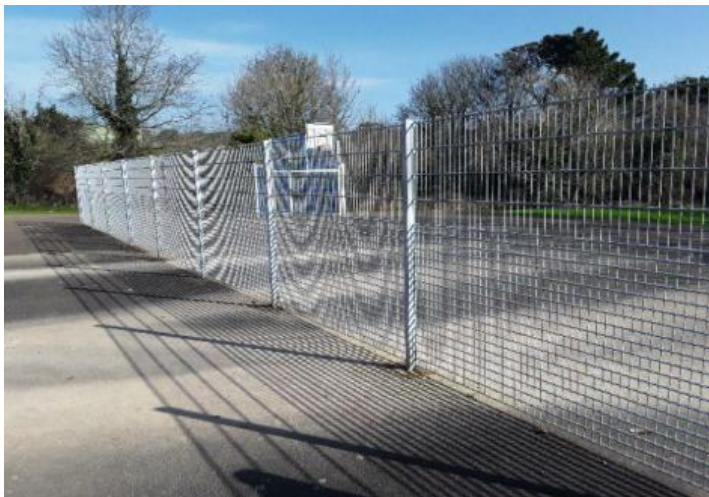
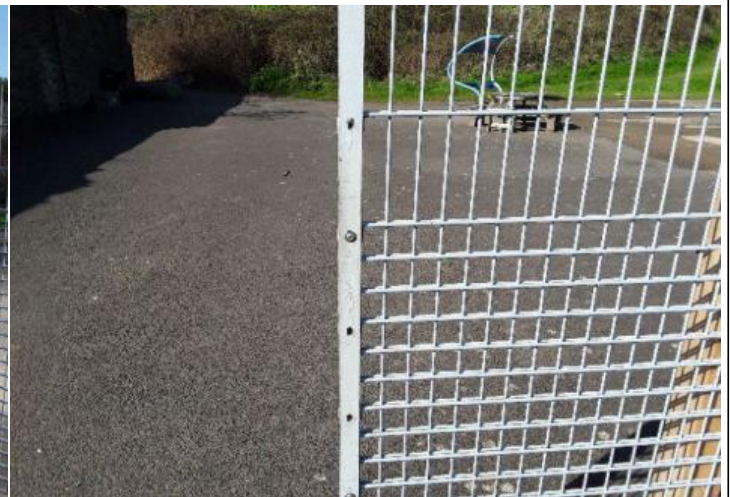
**Finding:** There are a number of fixings missing from the fence

**Action:** Replace missing fixings

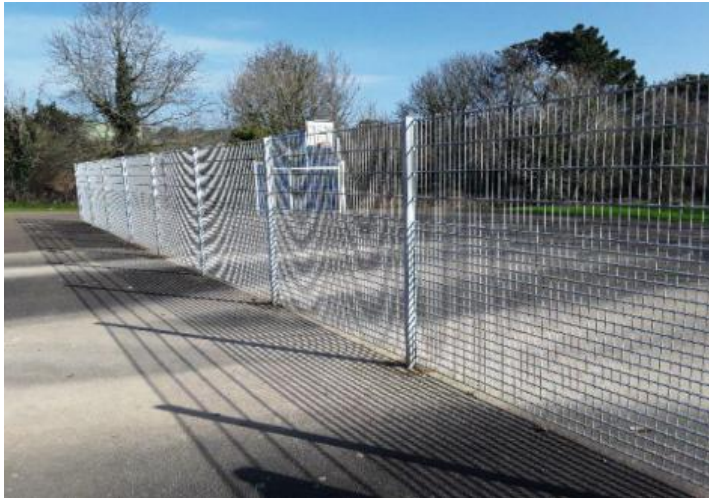
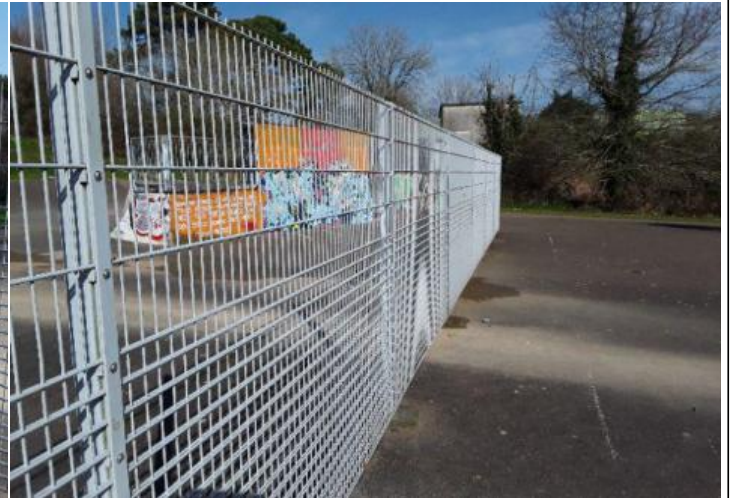
**Finding:** There are a number of loose posts around the fence

**Action:** Monitor for any further deterioration and reset as required

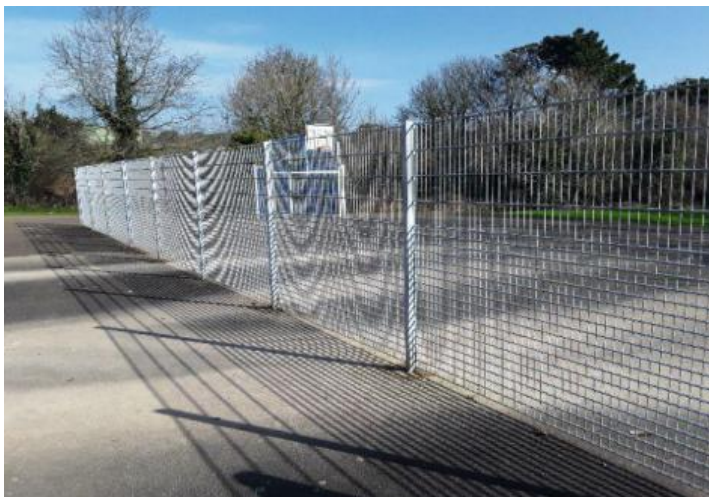
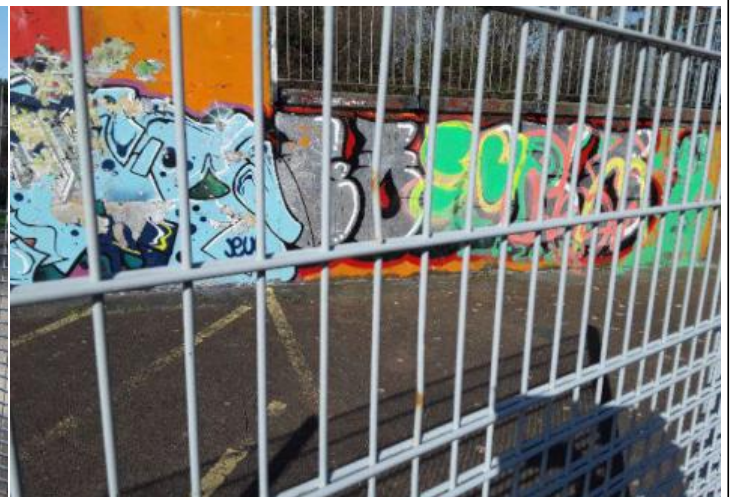
**Finding:** There is some damage to the fence sections

**Action:** Monitor for any further deterioration and repair as required

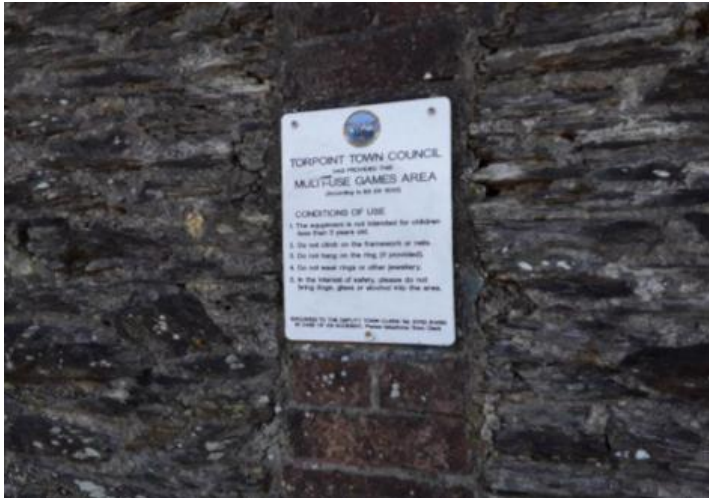
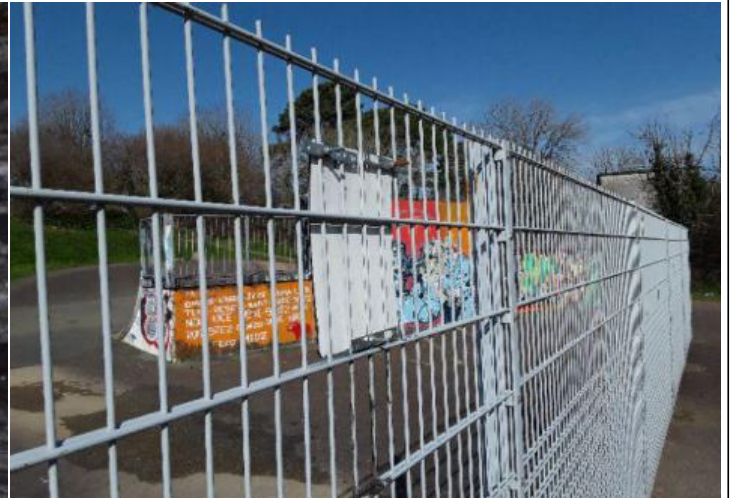
**Finding:** There are projecting bolt thread(s) present

**Action:** Remove excess thread length and deburr or provide cap

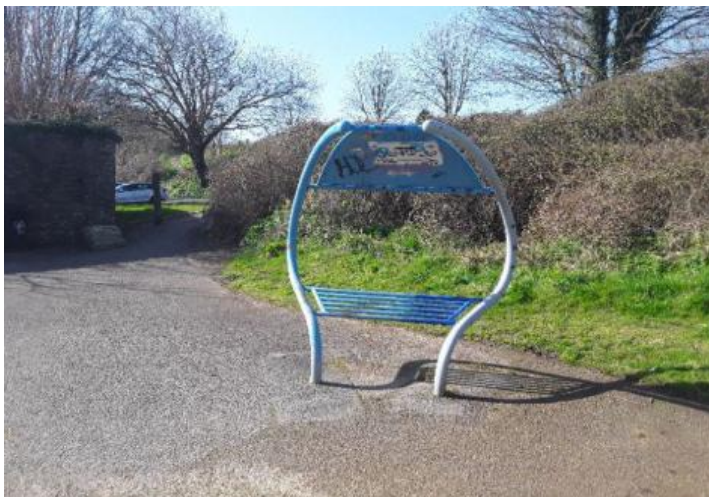
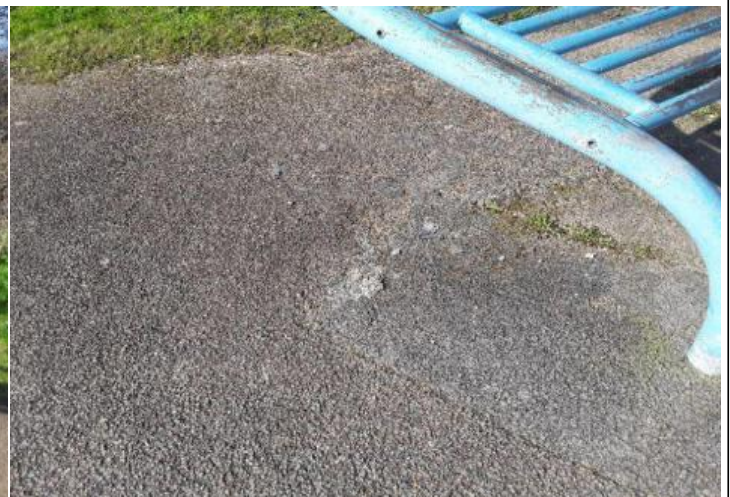
**Finding:** There is some evidence of fire damage to the surfacing

**Action:** Monitor for any further deterioration and repair as required

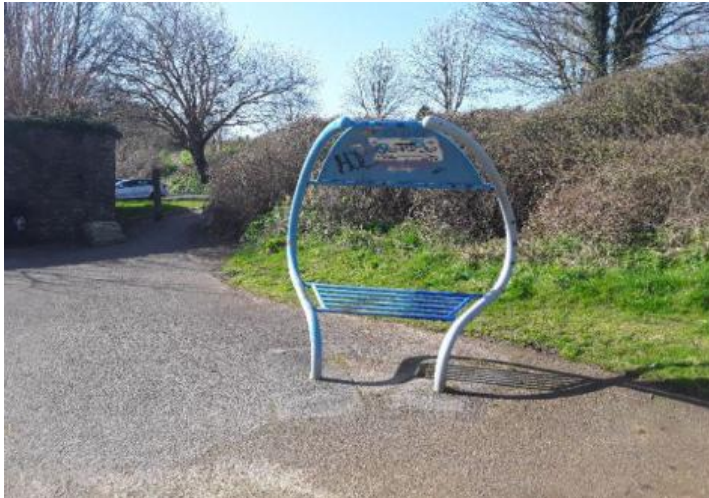
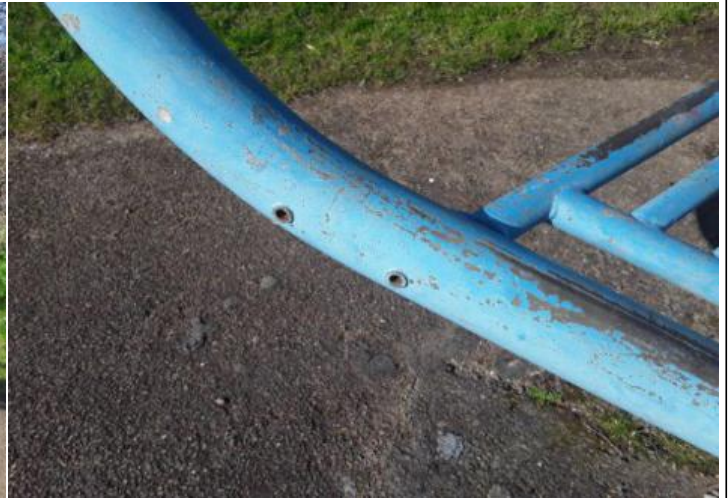
**Finding:** There is/are several inserts missing

**Action:** Replace missing inserts

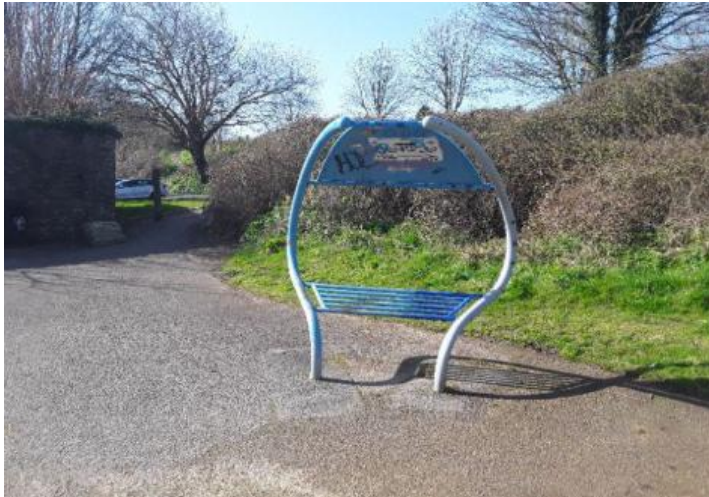
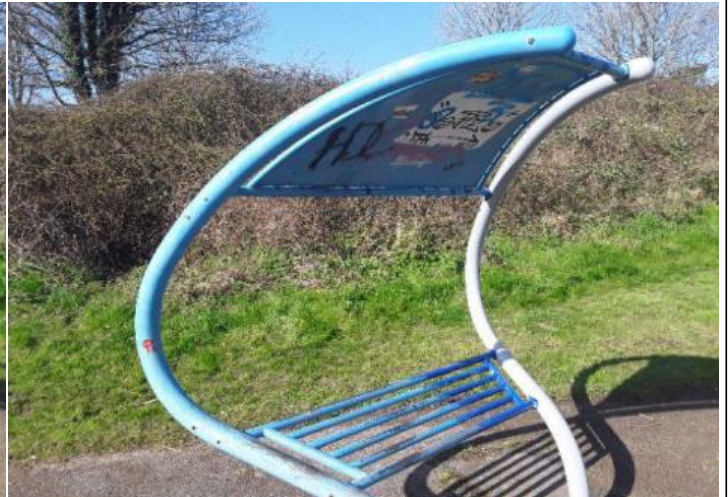
**Finding:** There is some graffiti present

**Action:** Remove the graffiti

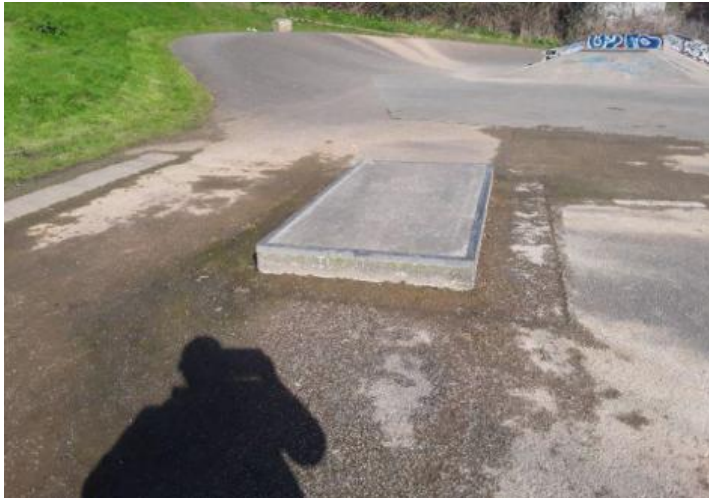
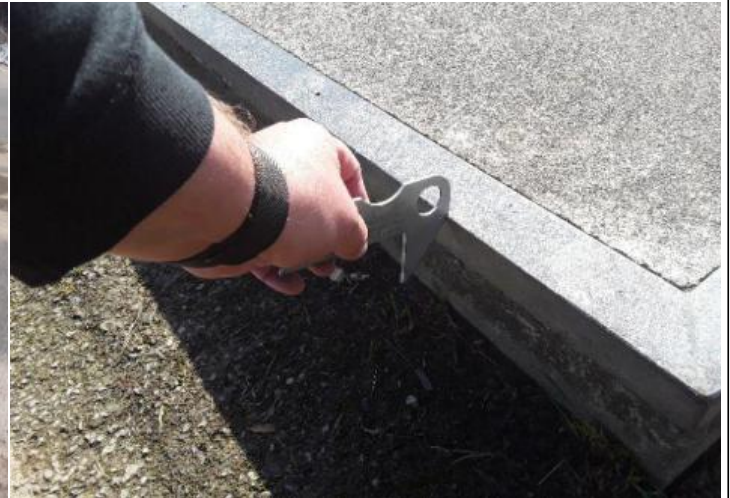
**Finding:** The item has exposed edges and corners with a radius of less than 3mm and fails the requirements of BS EN 14974

**Action:** Monitor - no remedial action recommended

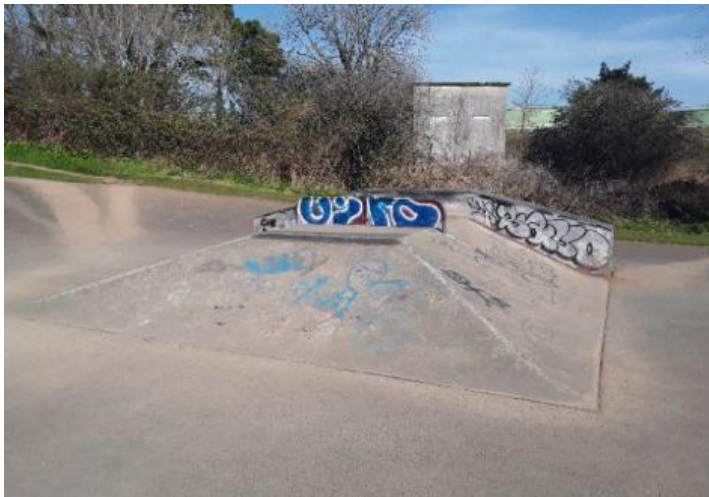
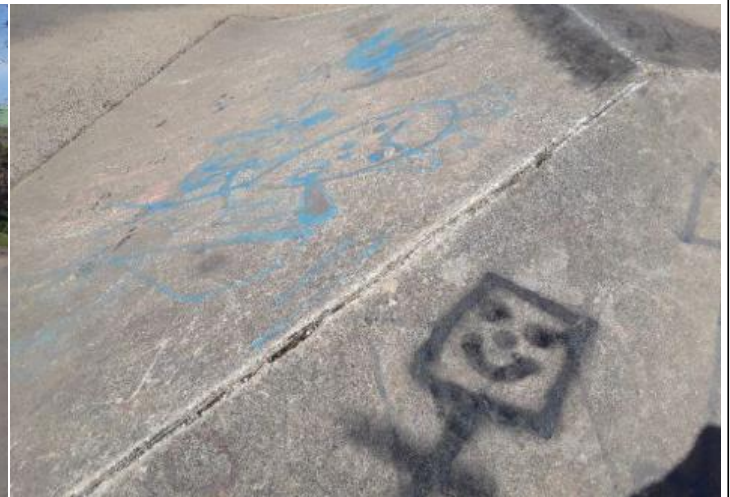
**Finding:** The riding surface of the ramp has some damage apparent

**Action:** Monitor for any further deterioration and repair as required

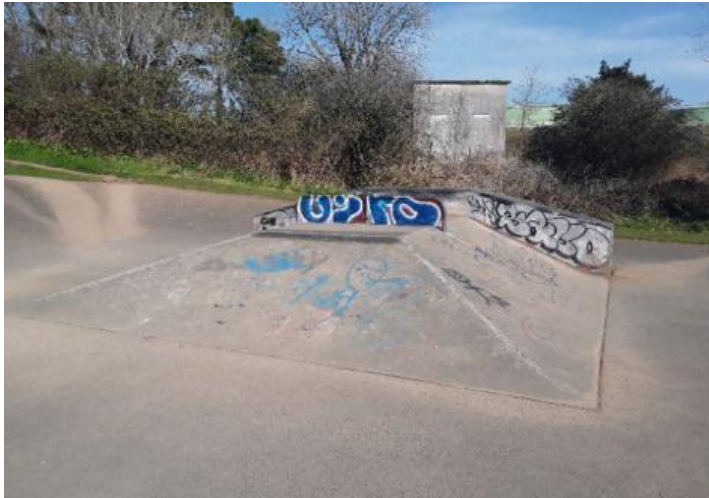
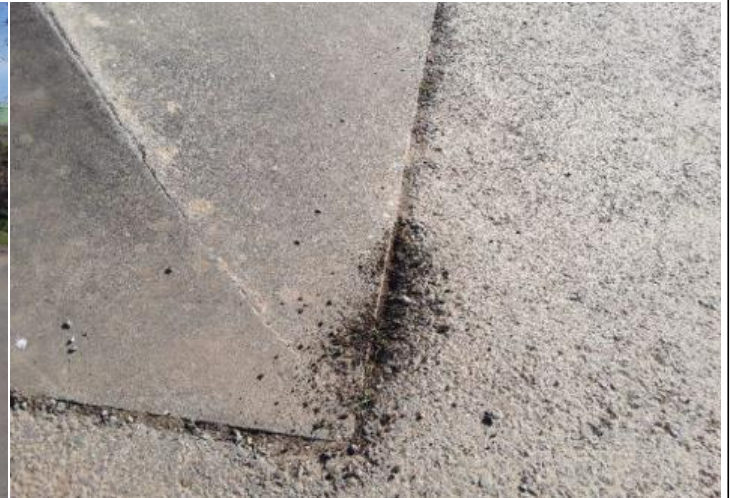
**Finding:** Joints between the riding surfaces should not be greater than 5mm to meet the requirements of BS EN 14974  
**Action:** Take corrective action to ensure that the gaps between the joints do not exceed 5mm

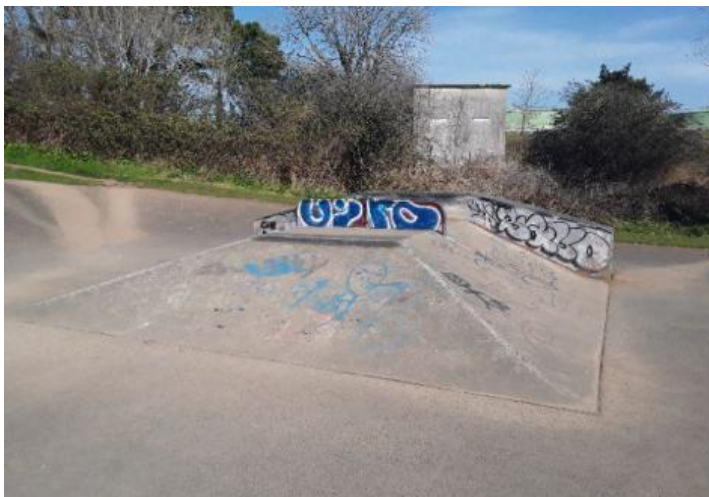
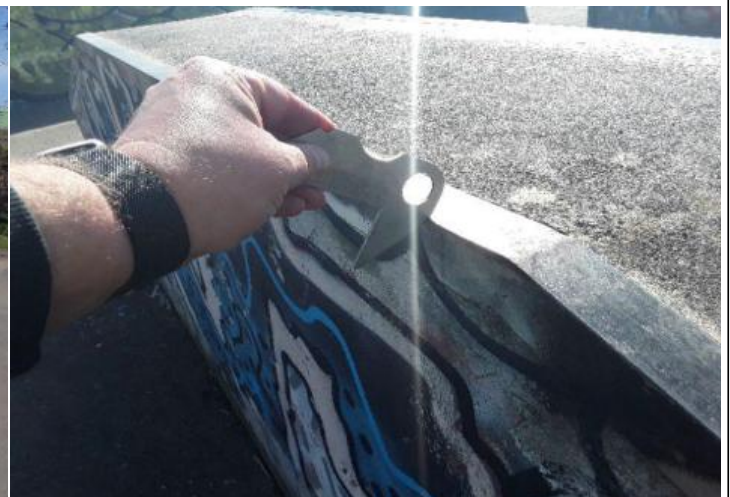
**Finding:** The item has exposed edges and corners with a radius of less than 3mm and fails the requirements of BS EN 14974  
**Action:** Monitor - no remedial action recommended

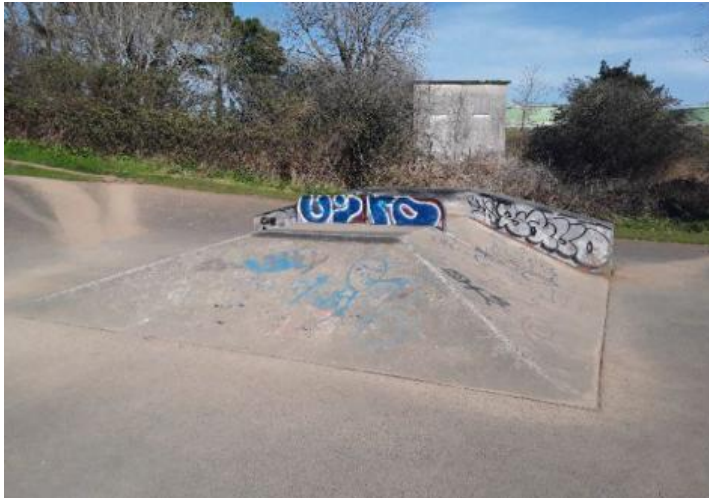
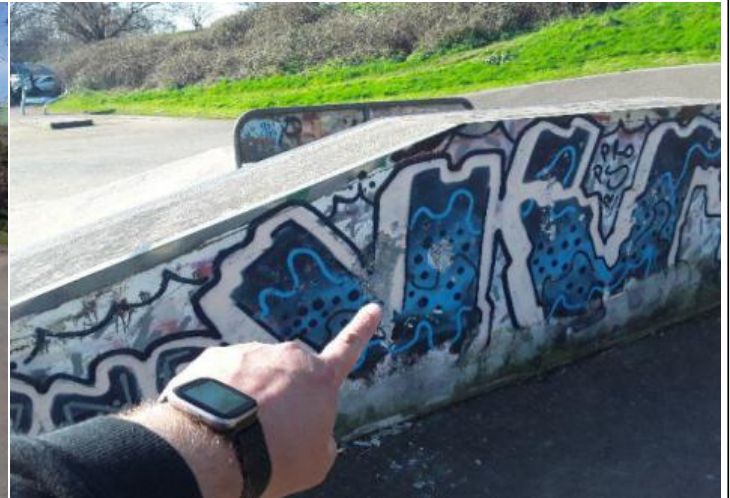
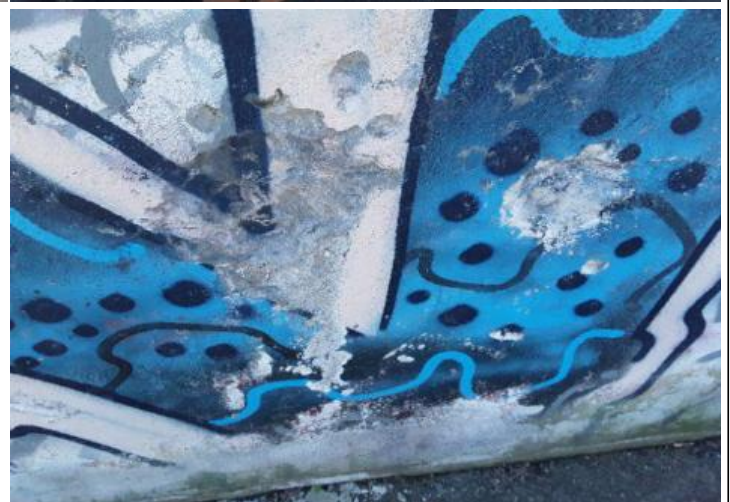
**Finding:** The concrete has been damaged at the side of the ramp  
**Action:** Monitor for any further deterioration and replace as required

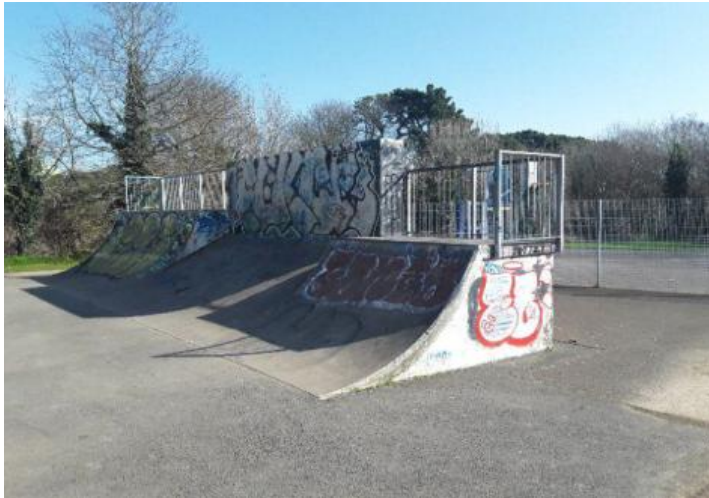
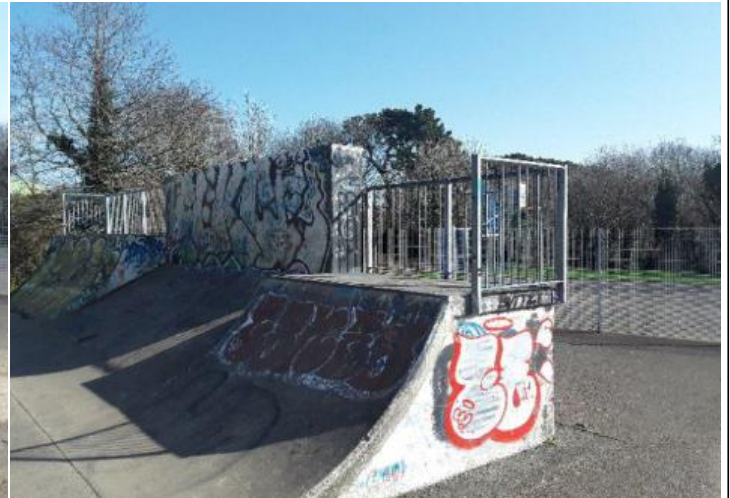
**Finding:** Barrier ends should have a radius of at least 50mm **Action:** Monitor, no remedial action is recommended as required by BS EN 14974

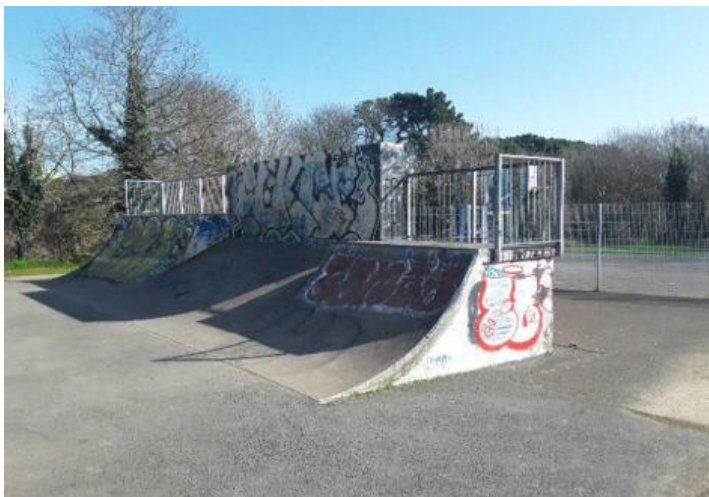
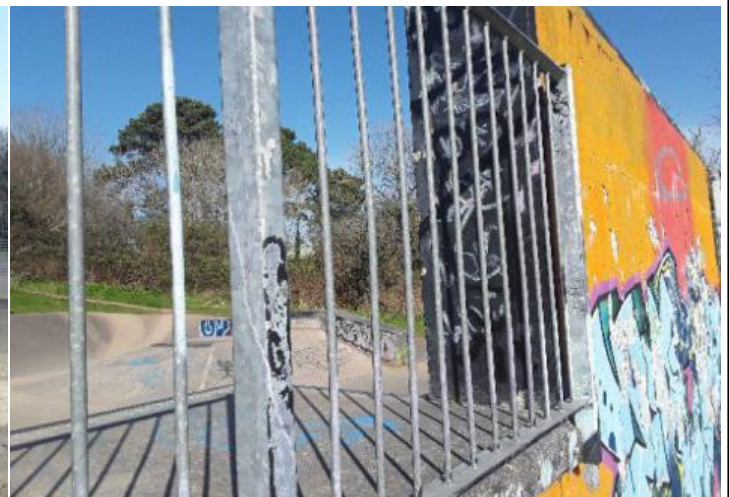
**Finding:** There is some damage to the barrier sections

**Action:** Monitor for any further deterioration and repair as required

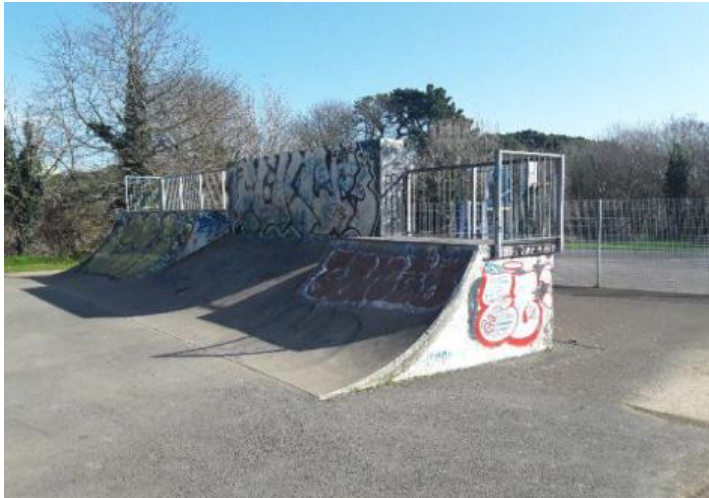
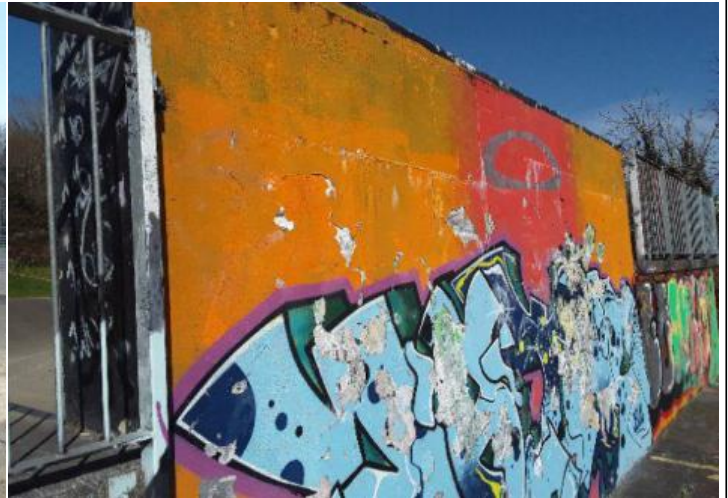
**Finding:** The paint is flaking off the wall

**Action:** Rub down and re-paint

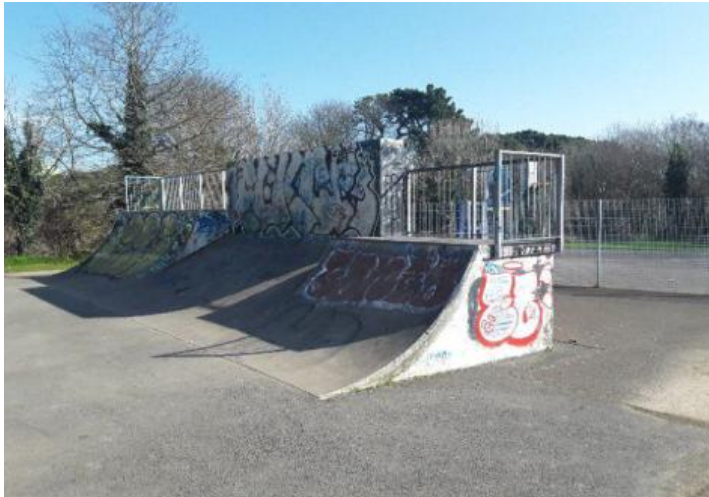
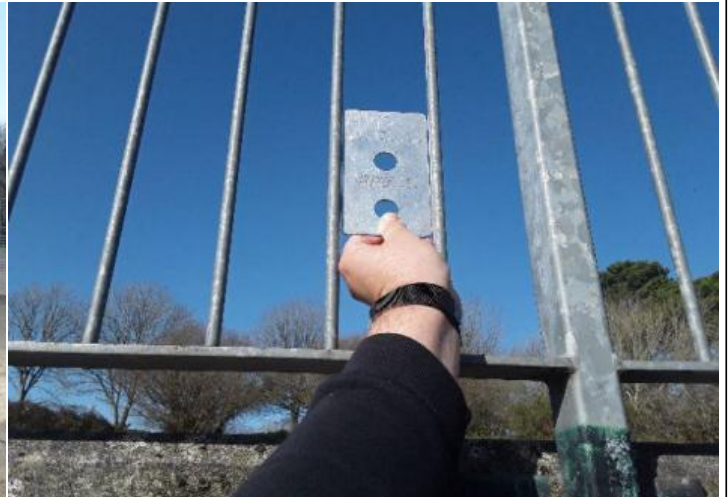
**Finding:** The horizontal opening in the barrier is in excess of 89mm and fails the requirements of BS EN 14974

**Action:** Monitor - No remedial work recommended

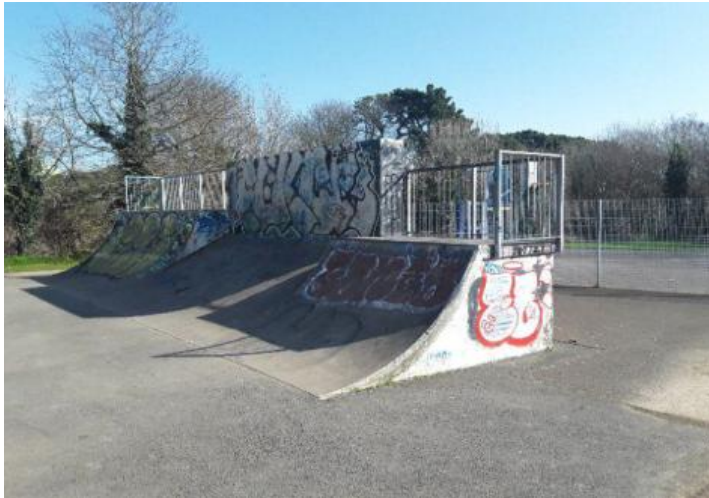
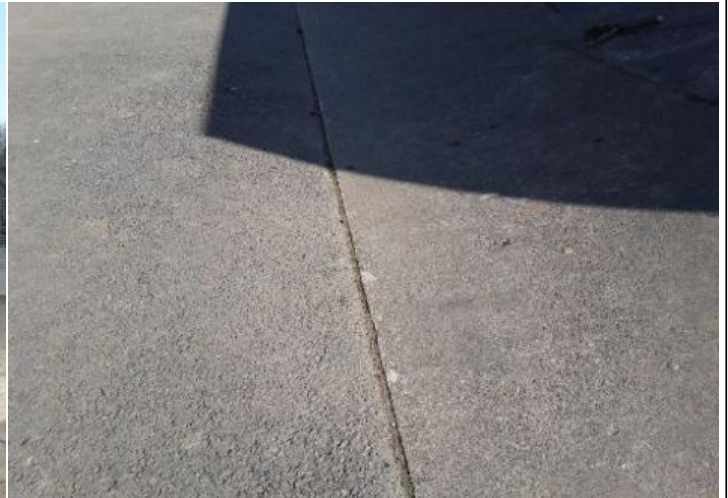
**Finding:** Joints between the riding surfaces should not be greater than 5mm to meet the requirements of BS EN 14974  
**Action:** Take corrective action to ensure that the gaps between the joints do not exceed 5mm

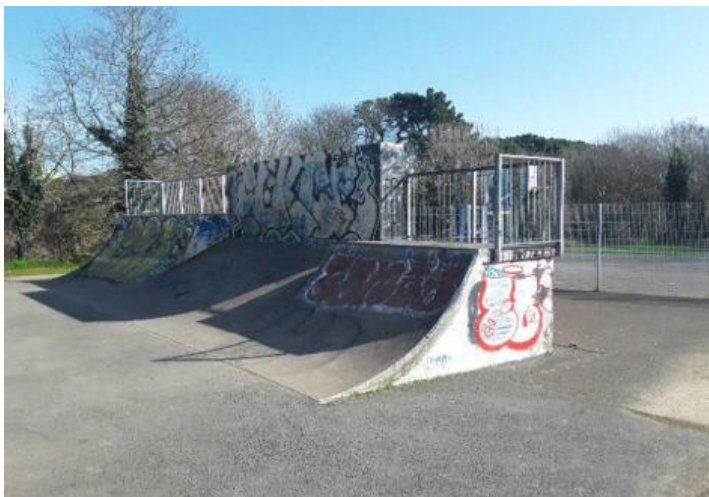
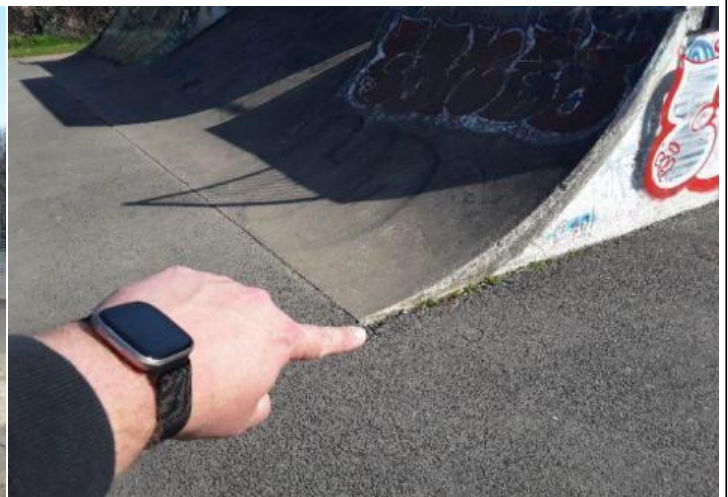
**Finding:** The riding surface of the ramp has some damage apparent  
**Action:** Monitor for any further deterioration and repair as required

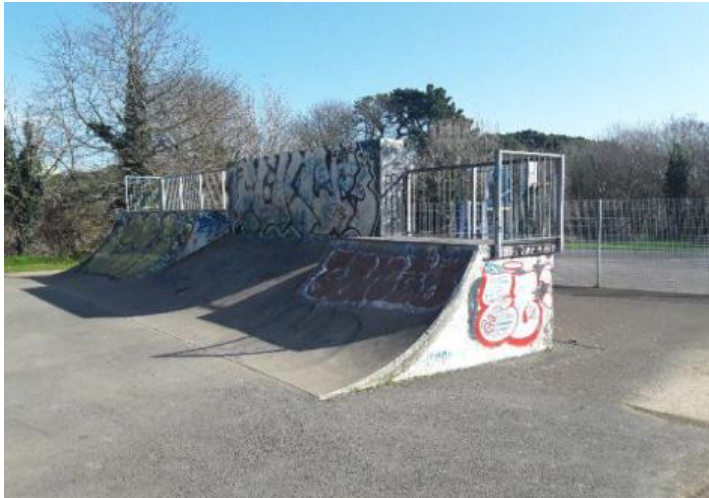
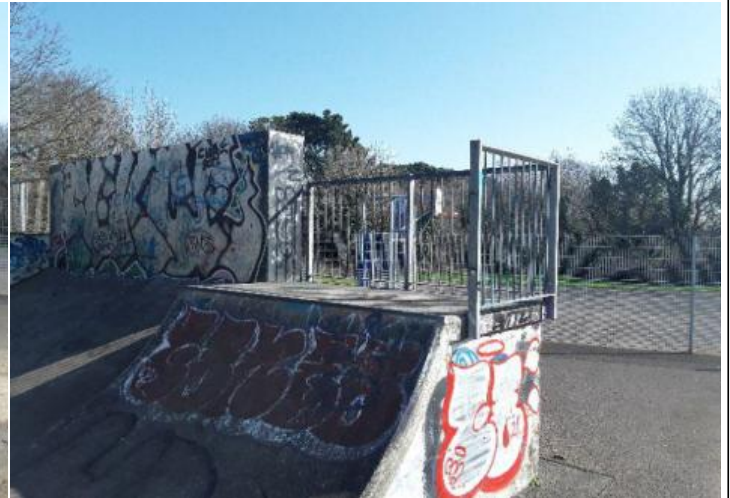
**Finding:** The height of the barrier is less than 1200mm and fails the requirements of BS EN 14974  
**Action:** Monitor - No remedial work recommended

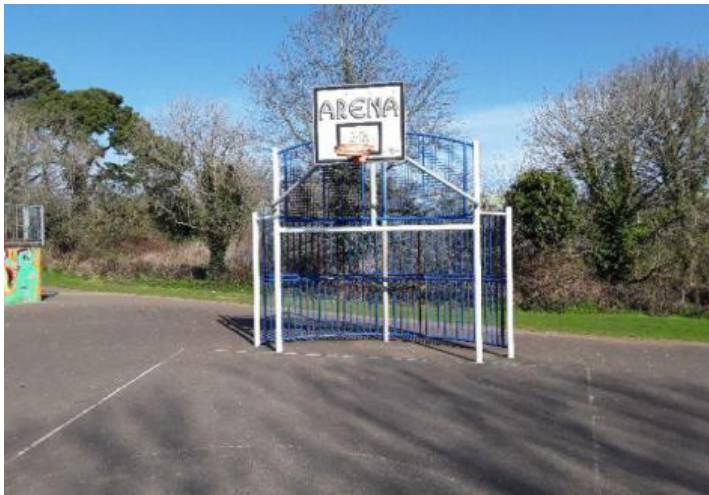
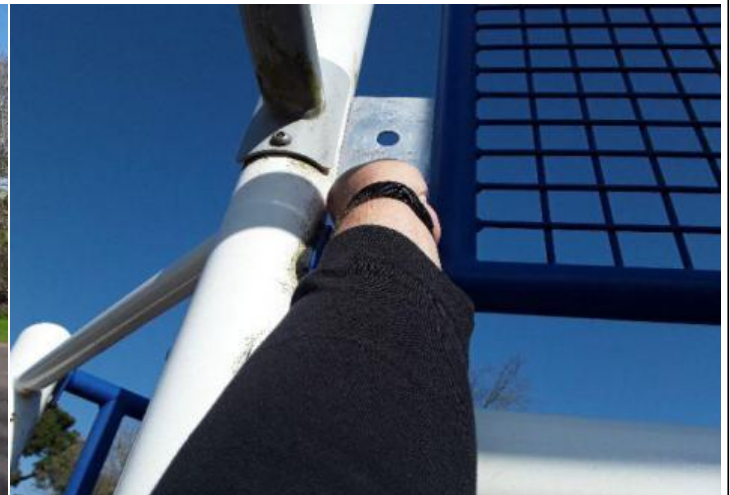
**Finding:** The item fails to meet the requirements of BS EN 15312 4.4.2.1 head and neck entrapment in the frame  
**Action:** Monitor - No remedial work recommended

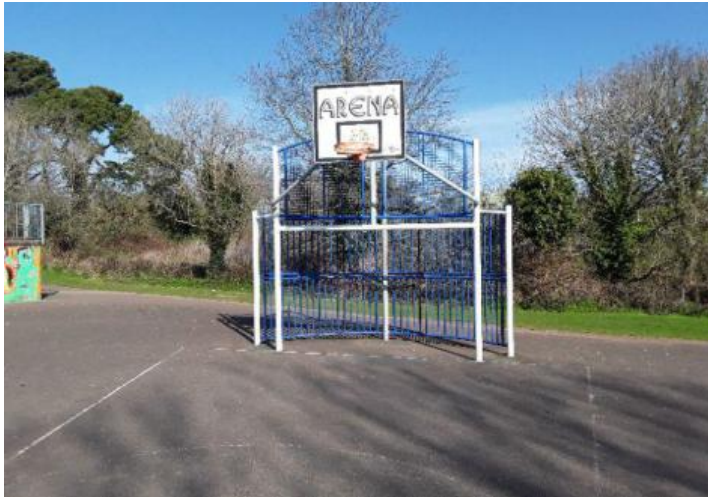
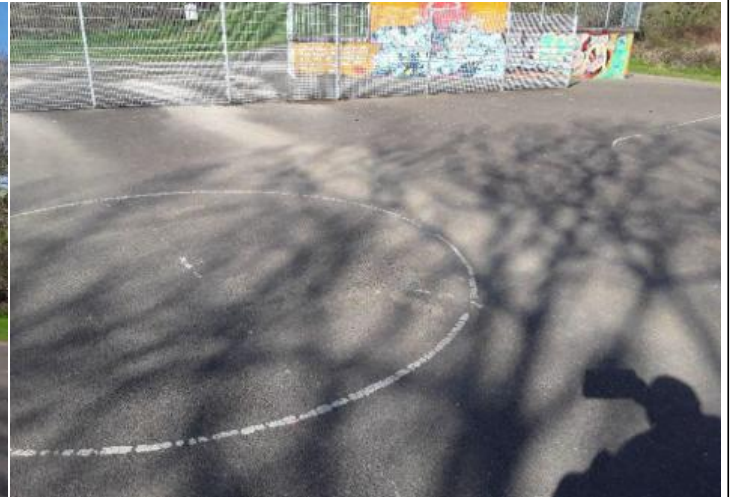
**Finding:** The bitumen surface is worn or damaged

**Action:** Repair the bitumen to provide a uniform surface

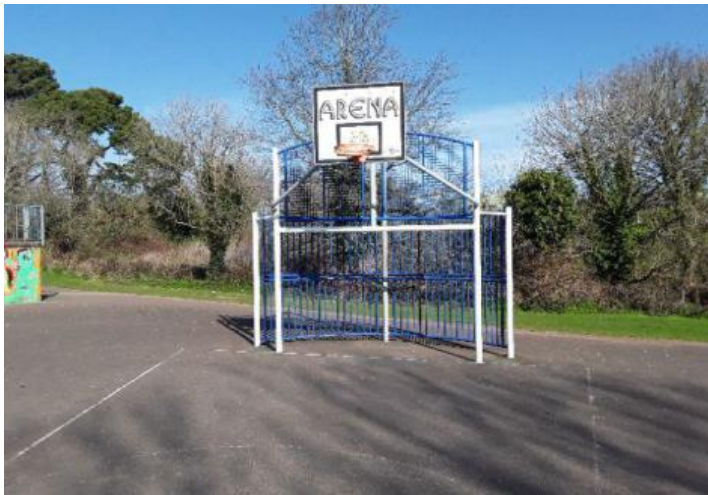
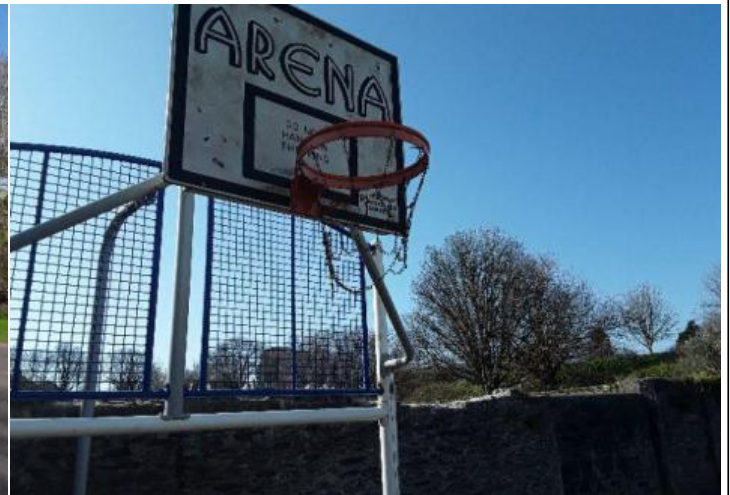
**Finding:** There is some damage to the netting

**Action:** Replace

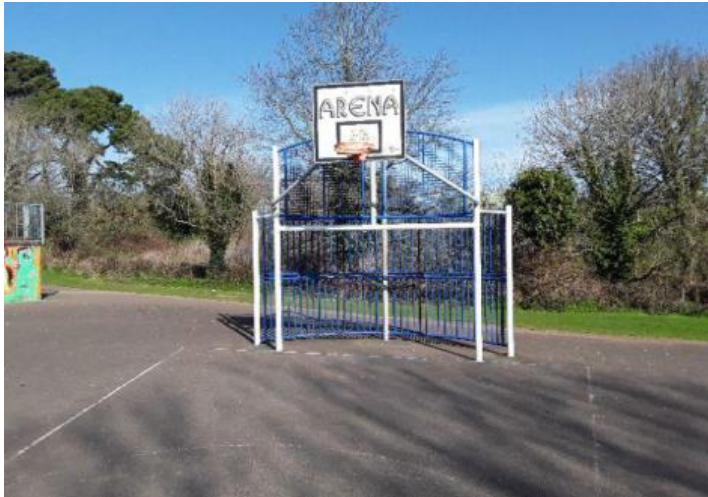
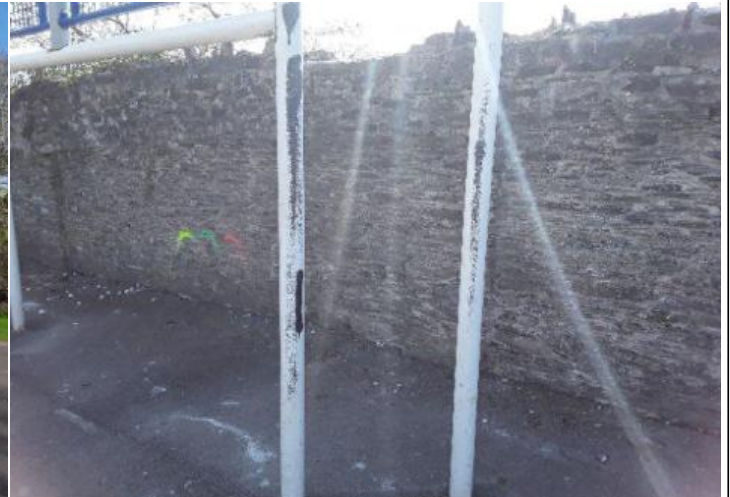
**Finding:** There is some graffiti present

**Action:** Remove the graffiti

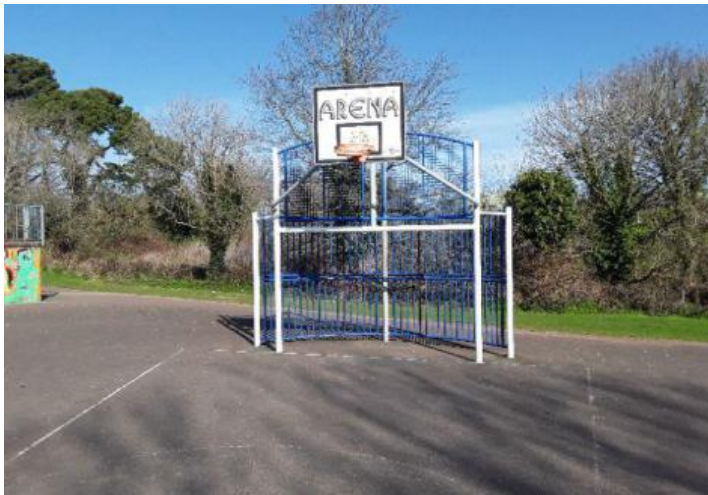
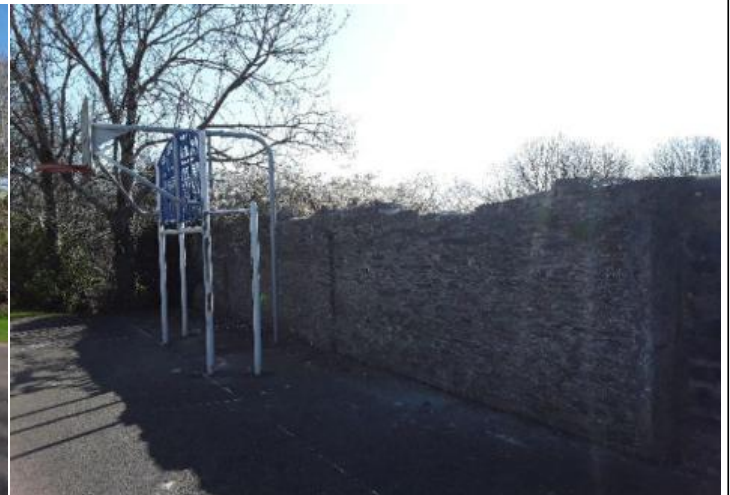
**Finding:** There is minor damage to the adjacent wall resulting in loose rocks on top of the wall and debris on the adjacent surface

**Action:** Repair as required to remove / secure all loose rocks, remove debris from the surface and maintain

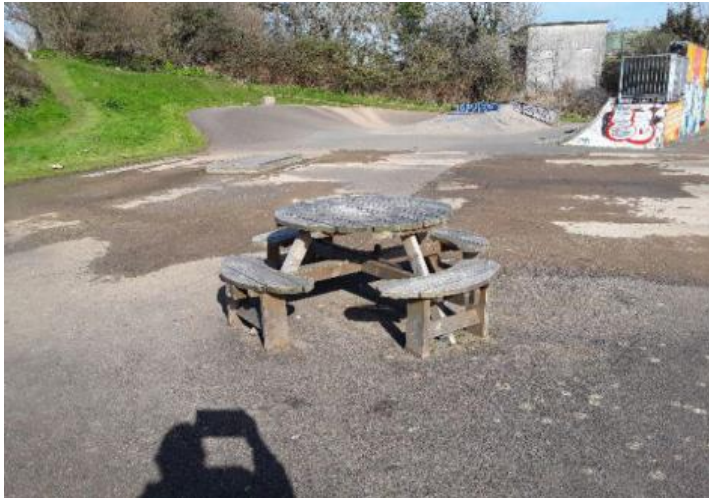
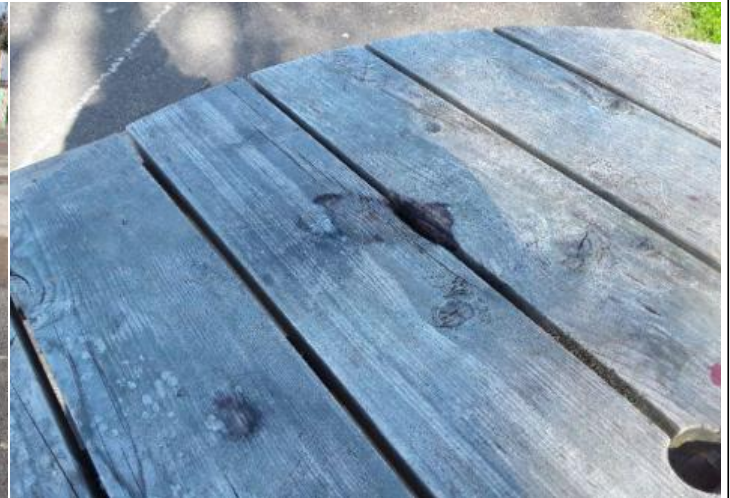
**Finding:** There is some evidence of fire damage to the item **Action:** Monitor for any further deterioration and repair as required

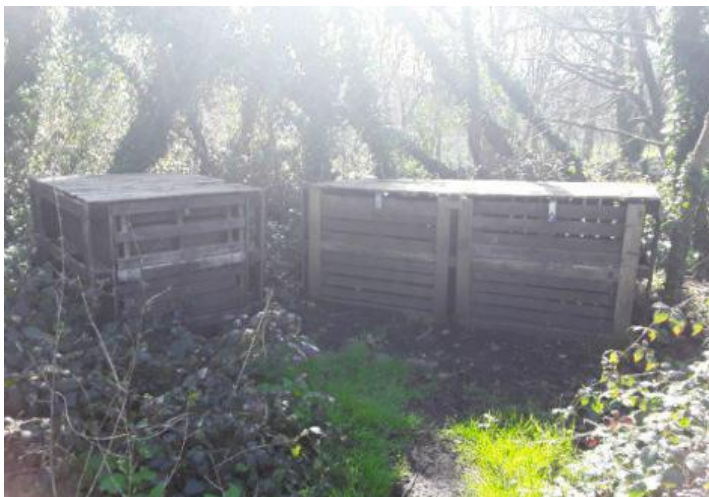
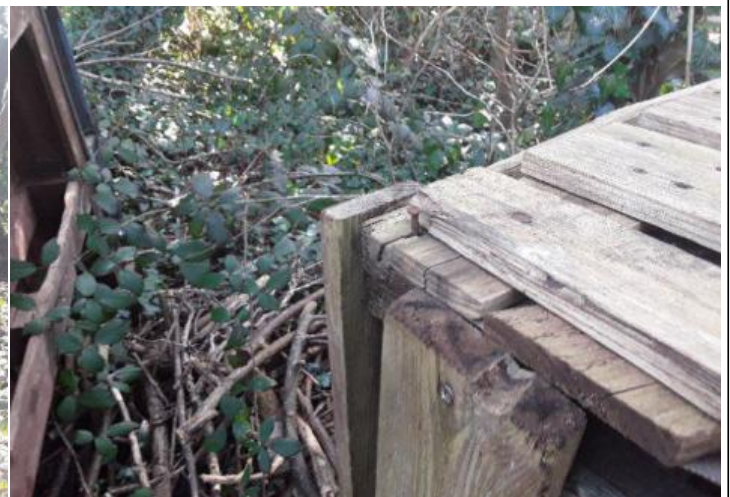
**Finding:** There are projecting nail ends present **Action:** Remove and provide more appropriate fixings if required
