## Annual Inspection

Torpoint Town Council

Torpoint Skateboard Park

Inspection Ref: 1610375

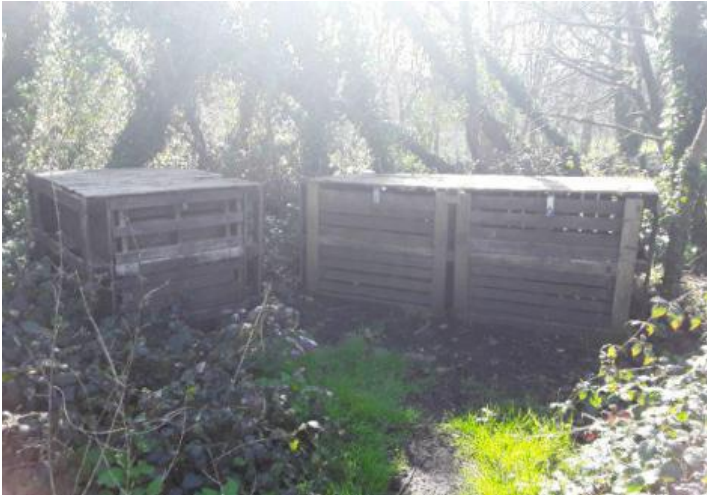
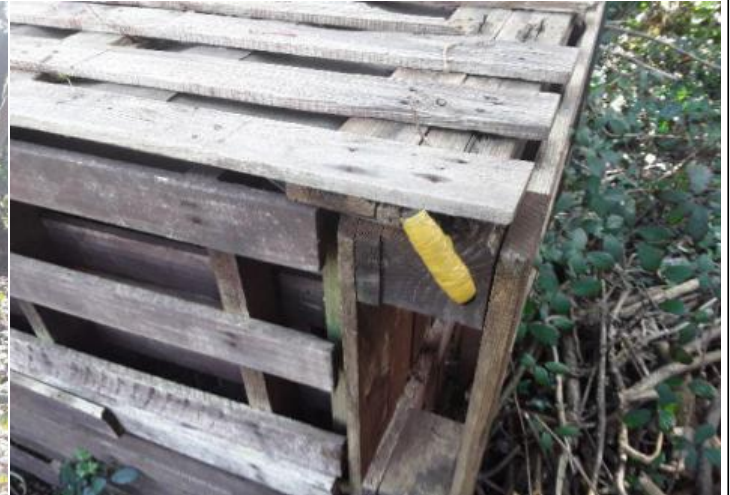
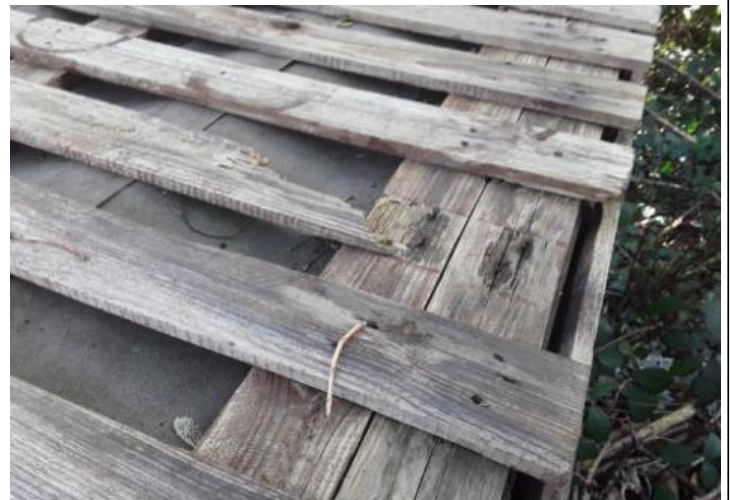
**Finding:** There are areas or parts of the timber on the structure that have rotted

**Action:** Replace all affected timbers

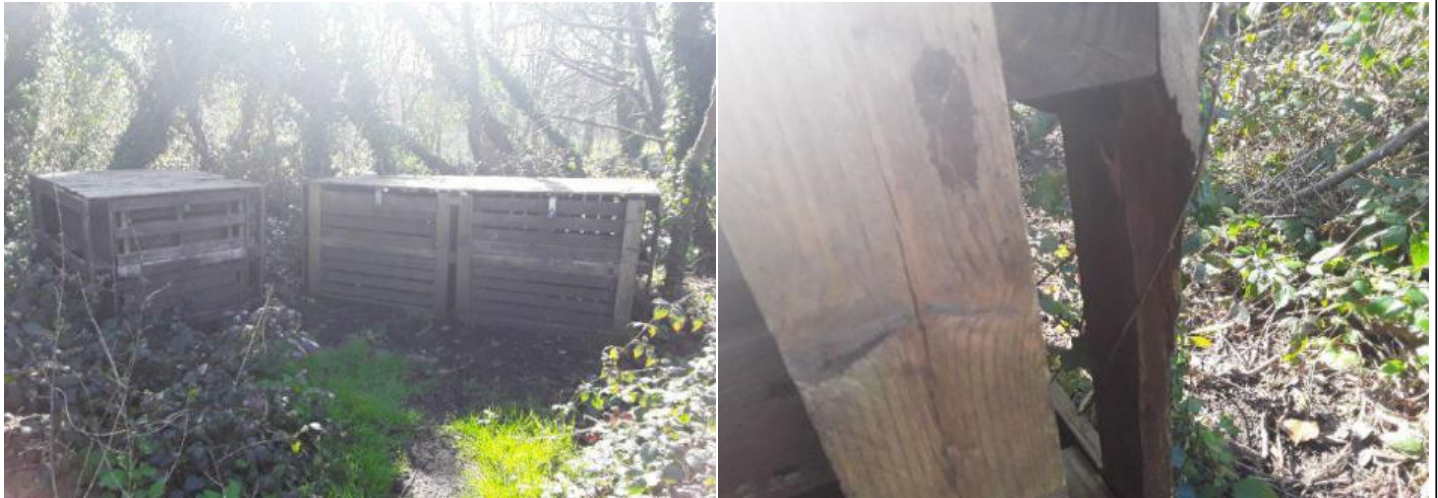
**Finding:** Parts of the timber are rough or splintered

**Action:** Remove all rough or sharp edges
