the play inspection company

Annual Inspection

Torpoint Town Council

Cambridge Field

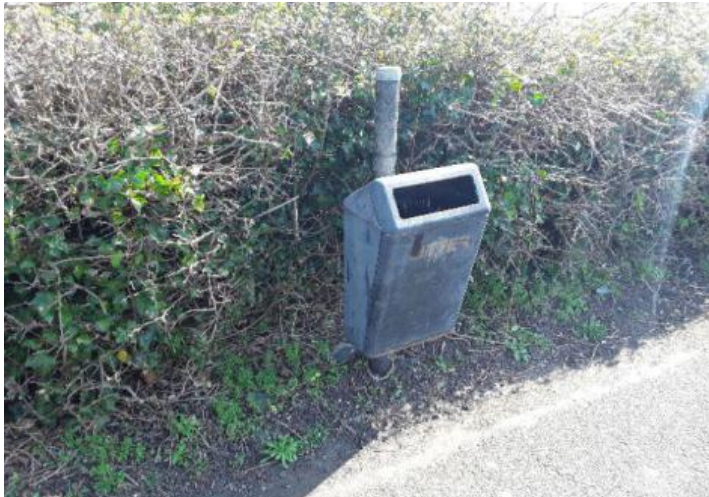
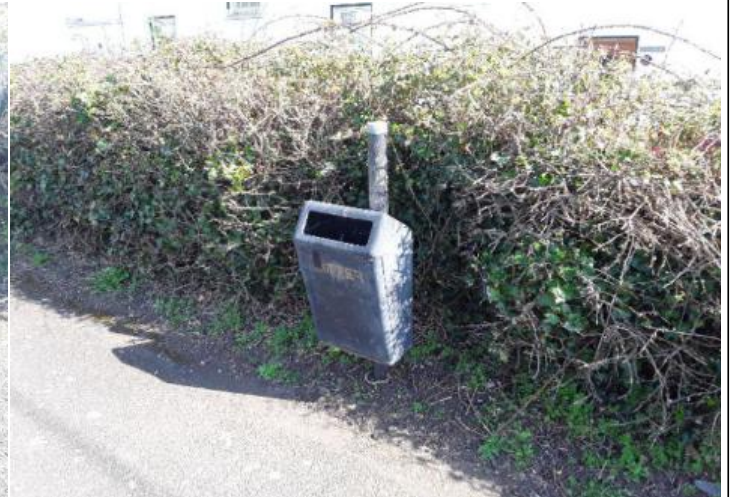
The item is slightly loose in its foundations - Monitor for any further deterioration and repair as required

Finding: The item is slightly loose in its foundations

Action: Monitor for any further deterioration and repair as required

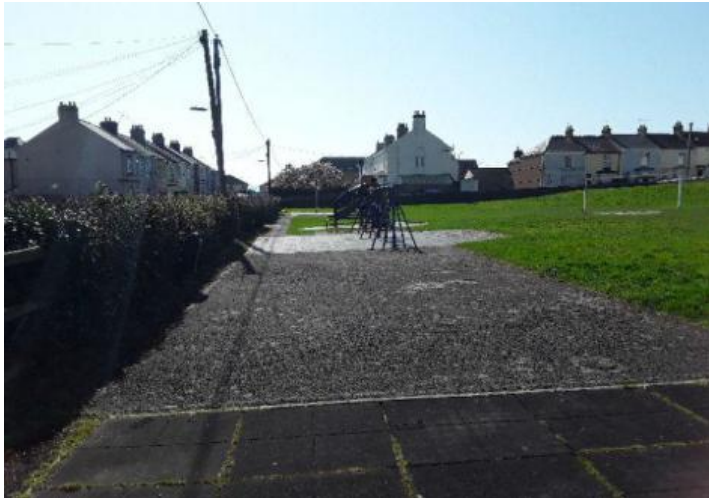
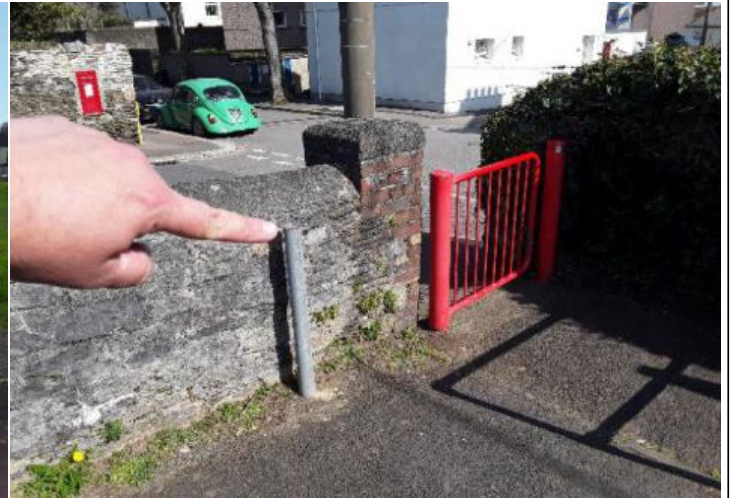
Finding: There are post / end caps missing from the item

Action: Replace missing post caps

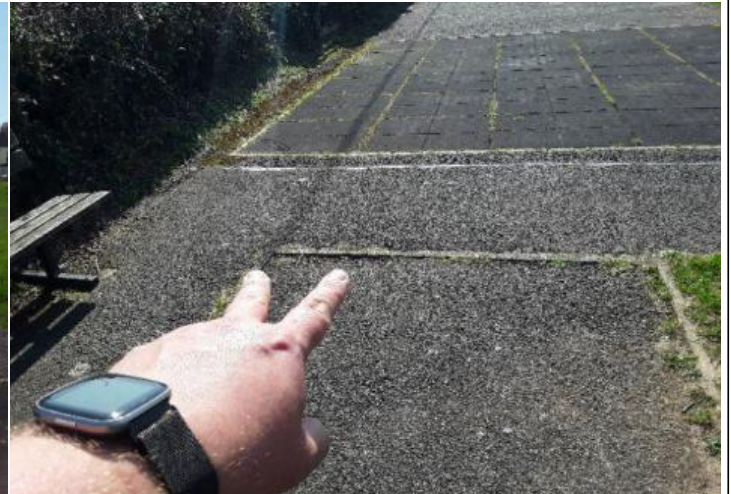
There are trip hazards present - Reinstate surrounding surfaces to level to remove the trip points

Finding: There are trip hazards present

Action: Reinstate surrounding surfaces to level to remove the trip points

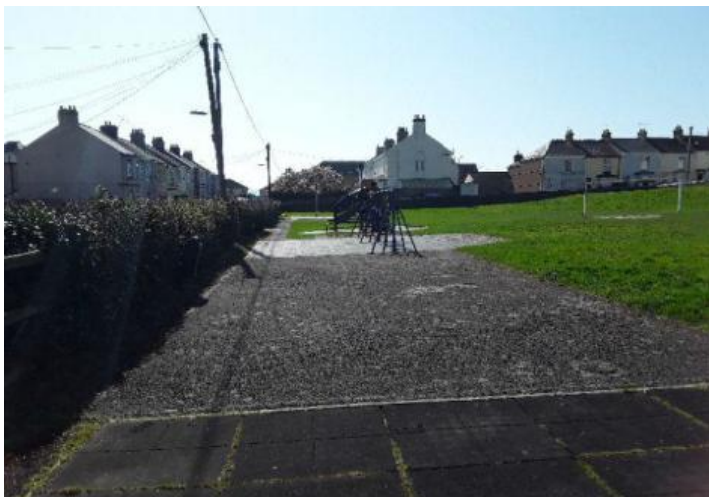
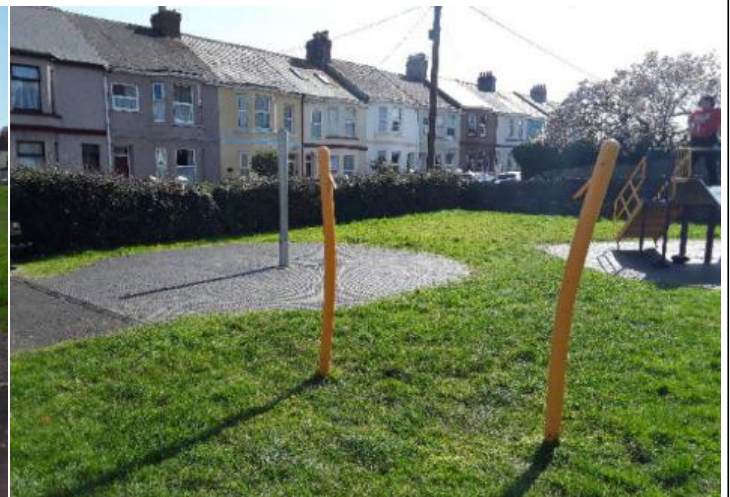
There are some redundant items of equipment in the area - Repair or remove the remaining structures

Finding: There are some redundant items of equipment in the area

Action: Repair or remove the remaining structures

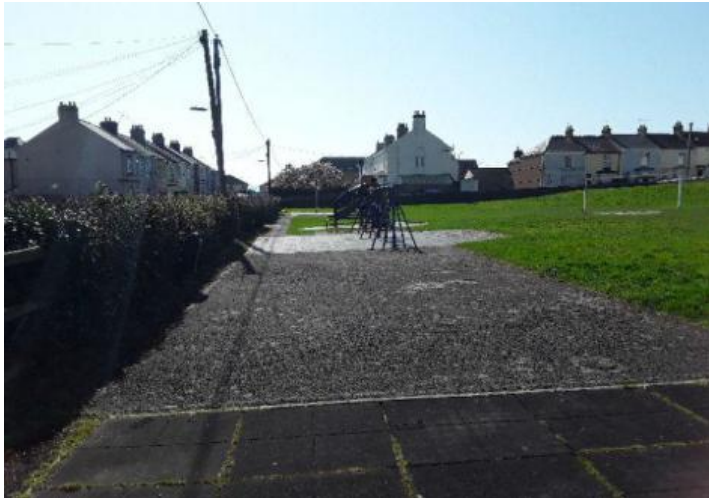
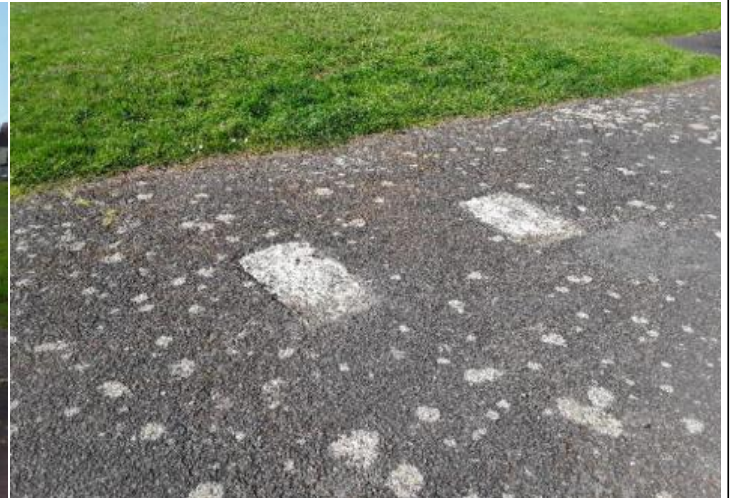
The bitumen surface is worn or damaged in places - Repair the bitumen to provide a uniform surface

Finding: The bitumen surface is worn or damaged in places **Action:** Repair the bitumen to provide a uniform surface

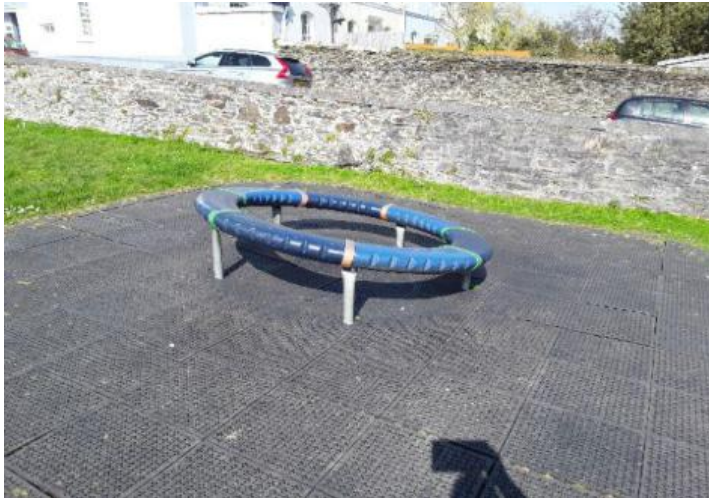
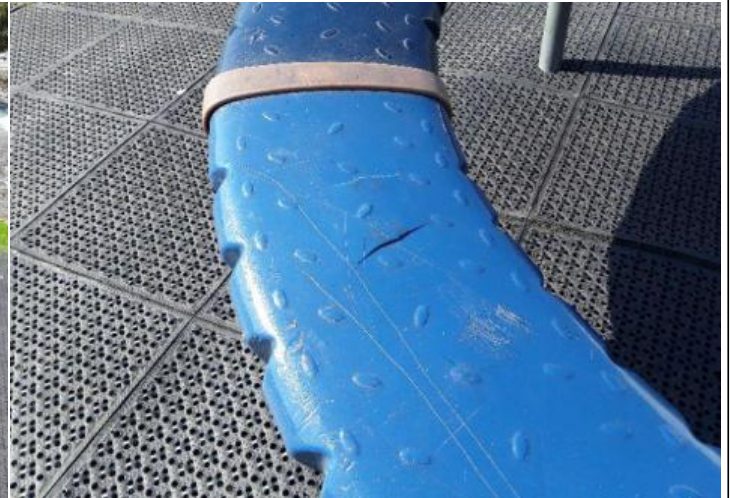
There are large cracks in the body of the unit - Repair or replace the item

Finding: There are large cracks in the body of the unit

Action: Repair or replace the item

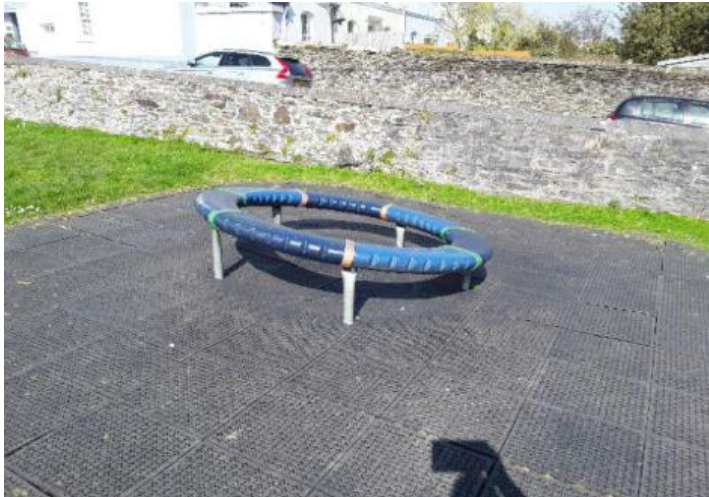
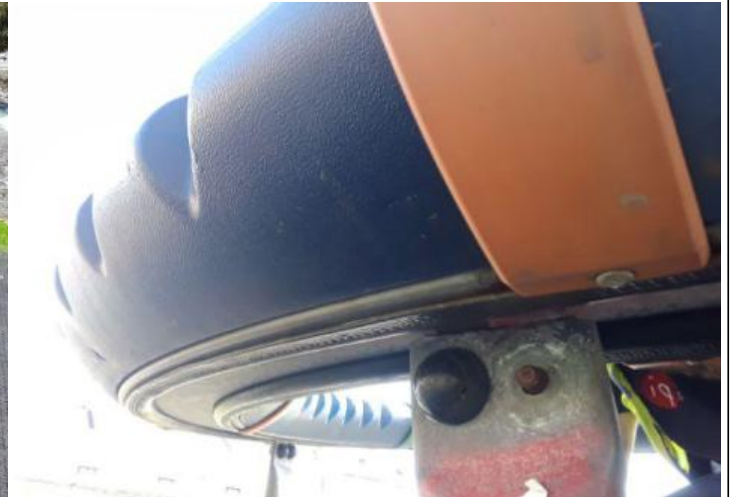
Finding: There is or are fixings missing on the item

Action: Replace all missing fixings

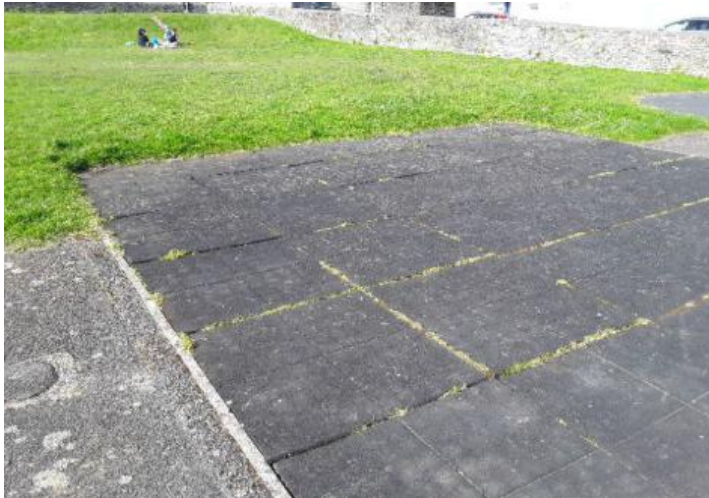
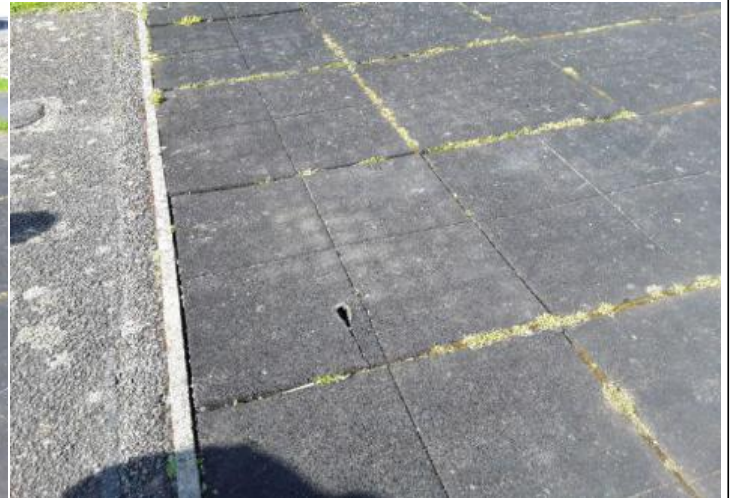
Finding: There is some minor damage to the surface

Action: Monitor for any further deterioration and repair as required

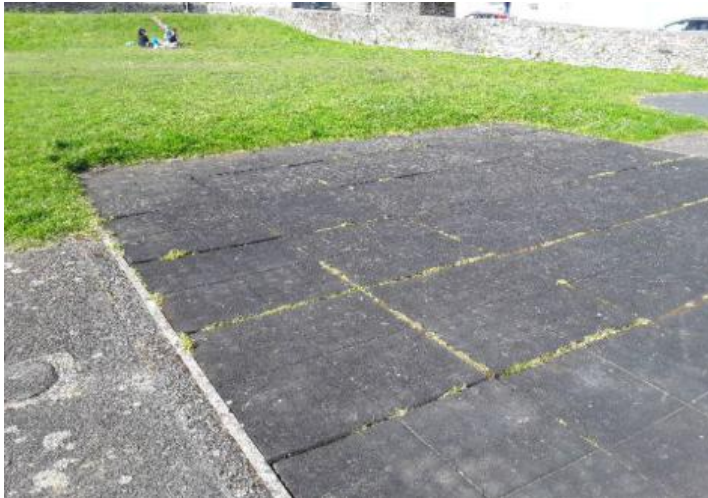
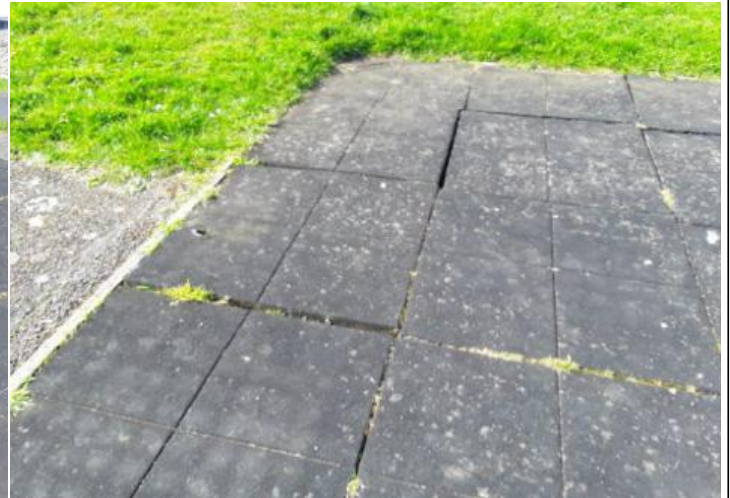
There are gaps opening in between the tiles - Monitor for any further deterioration and repair as required

Finding: There are gaps opening in between the tiles

Action: Monitor for any further deterioration and repair as required

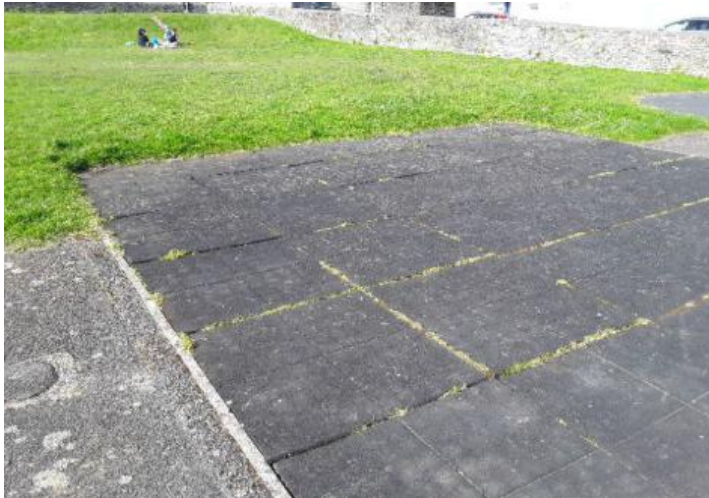
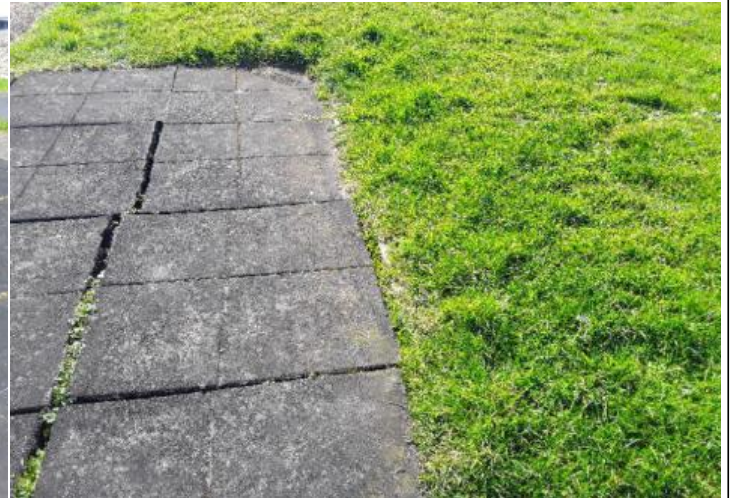
There are significant gaps (over 30mm) between the surface and the edging or between the joints in the surface; these are large enough for a small foot to enter - Repair surfacing

Finding: There are significant gaps (over 30mm) between the surface and the edging or between the joints in the surface; these are large enough for a small foot to enter

Action: Repair surfacing

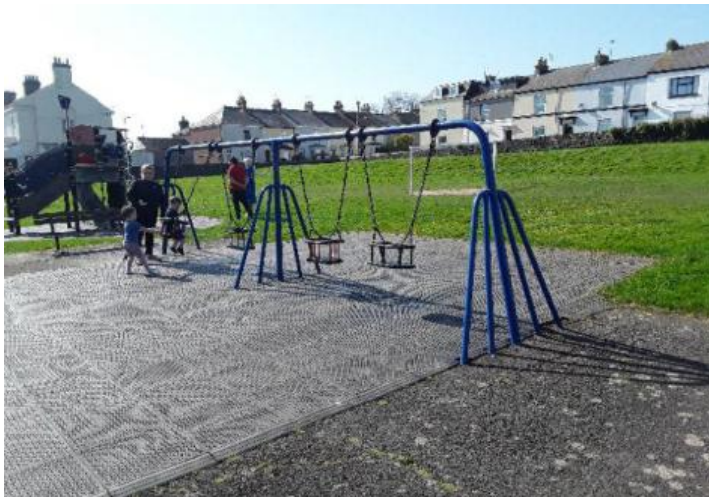
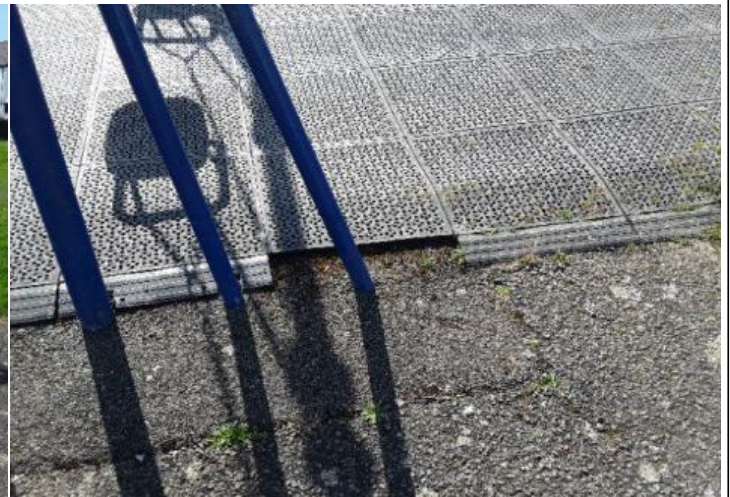
Finding: There is some minor damage to the surface

Action: Monitor for any further deterioration and repair as required

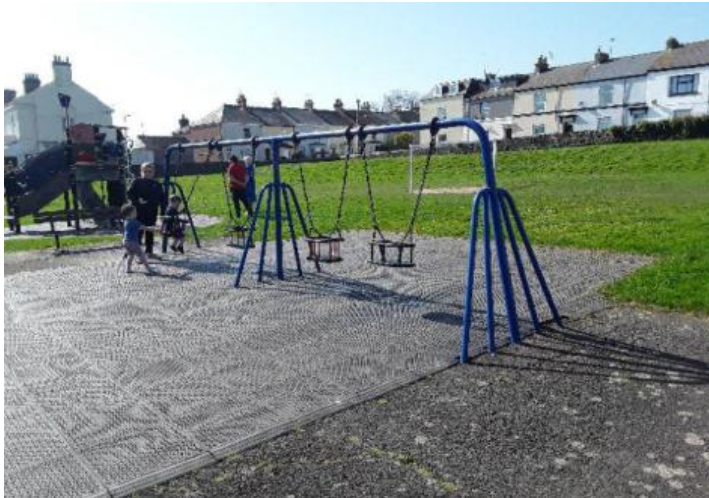
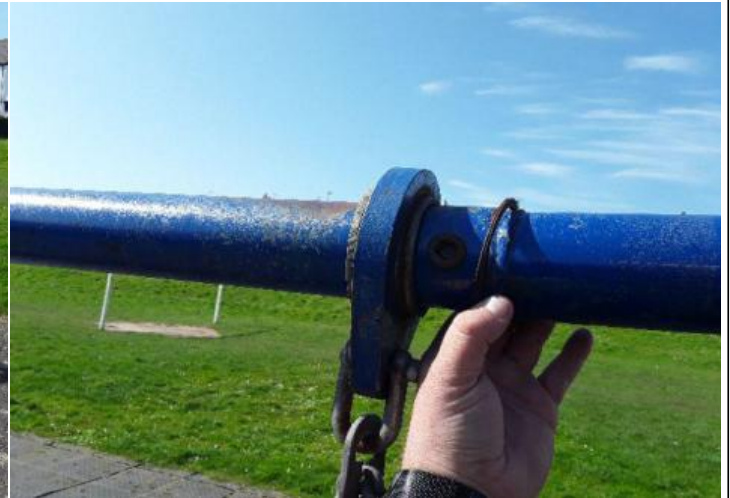
The anti wrap mechanism is damaged - Replace

Finding: The anti wrap mechanism is damaged

Action: Replace

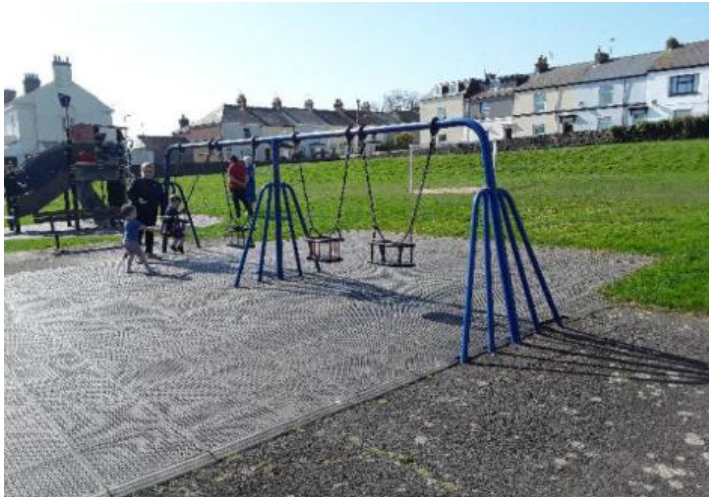
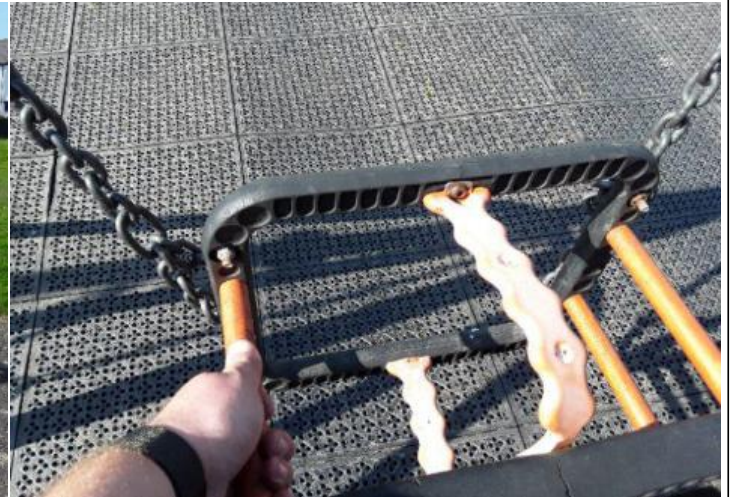
There are caps missing from the underside of the seats - Replace missing caps under the seats

Finding: There are caps missing from the underside of the seats

Action: Replace missing caps under the seats

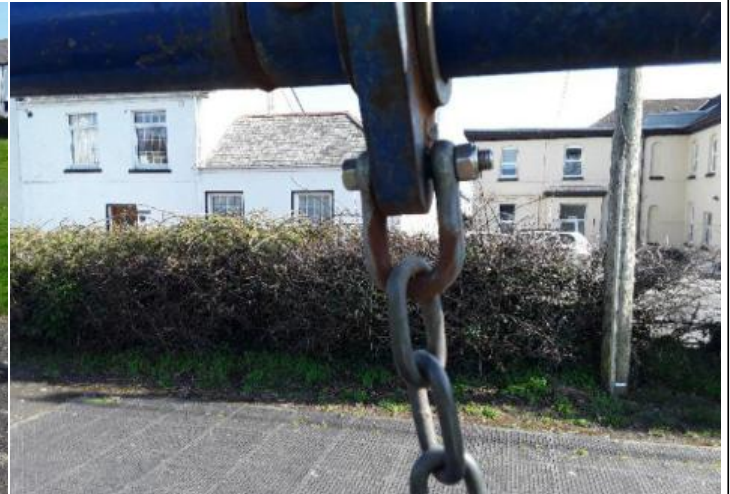
The bushes are showing signs of wear - Monitor for any further deterioration and replace as required

Finding: The bushes are showing signs of wear

Action: Monitor for any further deterioration and replace as required

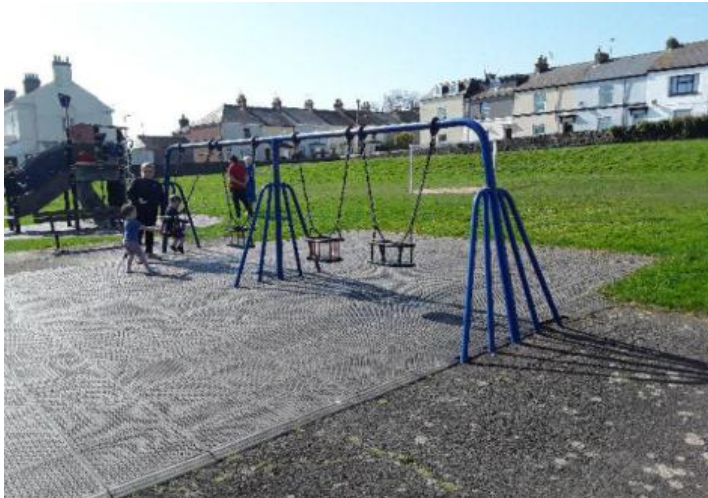
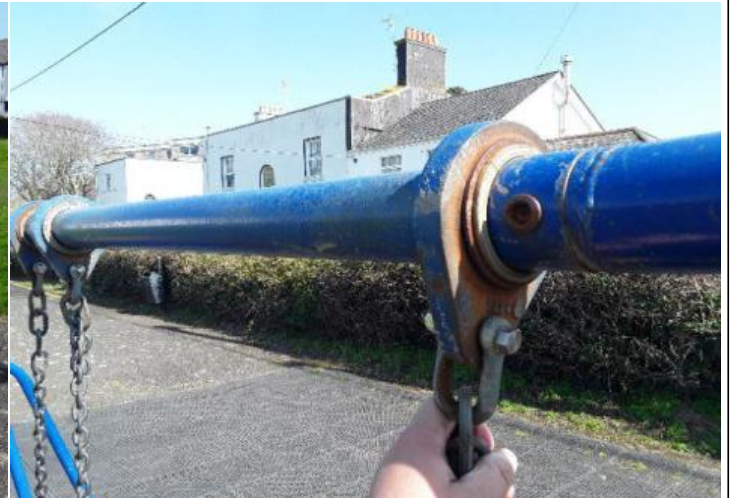
The Anti Wrap bearings are dry and not moving freely - Lubricate bearings in accordance with the manufacturers recommendations

Finding: The Anti Wrap bearings are dry and not moving freely

Action: Lubricate bearings in accordance with the manufacturers recommendations

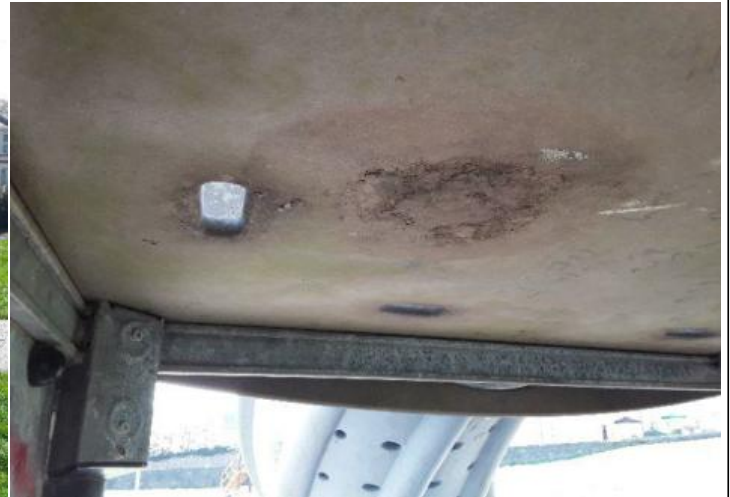
There is some evidence of fire damage to the item - Monitor for any further deterioration and repair as required

Finding: There is some evidence of fire damage to the item

Action: Monitor for any further deterioration and repair as required

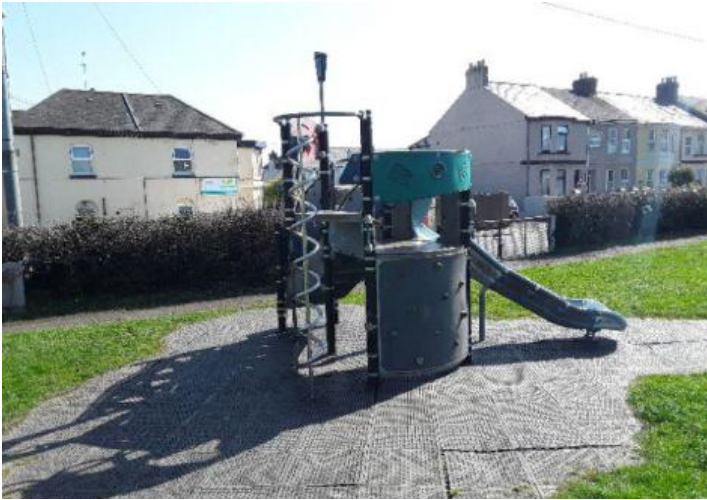
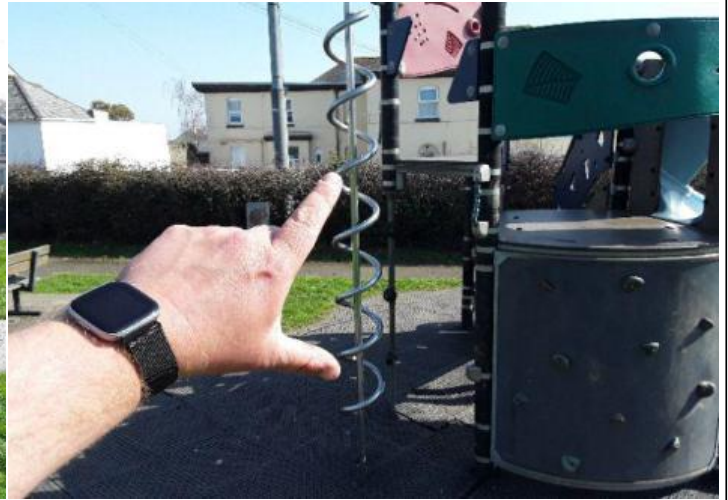
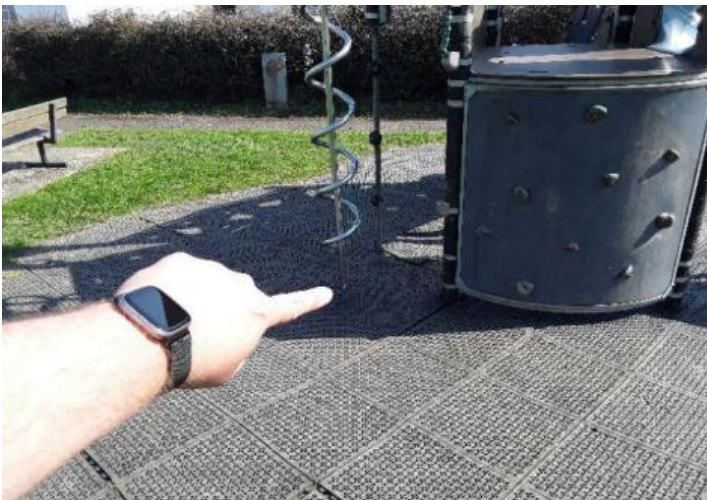
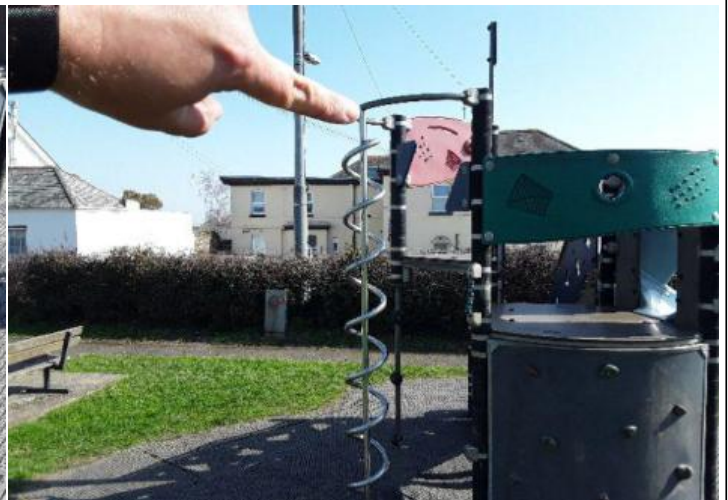
There is excessive movement in the corkscrew due to loose or missing fixings - Repair or replace

Finding: There is excessive movement in the corkscrew due to loose or missing fixings

Action: Repair or replace

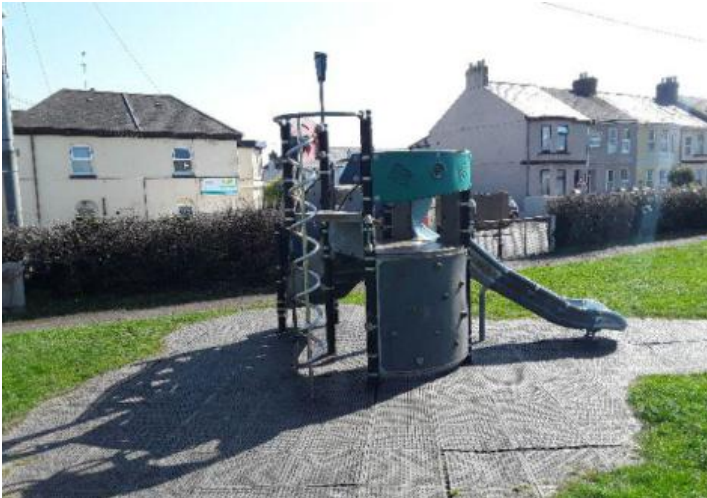
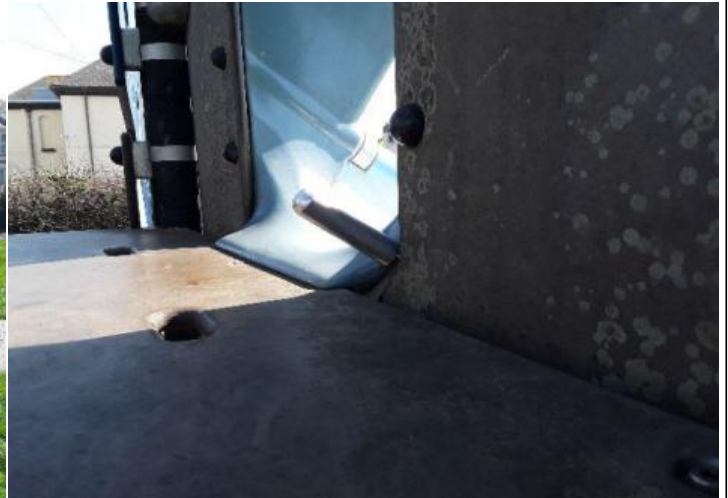
There is/are finger entrapment/s in the frame and the item fails to meet the requirements of BS EN 1176 Part 1 4.2.7.6 Entrapment of fingers - Monitor - No remedial work recommended

Finding: There is/are finger entrapment/s in the frame and the item fails to meet the requirements of BS EN 1176 Part 1 4.2.7.6 Entrapment of fingers

Action: Monitor - No remedial work recommended

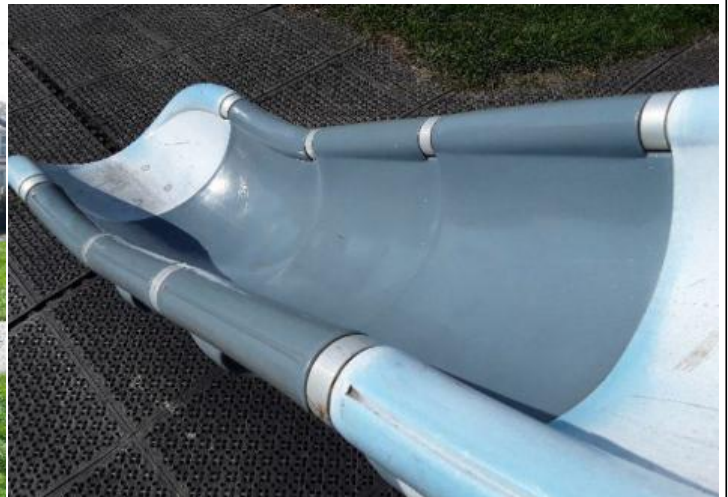
There is some minor damage to the slide surface - Monitor for any further deterioration and replace as required

Finding: There is some minor damage to the slide surface

Action: Monitor for any further deterioration and replace as required

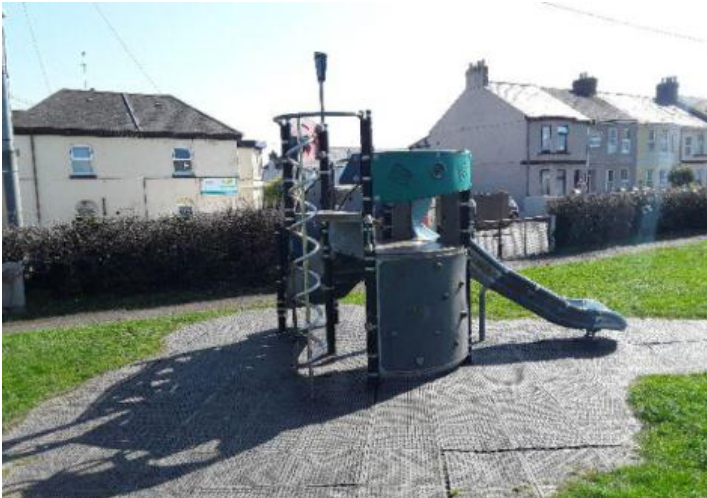
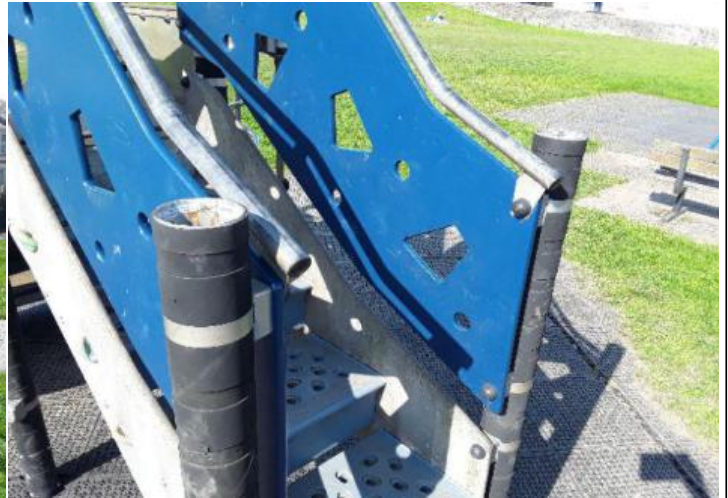
Finding: There are post / end caps missing from the item

Action: Replace missing post caps

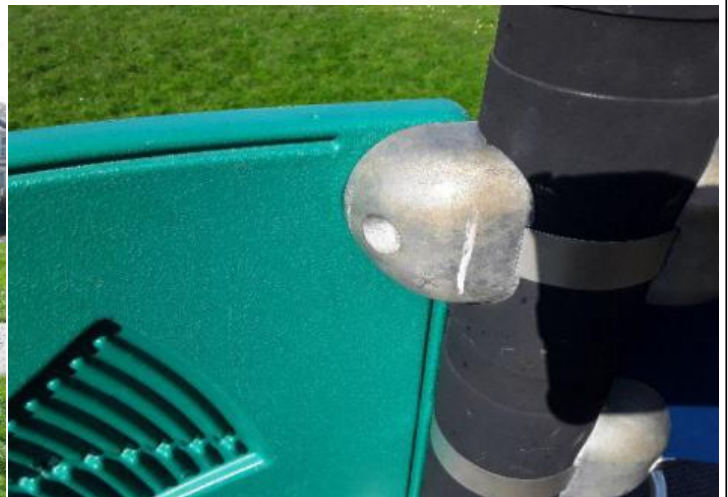
Finding: There is/are several inserts missing

Action: Replace missing inserts

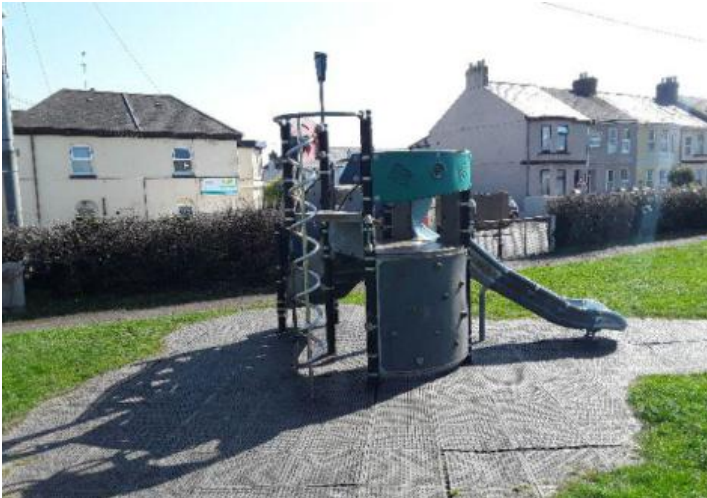
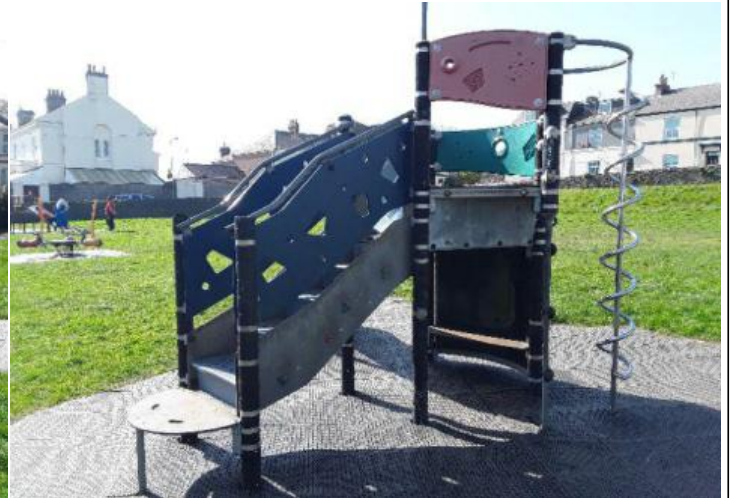
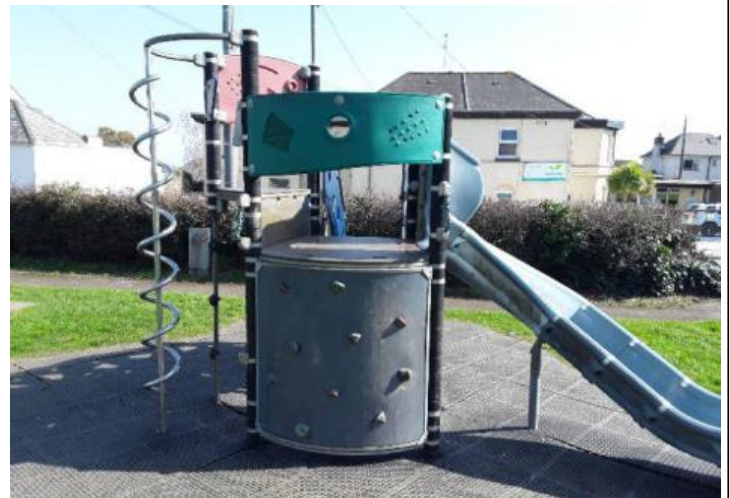
There is an opening in the barriers exceeding the width allowed (500mm) in BS EN 1176, this is a low risk failure and no remedial action is required - Monitor - No remedial work recommended

Finding: There is an opening in the barriers exceeding the width allowed (500mm) in BS EN 1176, this is a low risk failure and no remedial action is required

Action: Monitor - No remedial work recommended

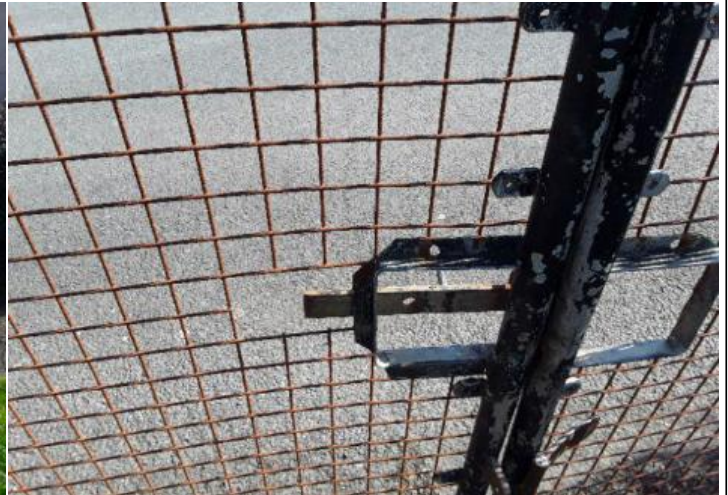
Finding: The paintwork on this item has been damaged or worn exposing the metal underneath which is rusting

Action: Treat any rusting components and repaint

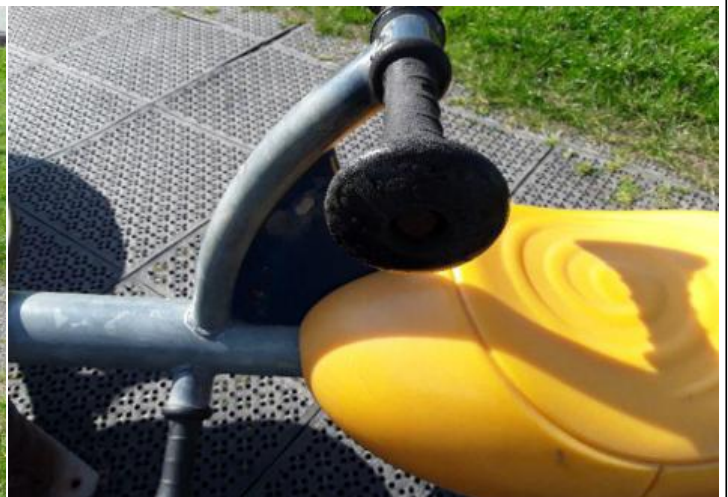
The end caps are missing on the Handgrips/Footrests - Replace missing end caps

Finding: The end caps are missing on the Handgrips/Footrests

Action: Replace missing end caps

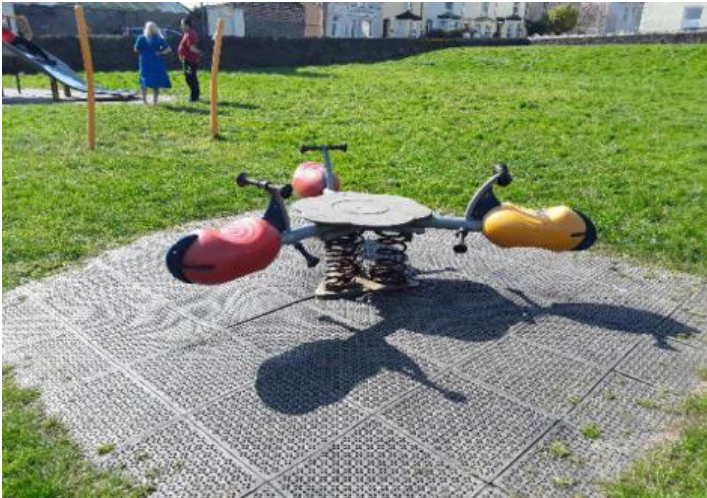
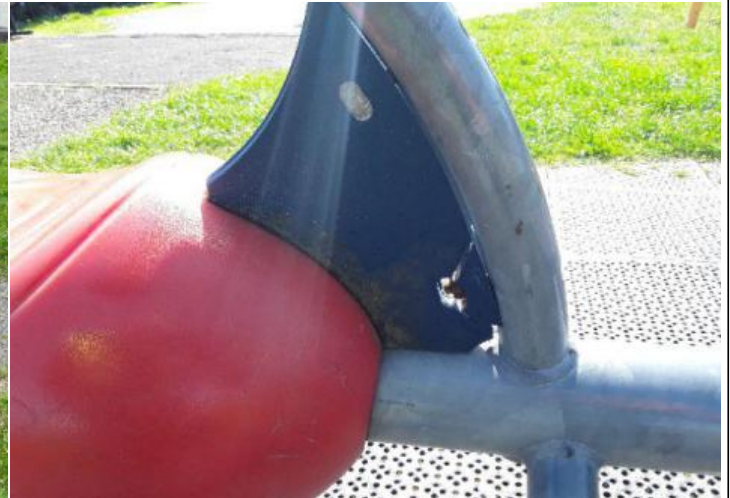
The plastic panels are damaged on the unit - Repair or replace the item

Finding: The plastic panels are damaged on the unit

Action: Repair or replace the item

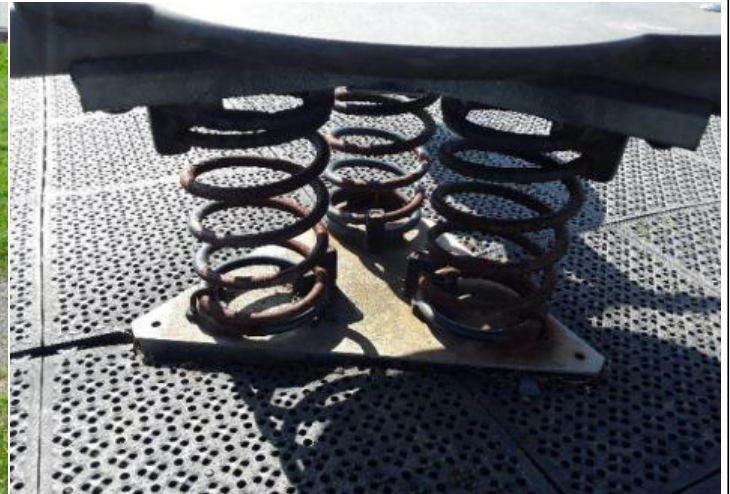
The spring clamps are loose - Tighten all loose fixings

Finding: The spring clamps are loose

Action: Tighten all loose fixings

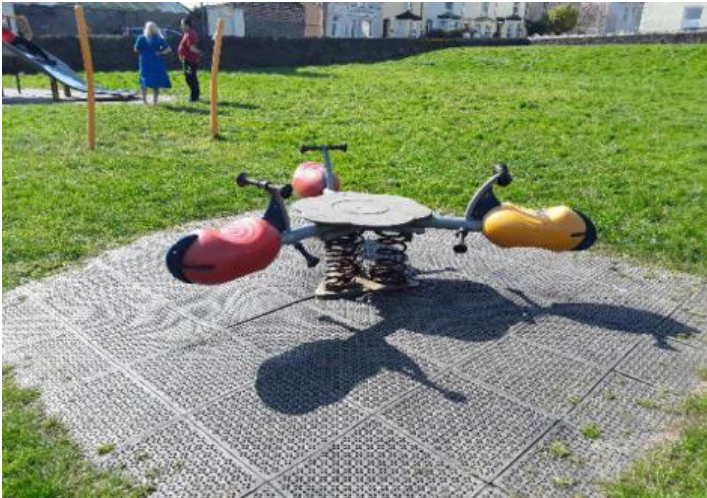
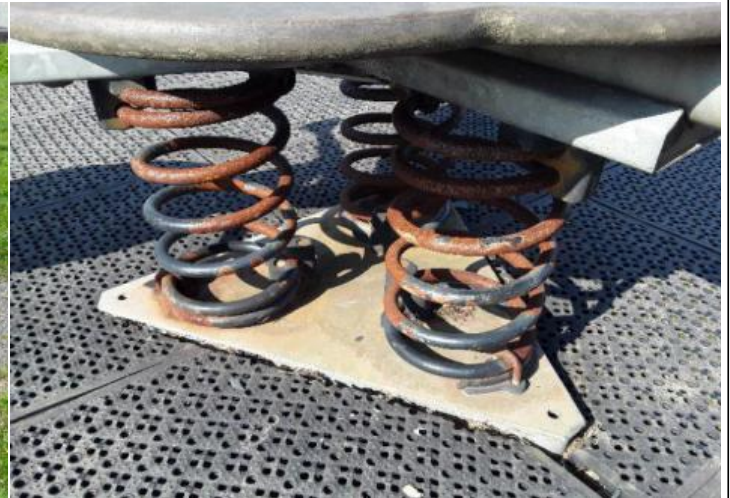
The paintwork on the spring has been damaged or worn exposing the metal underneath which is rusting - Treat any rusting components and repaint

Finding: The paintwork on the spring has been damaged or worn exposing the metal underneath which is rusting
Action: Treat any rusting components and repaint

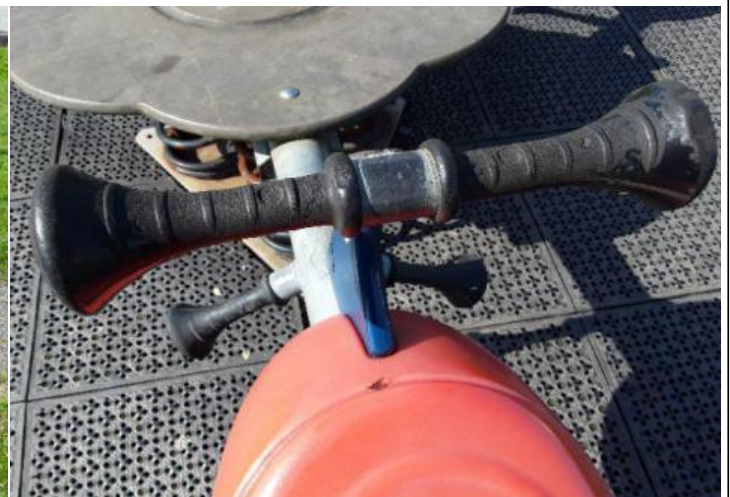
There is minor damage to the hand grips - Monitor for any further deterioration and replace as required

Finding: There is minor damage to the hand grips
Action: Monitor for any further deterioration and replace as required

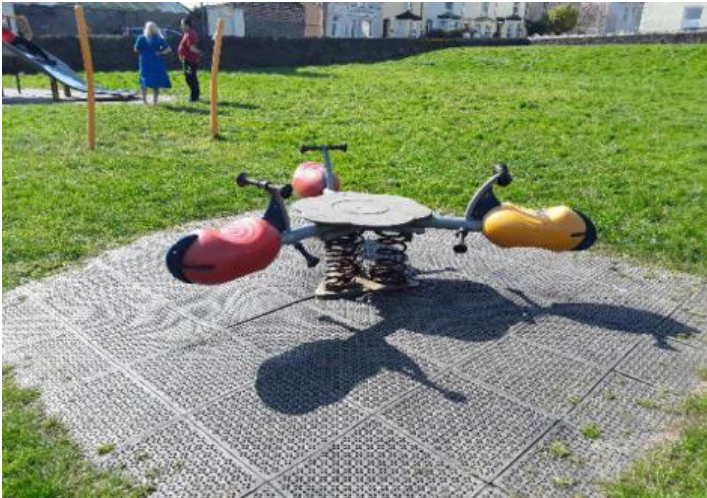
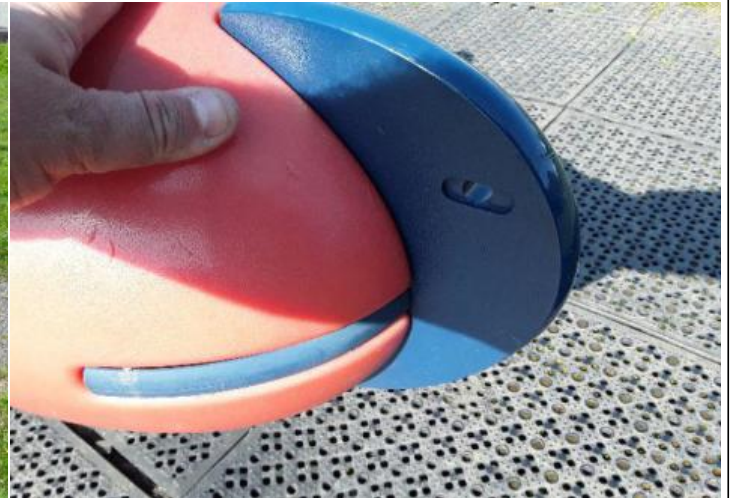
Finding: There is/are several inserts missing

Action: Replace missing inserts

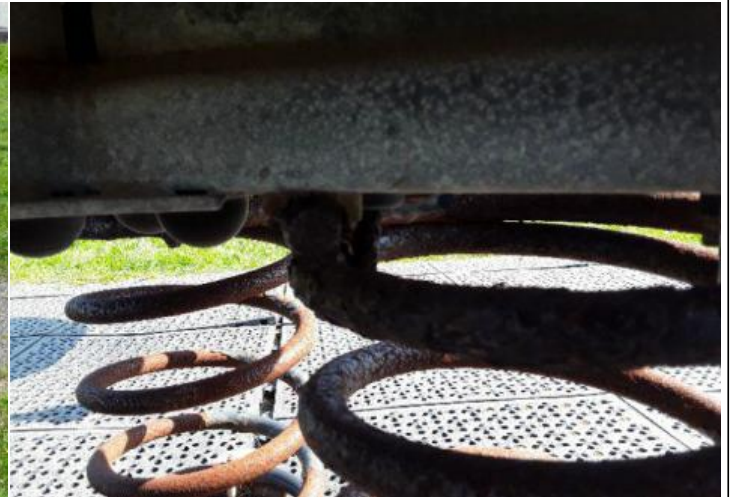
The spring clamp fixings have corroded excessively - Replace all corroded fixings

Finding: The spring clamp fixings have corroded excessively

Action: Replace all corroded fixings

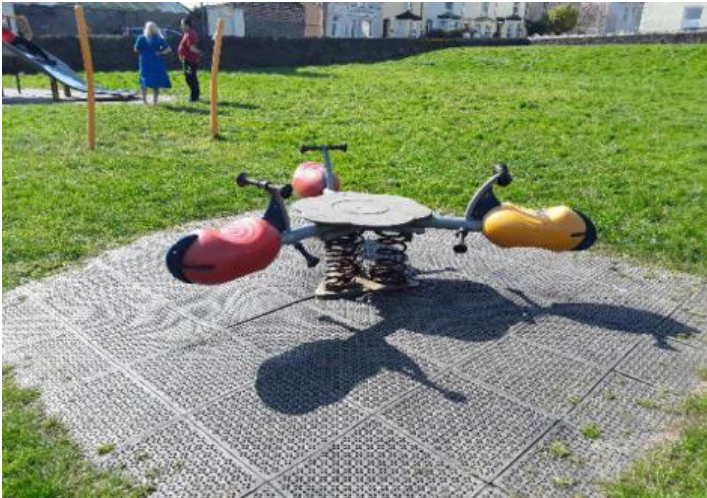
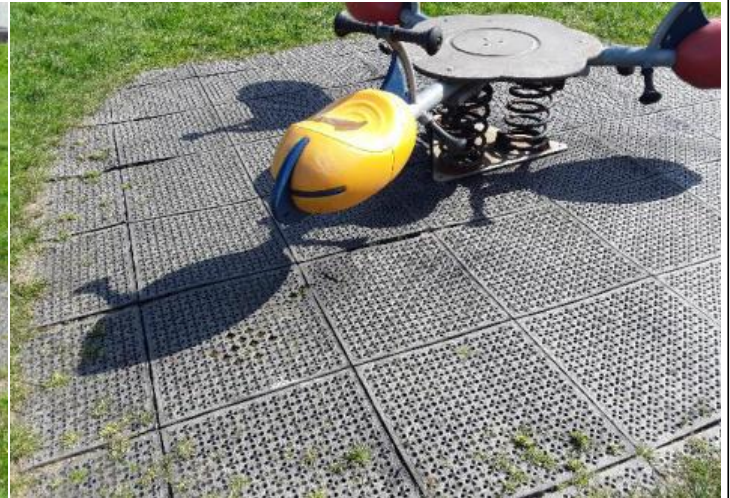
Finding: There is some minor damage to the surface

Action: Monitor for any further deterioration and repair as required

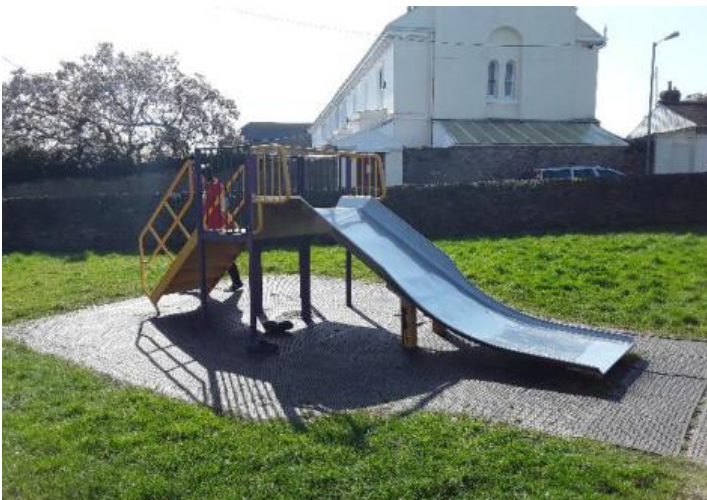
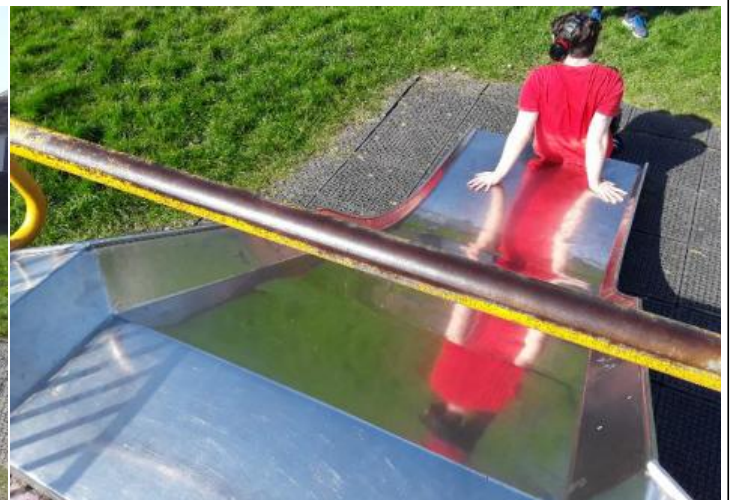
Finding: The paintwork on this item has been damaged or worn exposing the metal underneath which is rusting

Action: Treat any rusting components and repaint
