the play inspection company

Annual Inspection

Torpoint Town Council

Cambridge Field

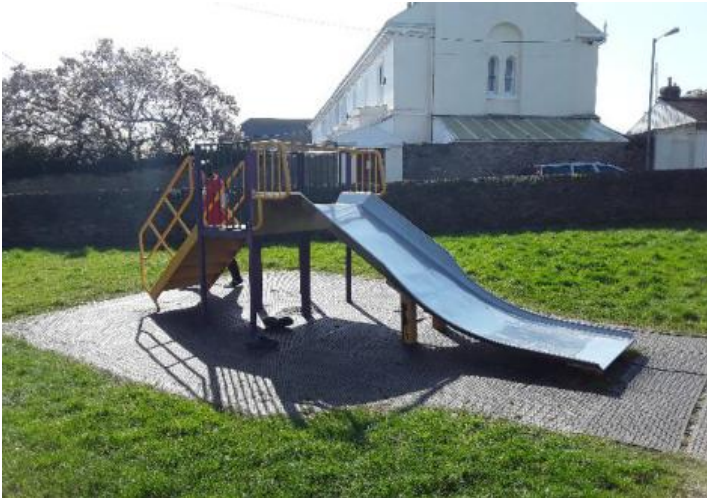
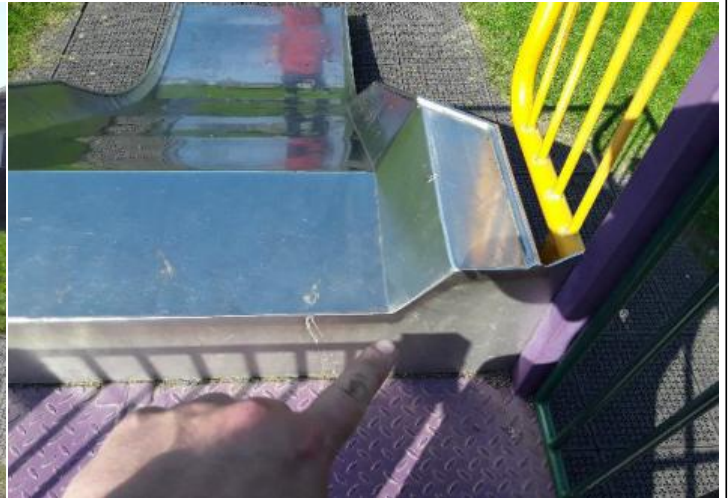
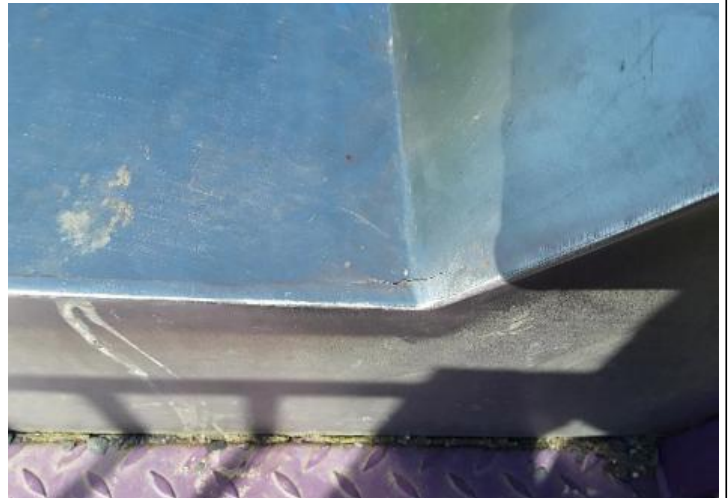
There are fractures or cracks in the slide start section - Repair or replace

Finding: There are fractures or cracks in the slide start section

Action: Repair or replace

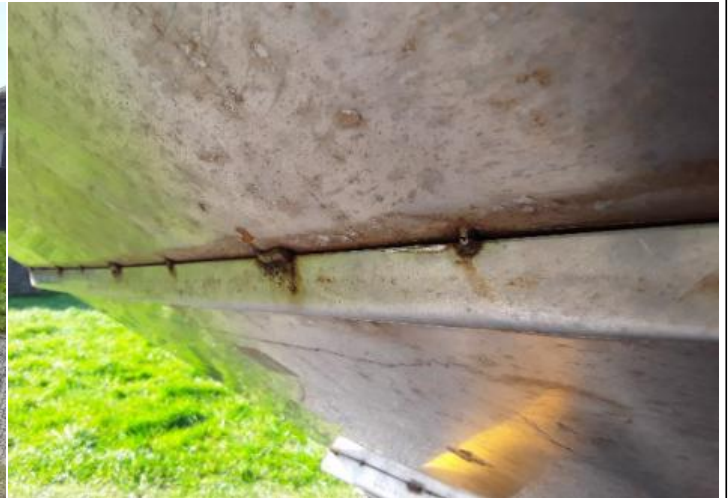
The weld(s) on this item have failed - Repair item

Finding: The weld(s) on this item have failed

Action: Repair item

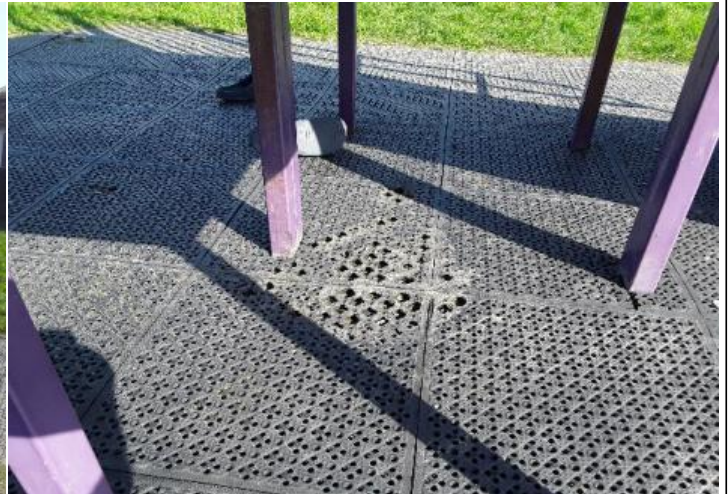
There is some evidence of fire damage to the surfacing - Monitor for any further deterioration and repair as required

Finding: There is some evidence of fire damage to the surfacing

Action: Monitor for any further deterioration and repair as required

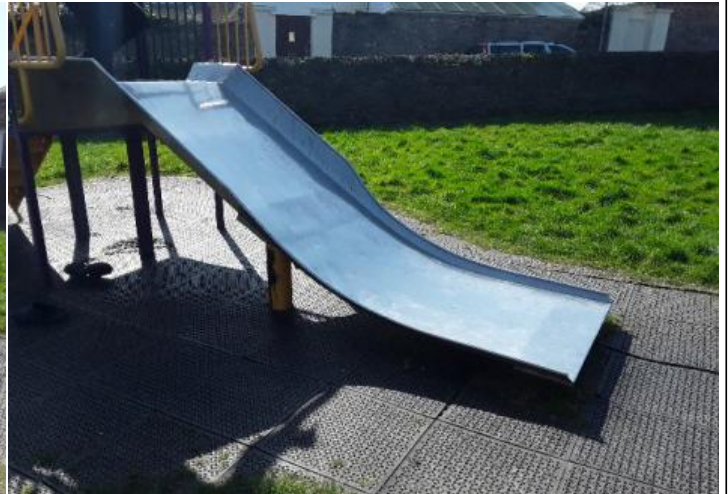
There are a number of dents in the slide surface - Monitor for any further deterioration and repair as required

Finding: There are a number of dents in the slide surface

Action: Monitor for any further deterioration and repair as required

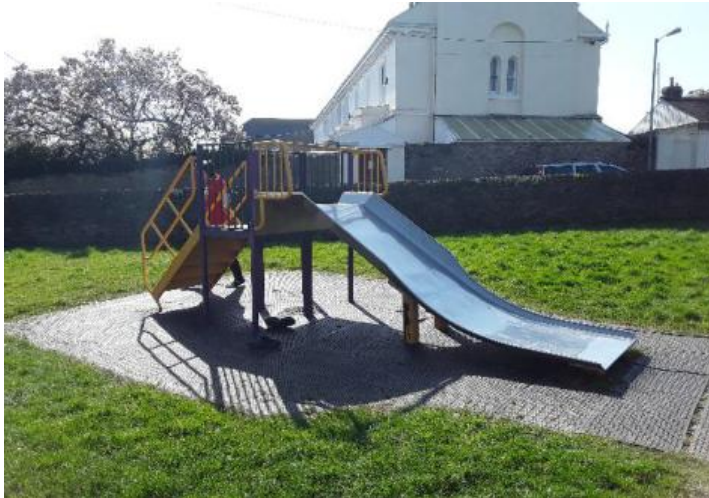
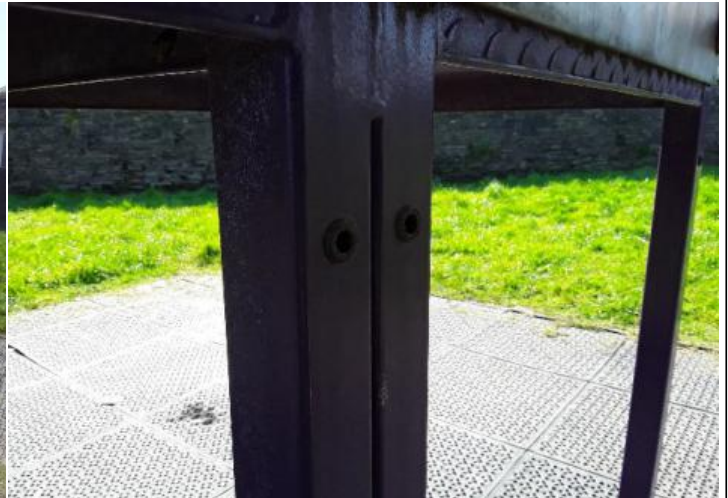
Finding: There is/are several inserts missing

Action: Replace missing inserts

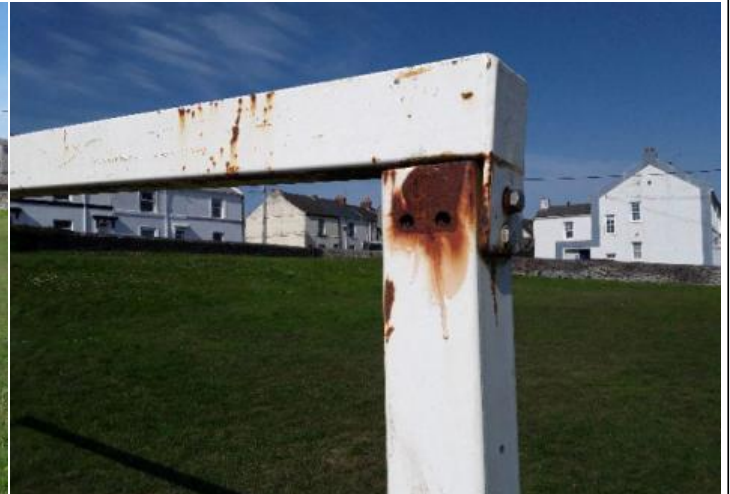
Finding: There is or are fixings missing on the item

Action: Replace all missing fixings

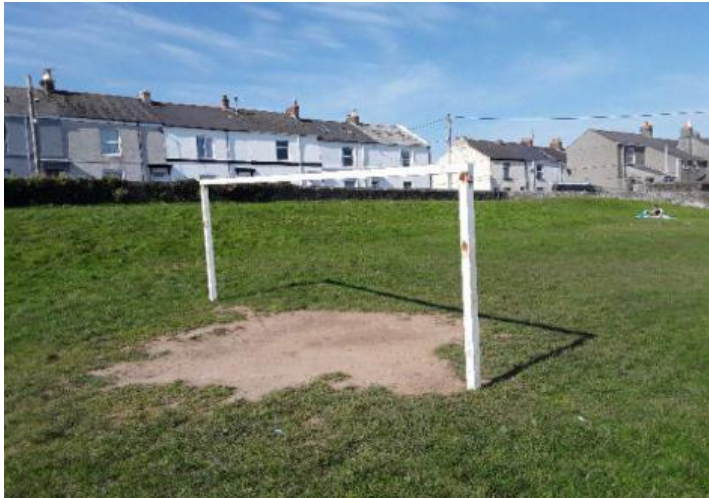
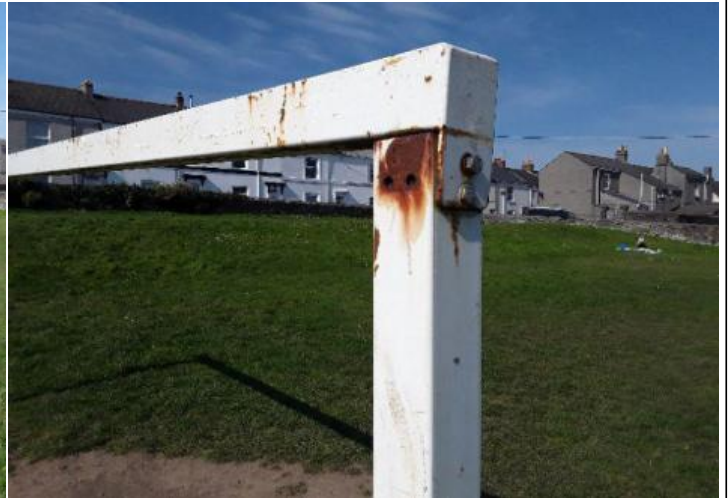
Finding: The paintwork on this item has been damaged or worn exposing the metal underneath which is rusting

Action: Treat any rusting components and repaint

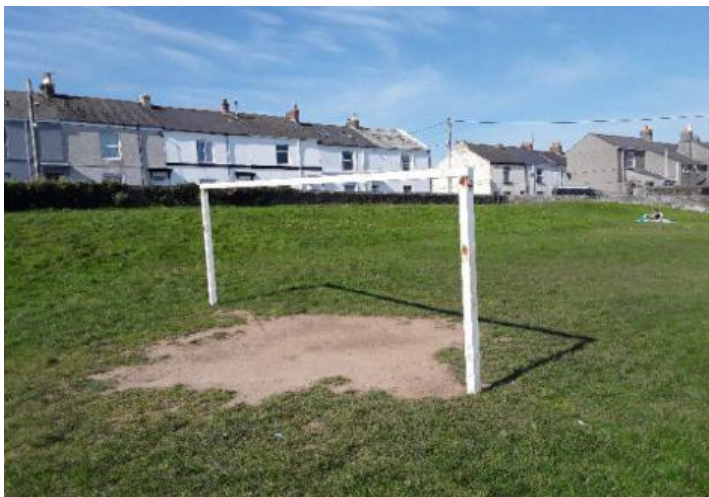
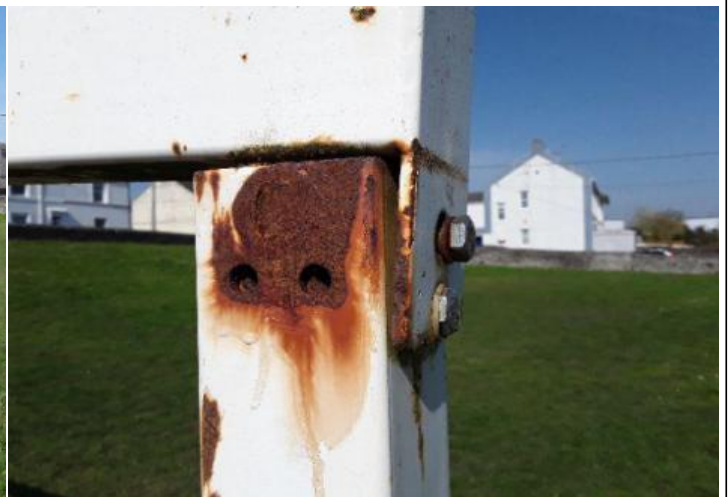
A number of fixing(s) have worked loose - Secure all loose fixings

Finding: A number of fixing(s) have worked loose

Action: Secure all loose fixings
