the play inspection company

Annual Inspection

Torpoint Town Council

Borough Farm

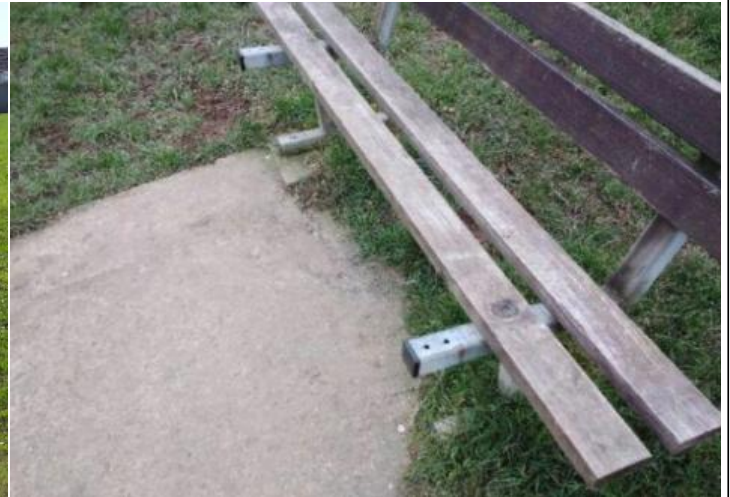
Risk Level: L - Low Risk
Surface: Concrete

Finding: A slat is missing from the bench

Action: Replace missing slat

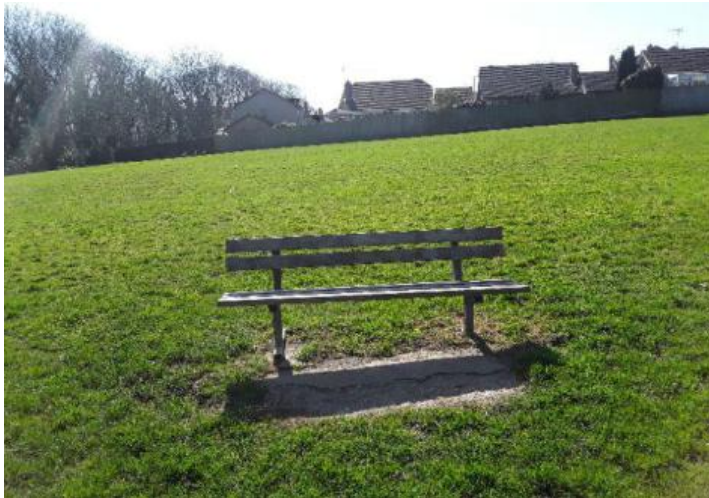
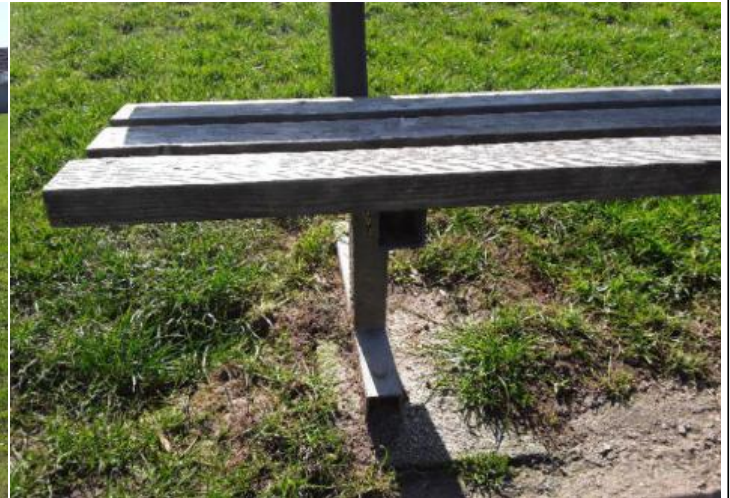
Risk Level: L - Low Risk
Surface: Concrete

Finding: There are post / end caps missing from the item

Action: Replace missing post caps

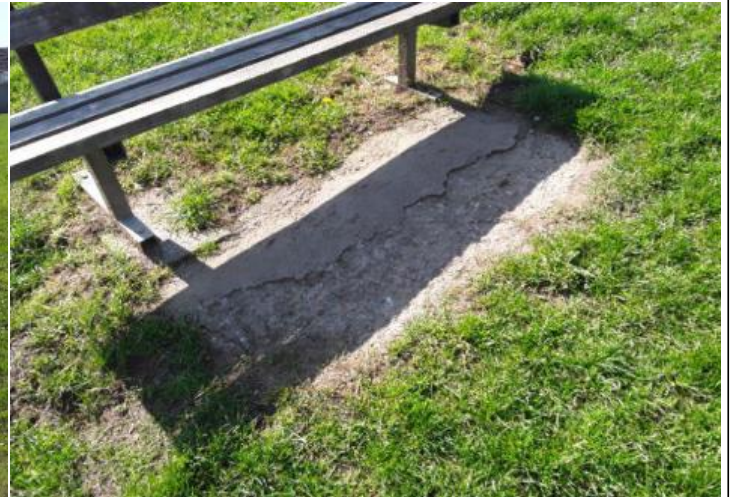
Risk Level: V - Very Low Risk
Surface: Concrete

Finding: There is some minor damage to the surface

Action: Monitor for any further deterioration and repair as required

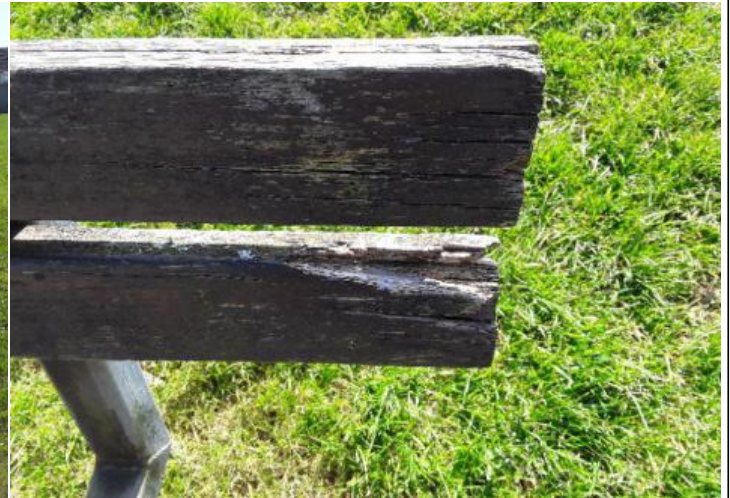
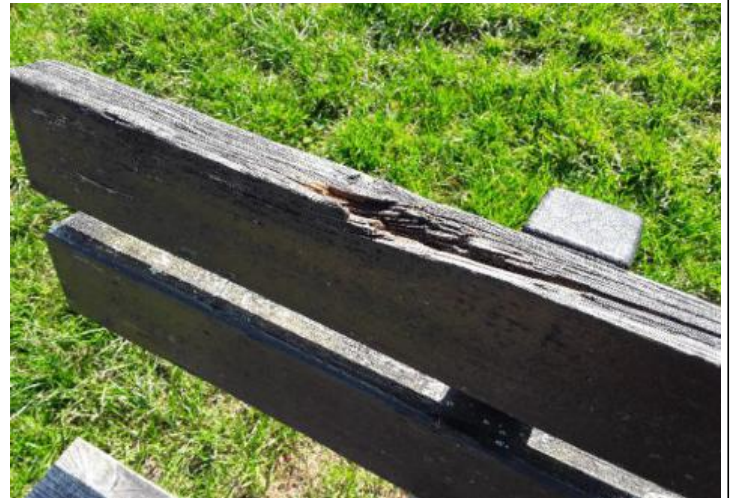
Risk Level: L - Low Risk
Surface: Concrete

Finding: There are areas or parts of the timber on the structure that have rotted

Action: Replace all affected timbers

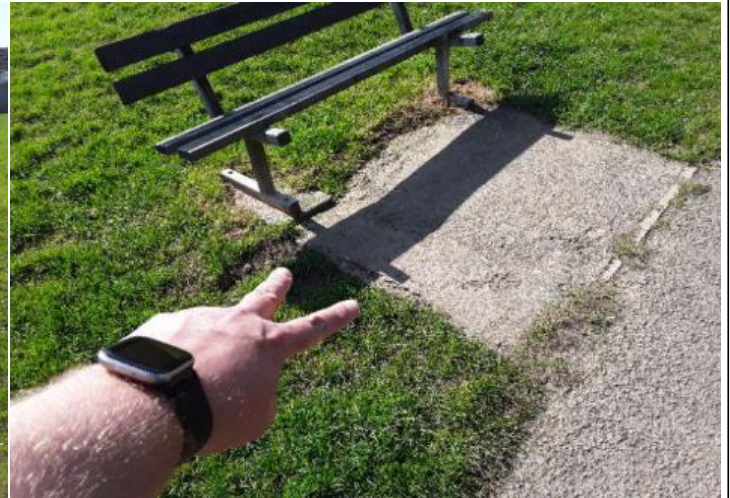
Risk Level: L - Low Risk
Surface: Concrete

Finding: There are trip hazards at the edges of the surface

Action: Reinstate surrounding surface levels to remove the trip points

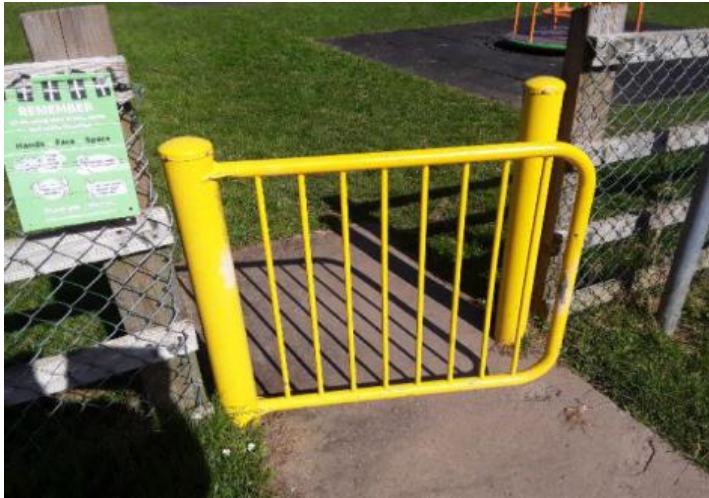
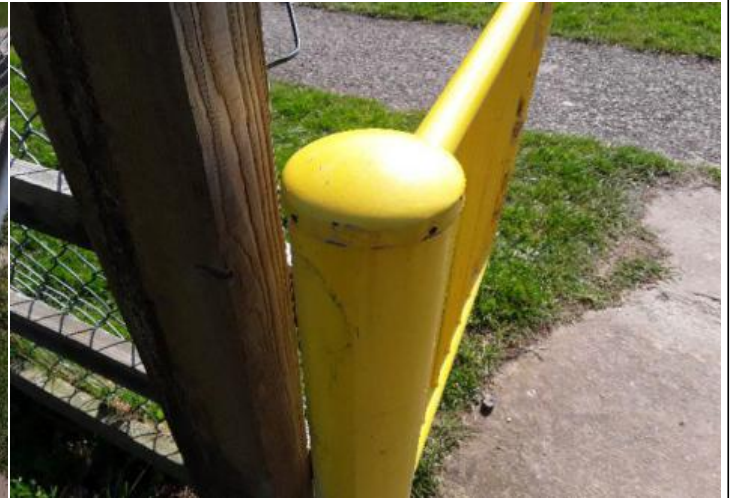
Risk Level: L - Low Risk
Surface: Concrete

Finding: There is or are fixings missing on the item

Action: Replace all missing fixings

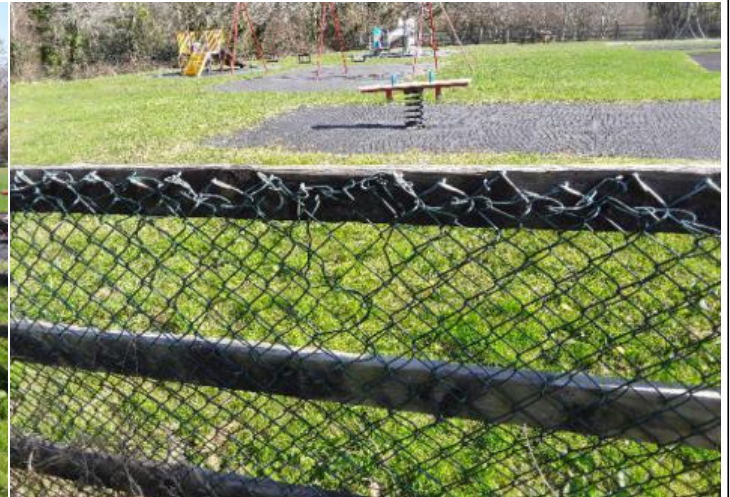
Risk Level: L - Low Risk
Surface: Grass

Finding: There is some damage to the fence sections

Action: Monitor for any further deterioration and repair as required

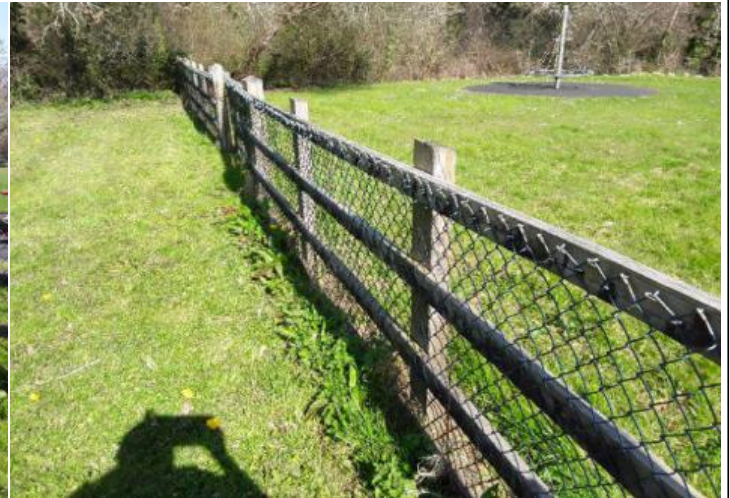
Risk Level: L - Low Risk
Surface: Grass

Finding: There are a number of loose posts around the fence

Action: Monitor for any further deterioration and reset as required

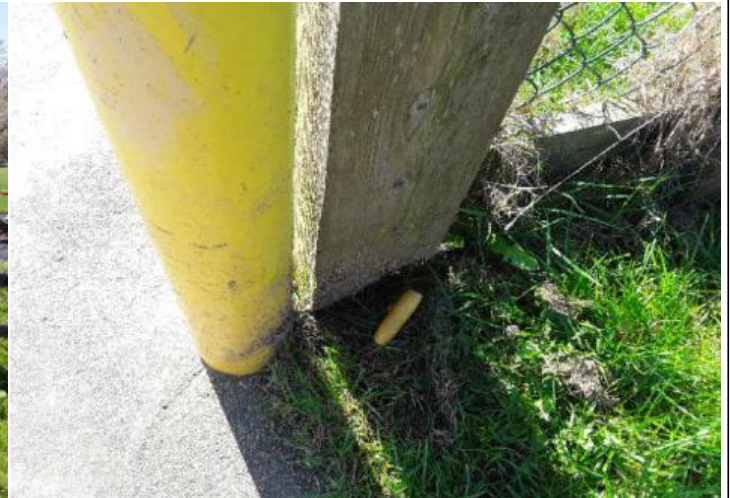
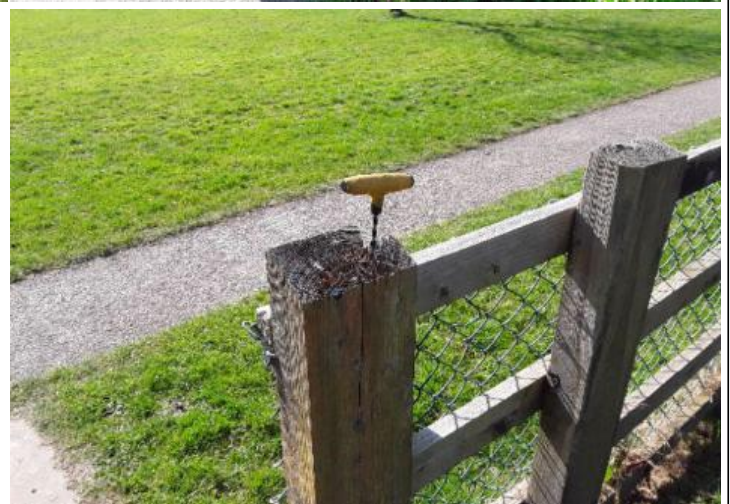
Risk Level: L - Low Risk
Surface: Grass

Finding: There are areas or parts of the timber on the structure that have rotted

Action: Replace all affected timbers

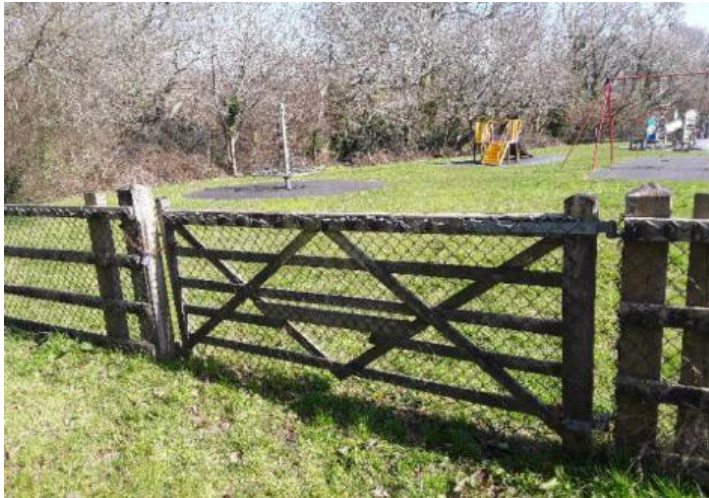
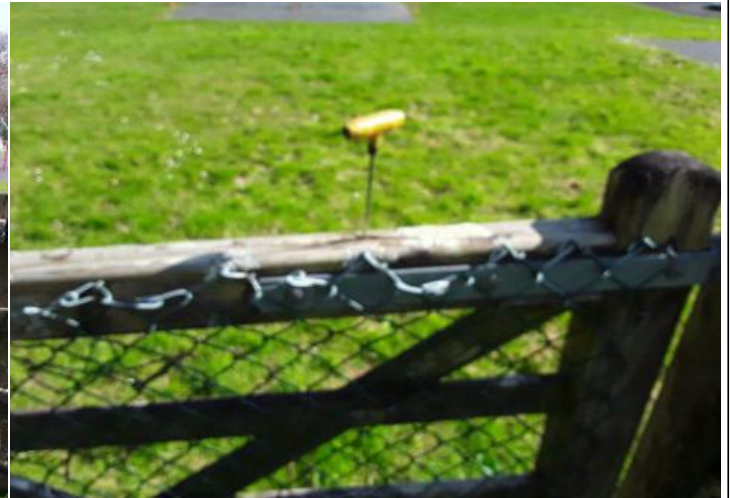
Risk Level: L - Low Risk
Surface: Grass

Finding: There is some evidence of rot in the timber

Action: Monitor for any further deterioration and replace as required

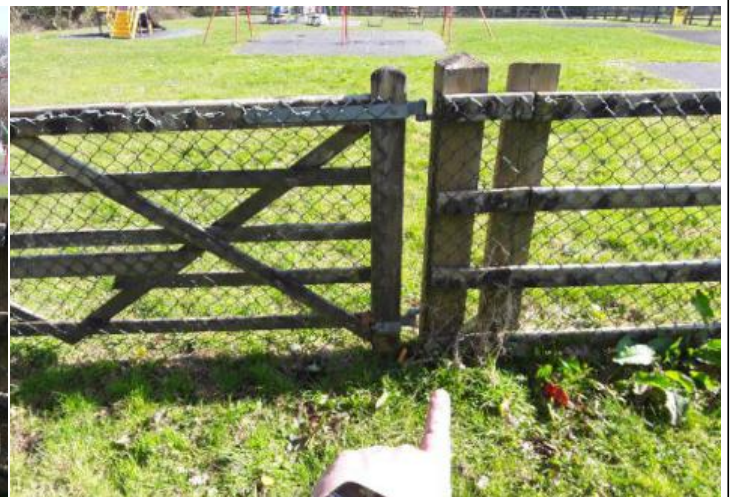
Risk Level: L - Low Risk
Surface: Grass

Finding: There are areas or parts of the timber on the structure that have rotted

Action: Replace all affected timbers

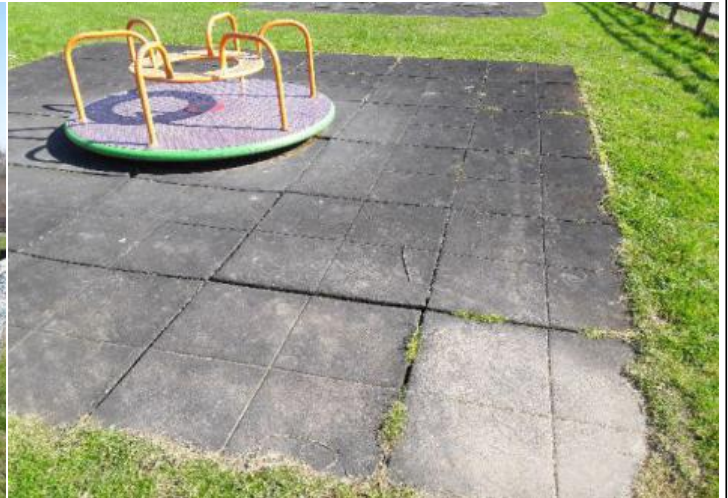
Risk Level: L - Low Risk
Surface: N/A

Finding: There are gaps opening in between the tiles

Action: Monitor for any further deterioration and repair as required

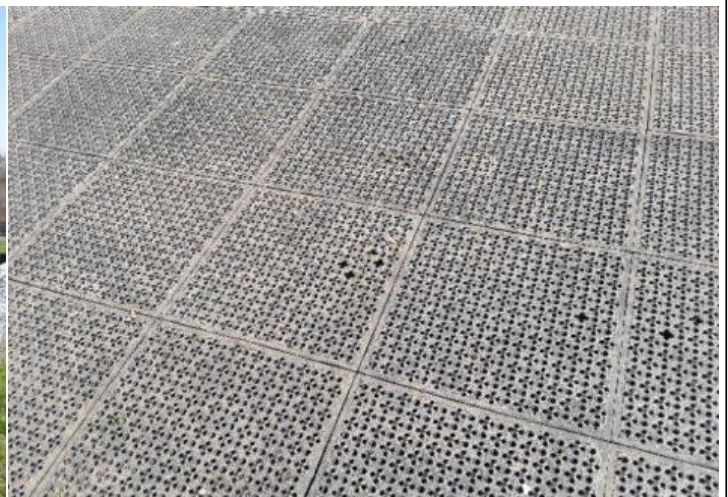
Risk Level: V - Very Low Risk
Surface: N/A

Finding: There is some minor damage to the surface

Action: Monitor for any further deterioration and repair as required

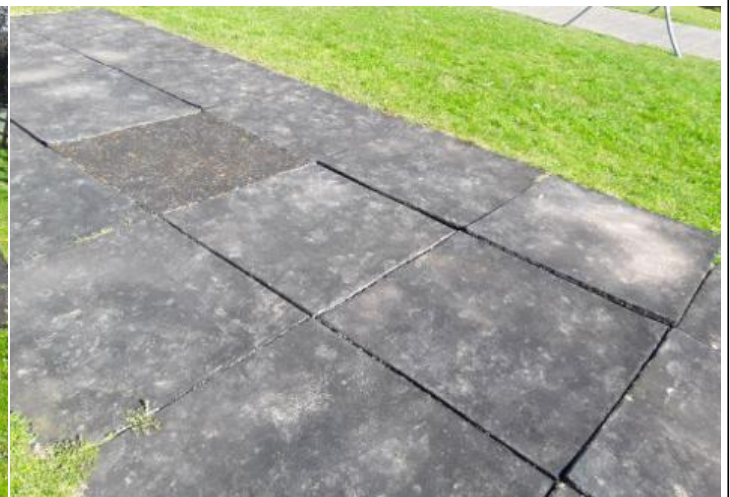
Risk Level: L - Low Risk
Surface: Rubber Tiles

Finding: There are gaps opening in between the tiles
Action: Monitor for any further deterioration and repair as required

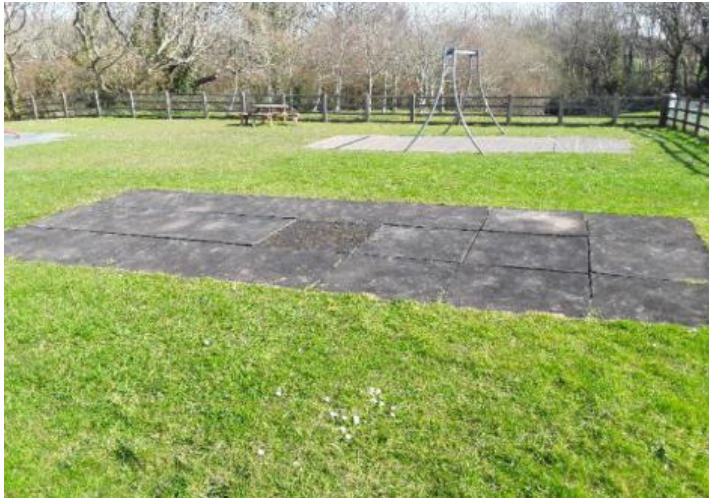
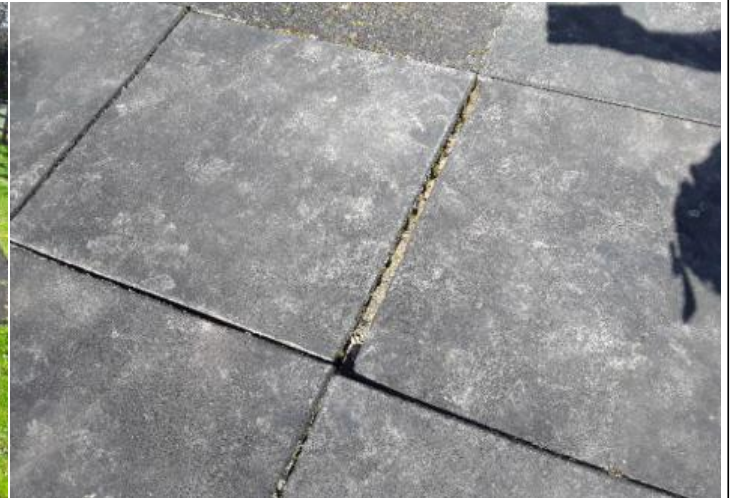
Risk Level: L - Low Risk
Surface: Rubber Tiles

Finding: There are significant gaps (over 30mm) between the surface and the edging or between the joints in the surface; these are large enough for a small foot to enter

Action: Repair surfacing

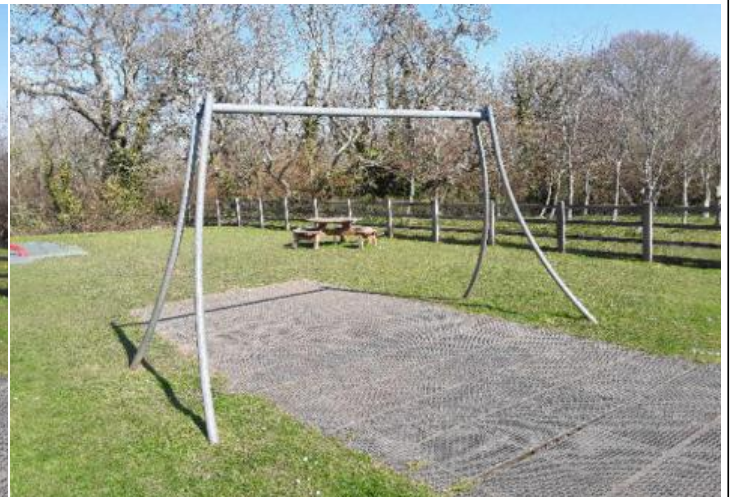
Risk Level: N - Risk Assessment not Undertaken
Surface: Matta

Finding: The seat(s) and suspension were missing at the time of inspection and the inspector was unable to make a full compliance assessment

Action: Replace missing seat(s) and suspension

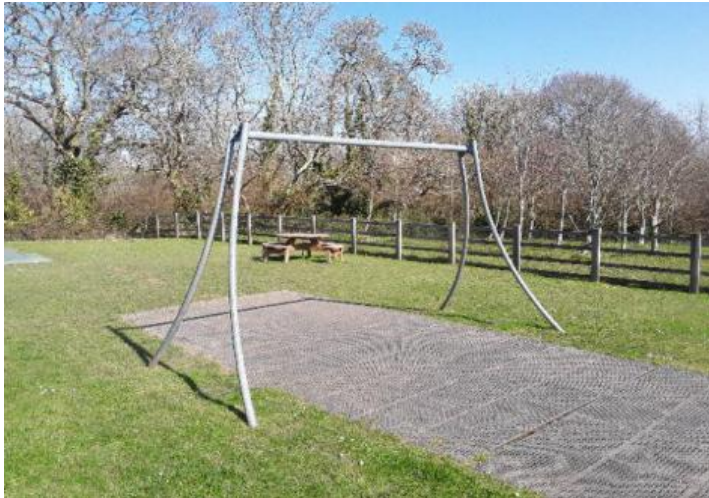
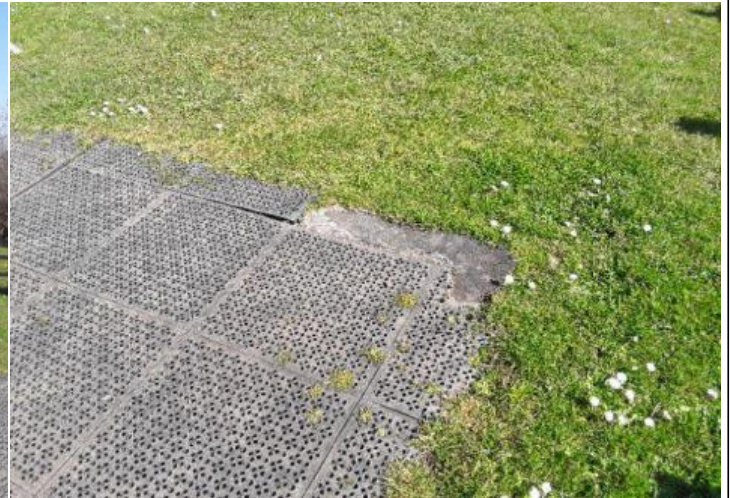
Risk Level: L - Low Risk
Surface: Matta

Finding: There is moderate damage to the surface

Action: Repair the damaged areas of surfacing

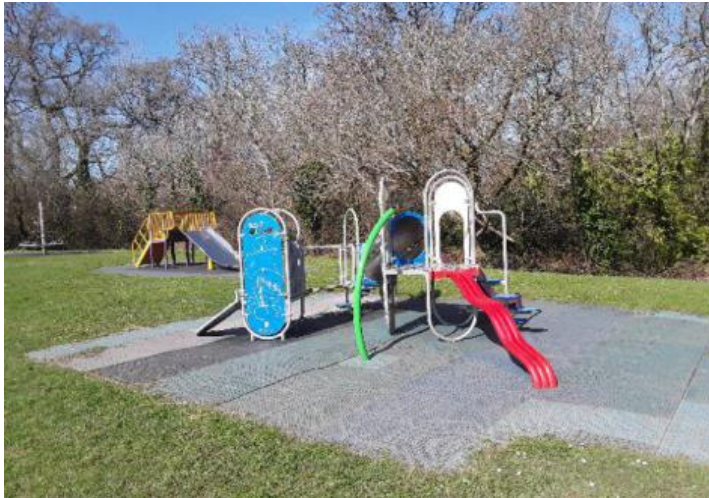
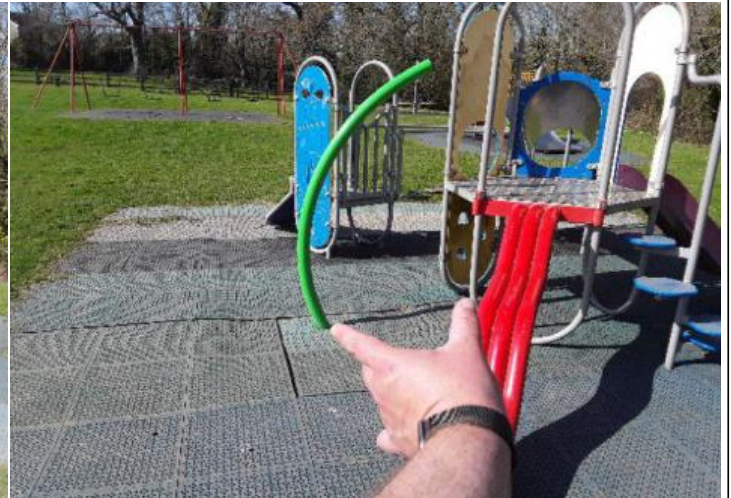
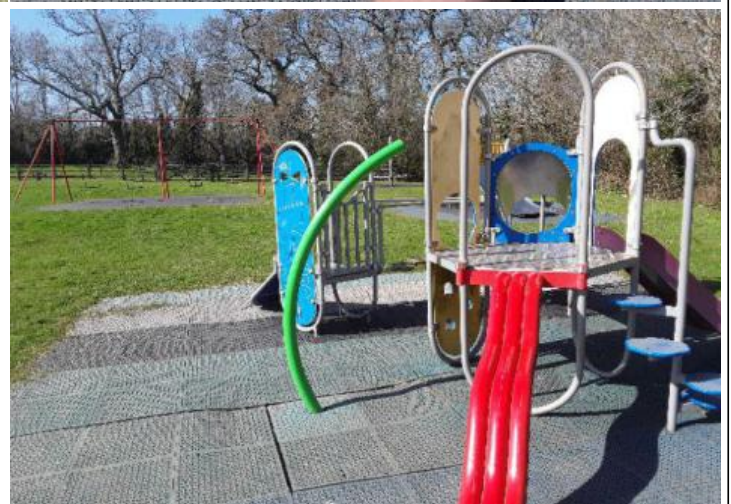
Risk Level: L - Low Risk
Surface: Matta

Finding: The green firemans pole has been installed too far away from the structure in contravention of the manufacturers specifications
Action: Monitor, no remedial action is recommended

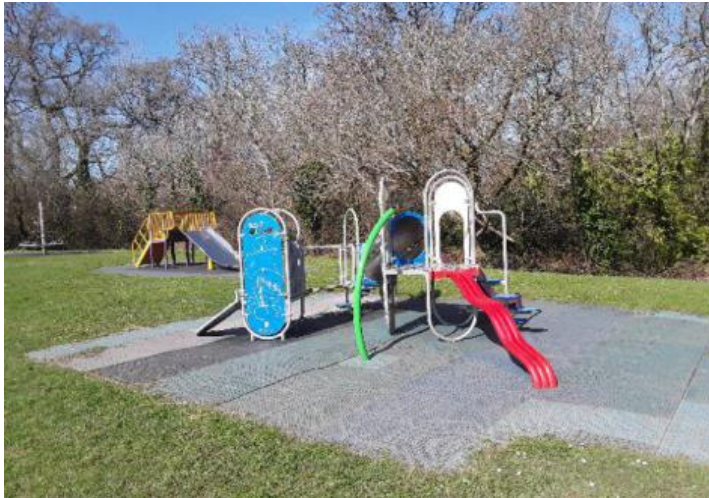
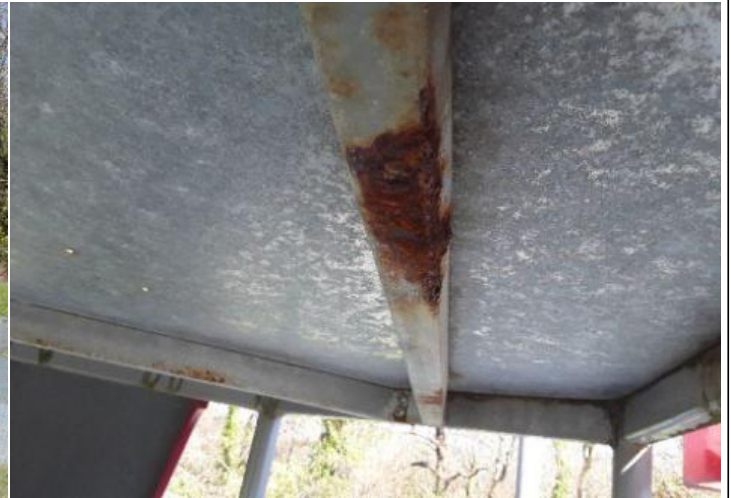
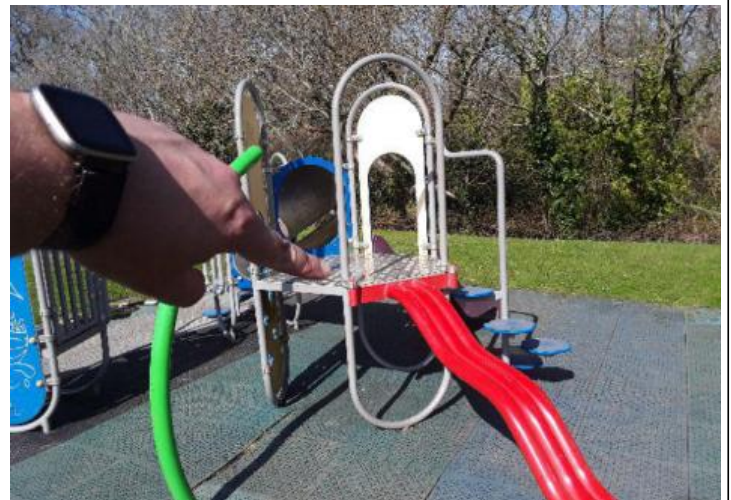
Risk Level: L - Low Risk
Surface: Matta

Finding: There is surface corrosion present on the item

Action: Consider treating the item

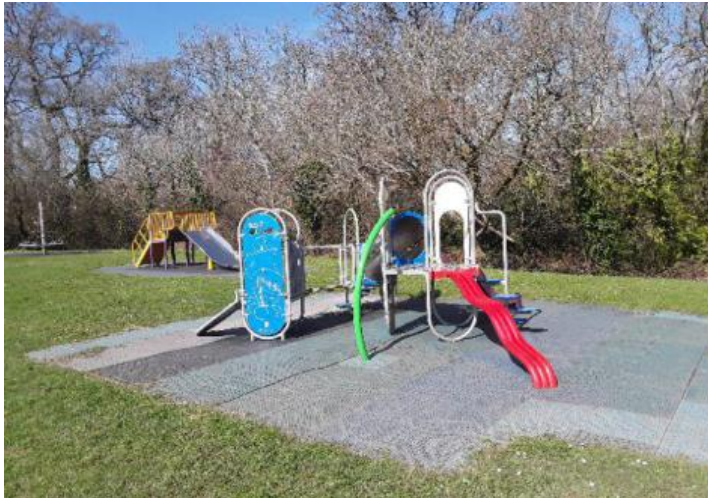
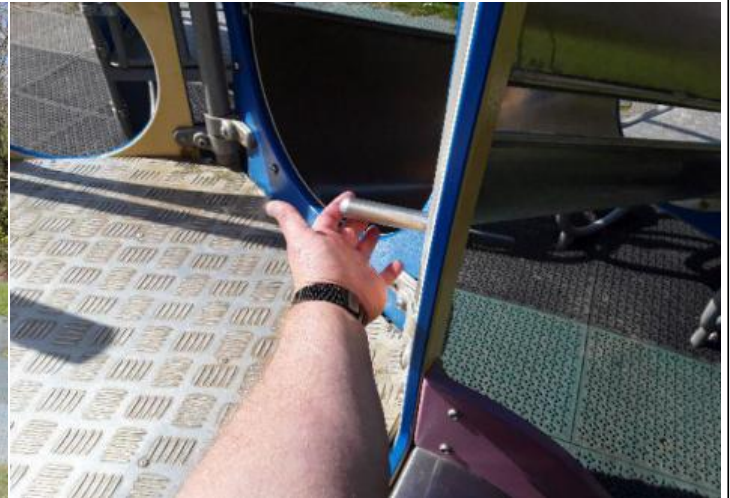
Risk Level: V - Very Low Risk
Surface: Matta

Finding: There is/are finger entrapment/s in the frame and the item fails to meet the requirements of BS EN 1176 Part 1 4.2.7.6 Entrapment of fingers

Action: Monitor - No remedial work recommended

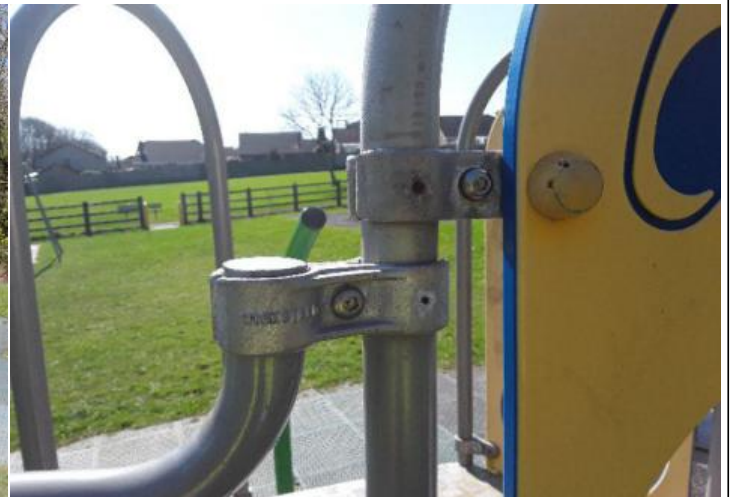
Risk Level: L - Low Risk
Surface: Matta

Finding: There is or are fixings missing on the item

Action: Replace all missing fixings

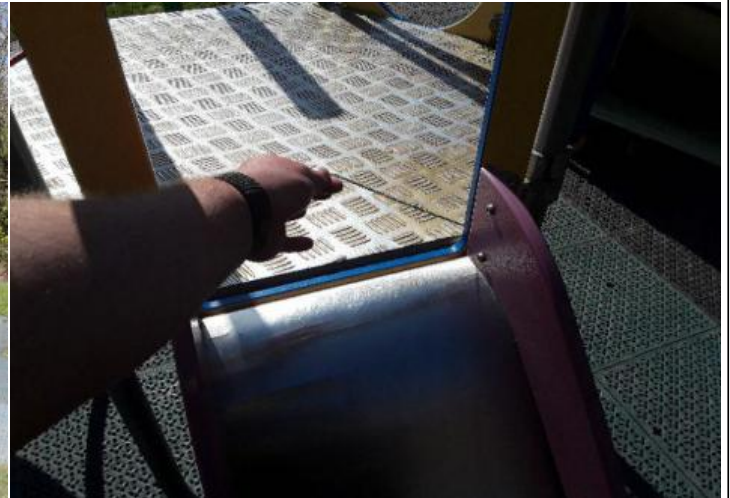
Risk Level: V - Very Low Risk
Surface: Matta

Finding: There is / are toggle entrapment/s present in contravention of the recommendations set out in BS EN 1176 Part 3

Action: Monitor - no remedial work recommended

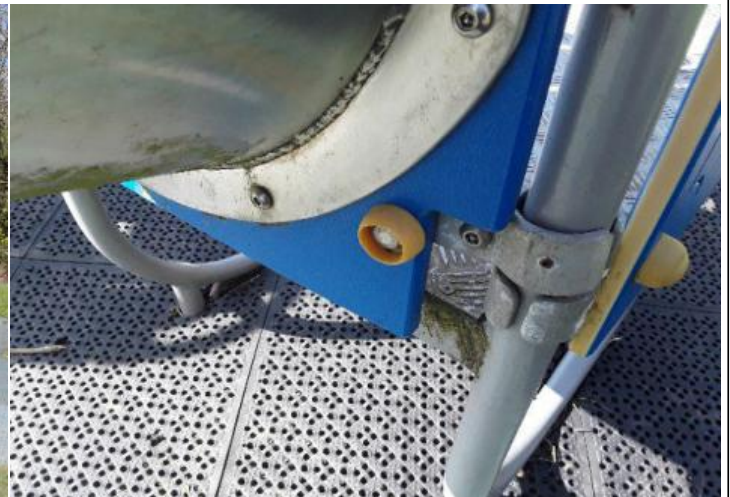
Risk Level: V - Very Low Risk
Surface: Matta

Finding: There is/are bolt cap covers missing or damaged on the item

Action: Replace missing or damaged bolt cap covers

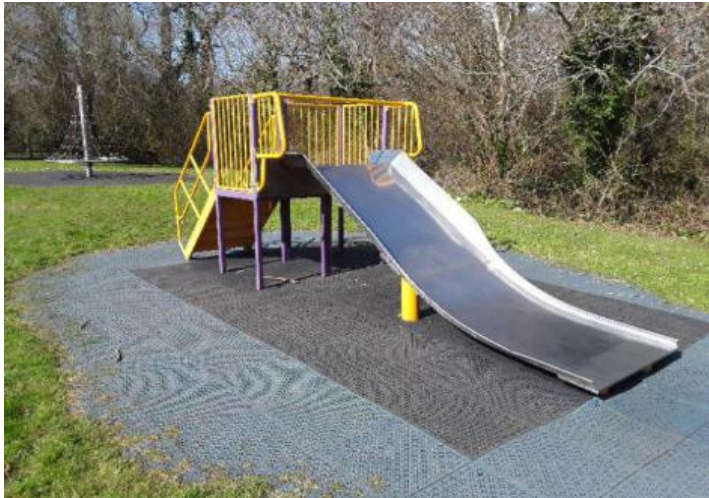
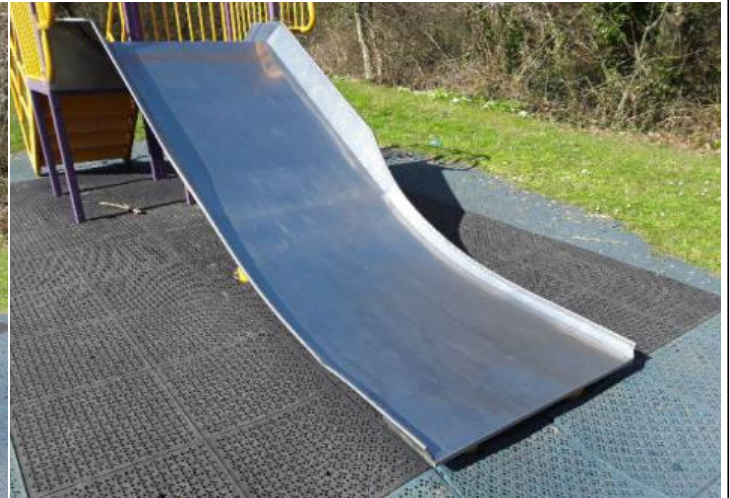
Risk Level: V - Very Low Risk
Surface: Matta

Finding: There are a number of dents in the slide surface

Action: Monitor for any further deterioration and repair as required

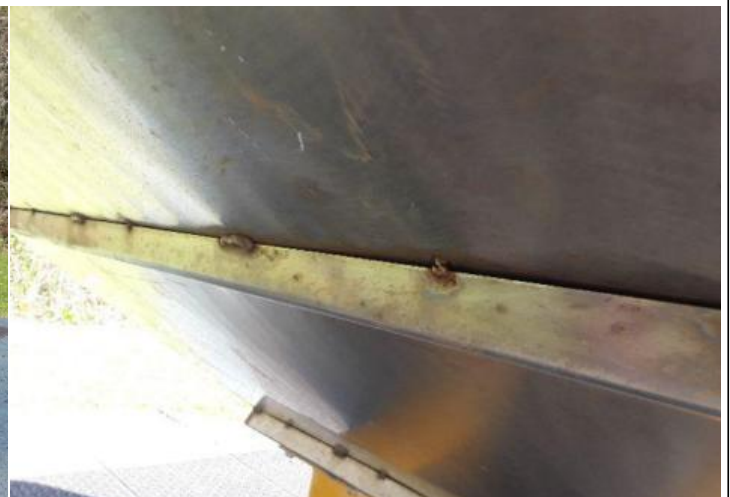
Risk Level: L - Low Risk
Surface: Matta

Finding: The weld(s) on this item have failed

Action: Repair item

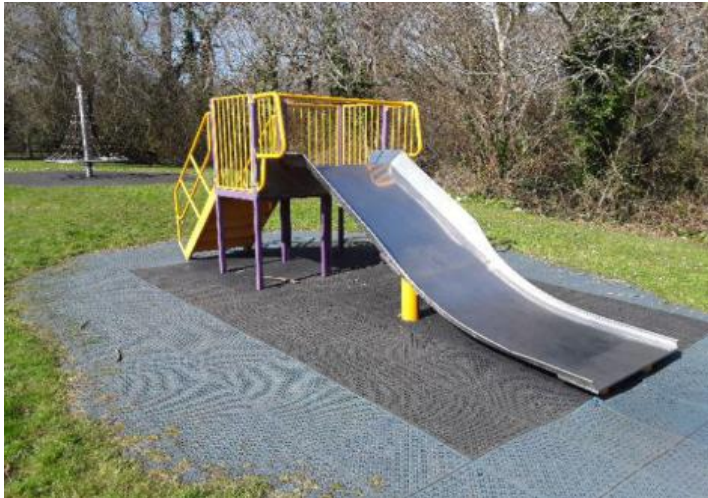
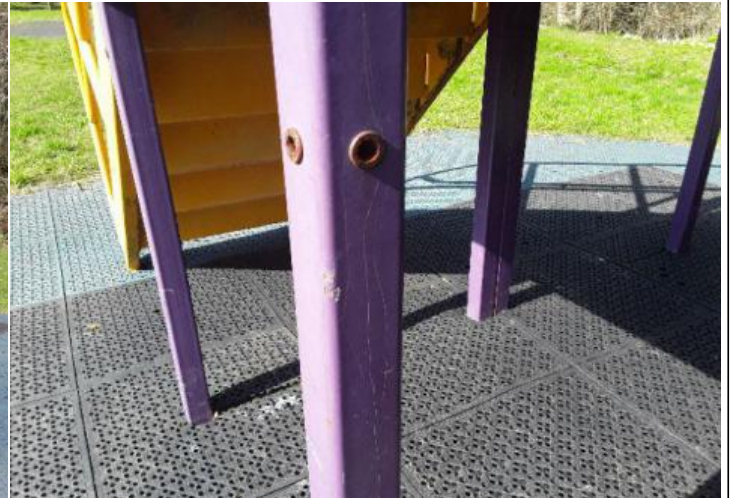
Risk Level: V - Very Low Risk
Surface: Matta

Finding: There is/are several inserts missing

Action: Replace missing inserts

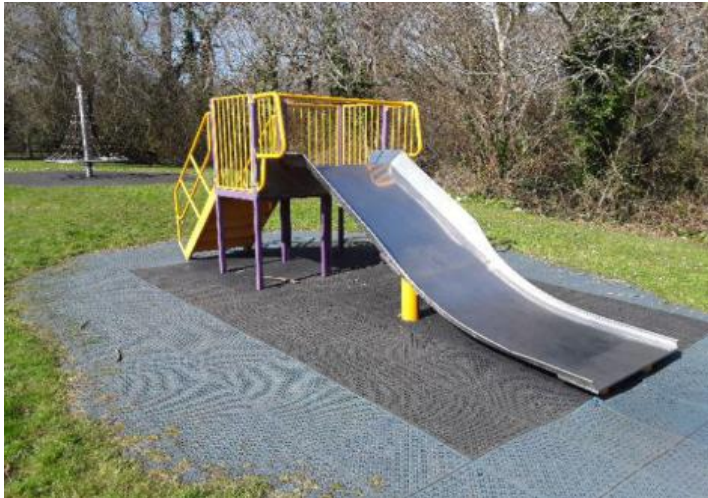
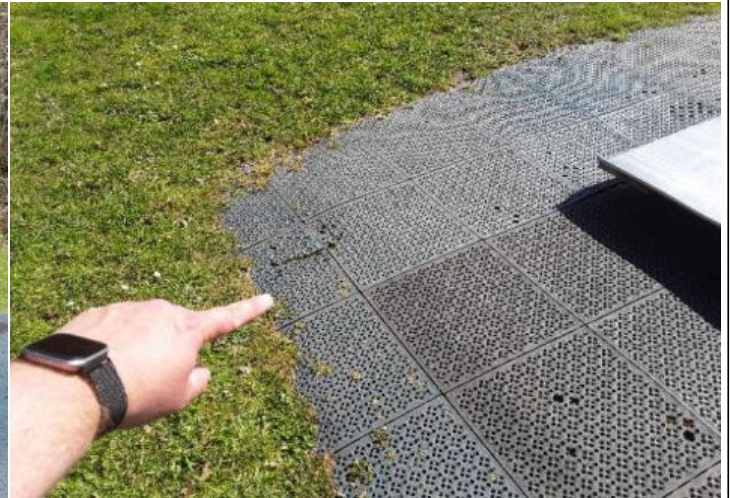
Risk Level: V - Very Low Risk
Surface: Matta

Finding: There is some minor damage to the surface

Action: Monitor for any further deterioration and repair as required

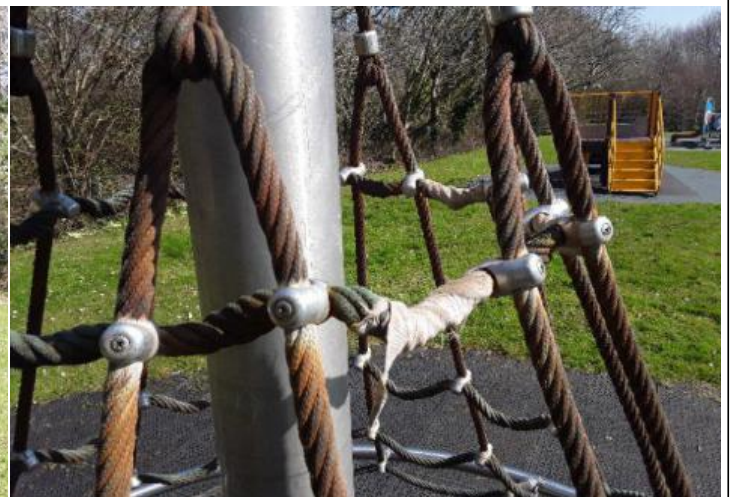
Risk Level: N - Risk Assessment not Undertaken
Surface: Matta

Finding: The ropes on this item have been taped and we are unable to fully assess the condition of the rope, ensure no wire strands are broken beneath the tape

Action: Repair or replace as required

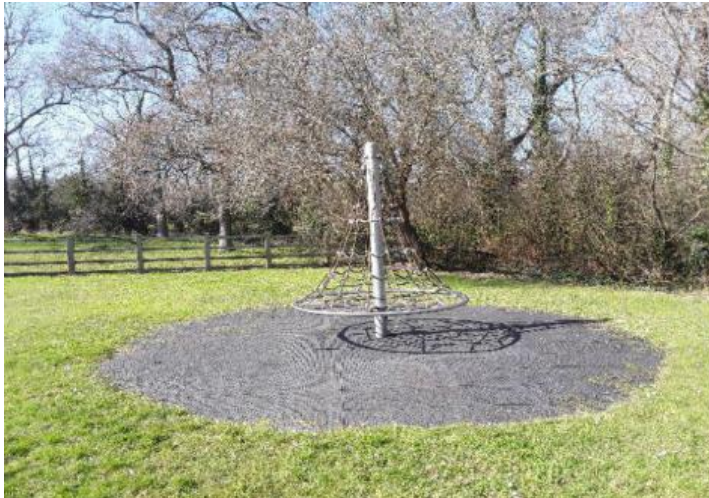
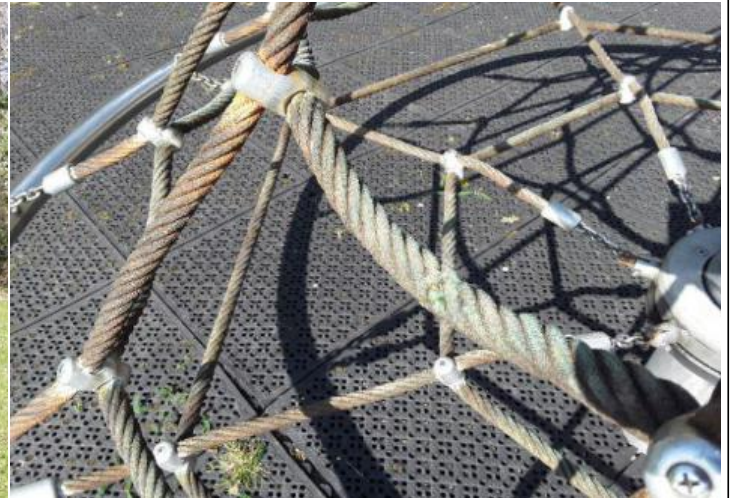
Risk Level: L - Low Risk
Surface: Matta

Finding: The ropes/nets are worn/damaged in places

Action: Monitor for any further deterioration and repair or replace as required

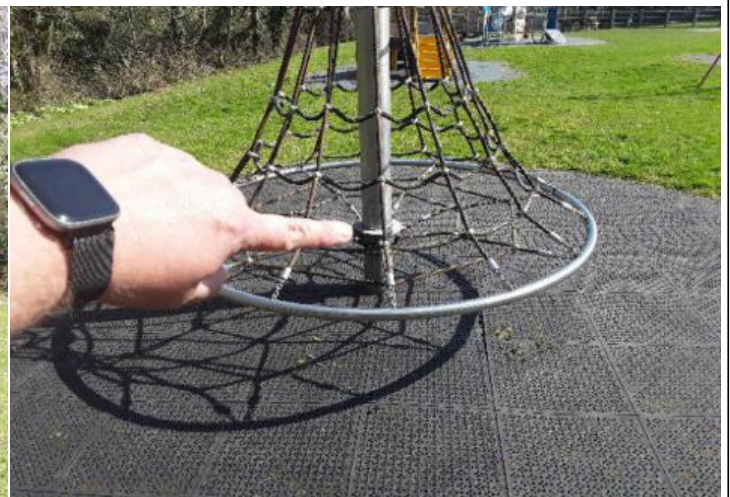
Risk Level: L - Low Risk
Surface: Matta

Finding: The bearing is showing signs of wear

Action: Monitor for any further deterioration and replace as required

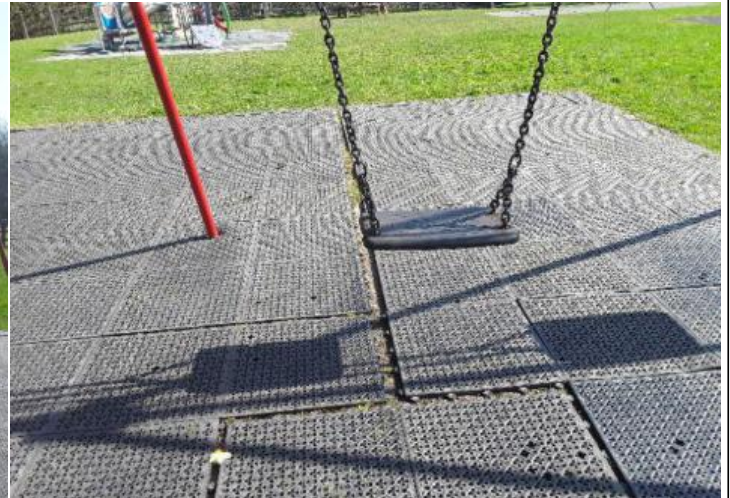
Risk Level: L - Low Risk
Surface: Matta

Finding: The surfacing mats have separated, are not secured and can be lifted creating trip points. The gaps between the mats are also large enough for a small foot to enter

Action: Repair as required to secure the mats

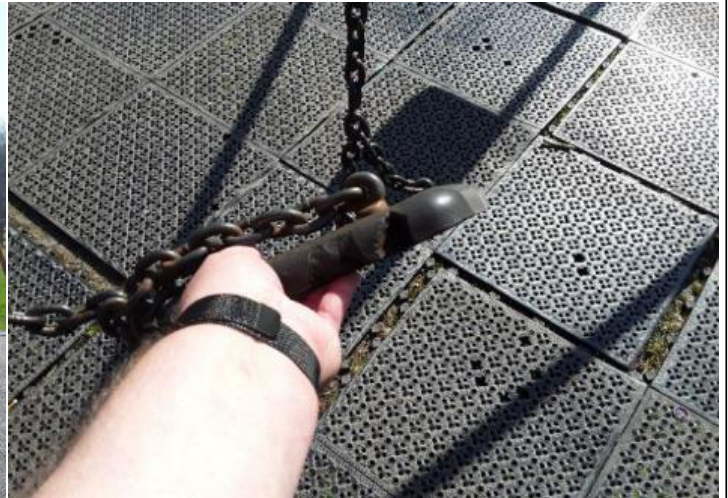
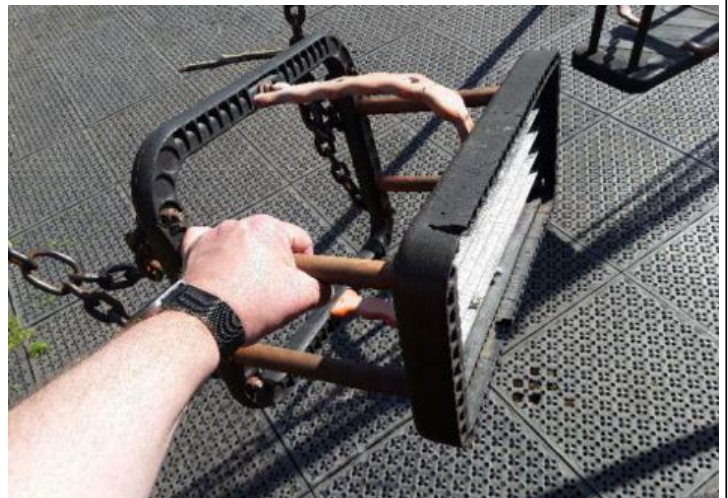
Risk Level: L - Low Risk
Surface: Matta

Finding: The seat has minor damage or wear

Action: Monitor for any further deterioration and replace as required

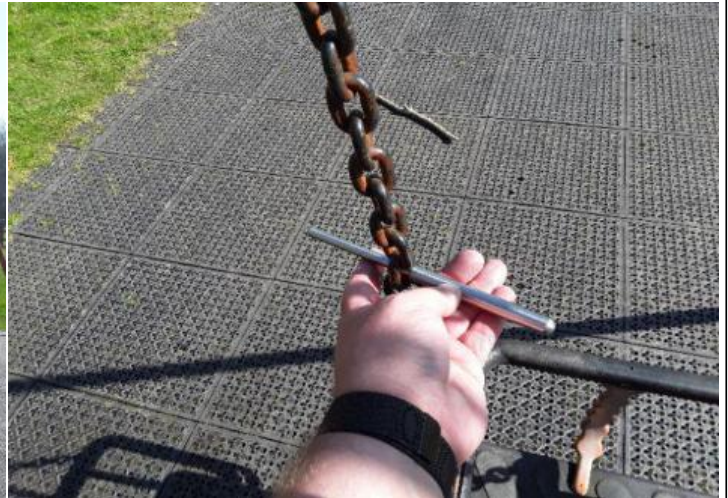
Risk Level: V - Very Low Risk
Surface: Matta

Finding: The connecting links are in excess of 8.6mm and less than 12mm and fail the requirements of BS EN 1176 Part 1; clause 4.2.13, Chains

Action: Monitor - No remedial work recommended

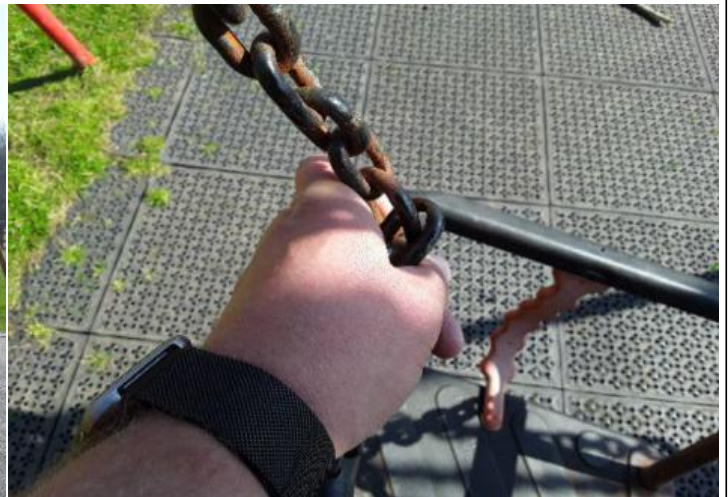
Risk Level: L - Low Risk
Surface: Matta

Finding: The chain links are worn in excess of 40% and require renewing

Action: Replace worn chains

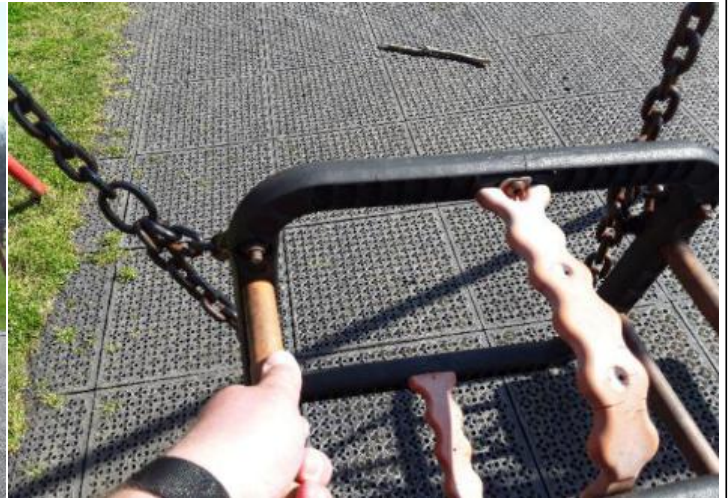
Risk Level: L - Low Risk
Surface: Matta

Finding: There are caps missing from the underside of the seats

Action: Replace missing caps under the seats

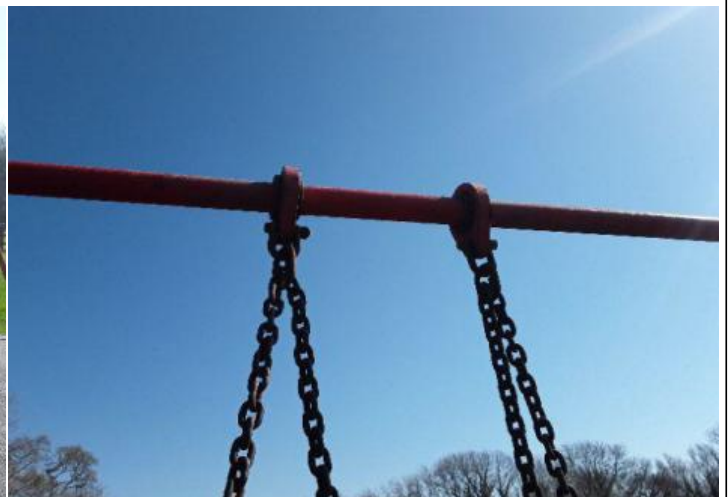
Risk Level: V - Very Low Risk
Surface: Matta

Finding: The bushes are showing signs of wear

Action: Monitor for any further deterioration and replace as required

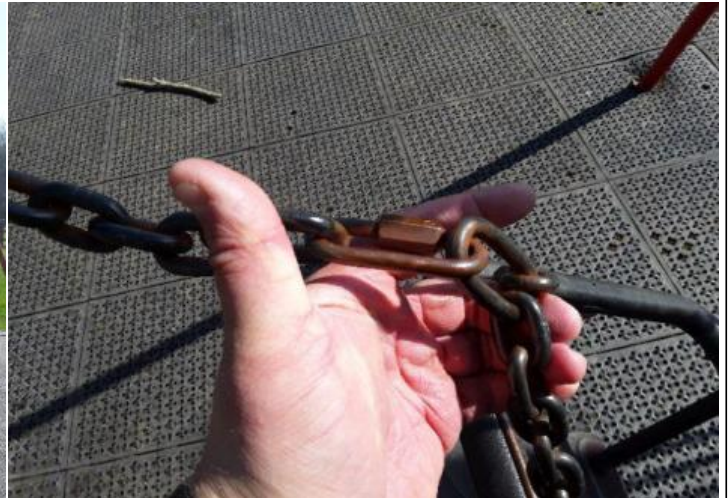
Risk Level: L - Low Risk
Surface: Matta

Finding: There is some wear to the shackles.

Action: Monitor for any further deterioration and replace when 40% worn

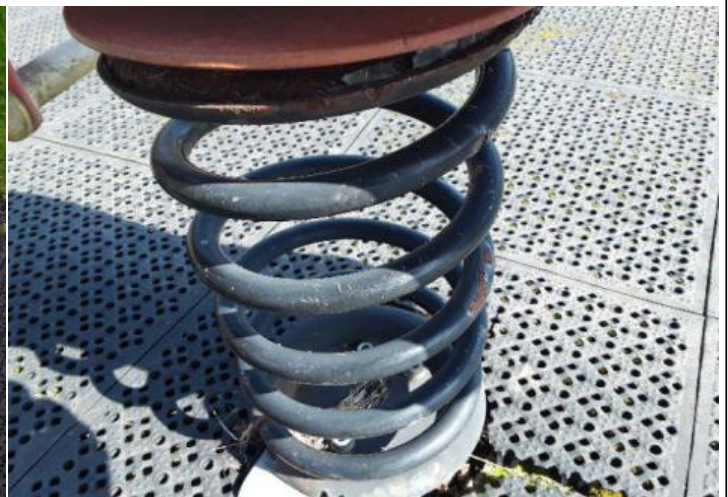
Risk Level: L - Low Risk
Surface: Matta

Finding: The paintwork on the spring has been damaged or worn exposing the metal underneath which is rusting

Action: Treat any rusting components and repaint

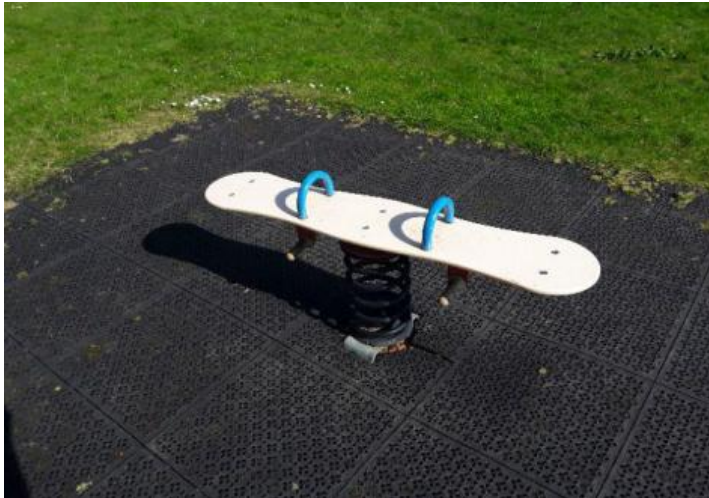
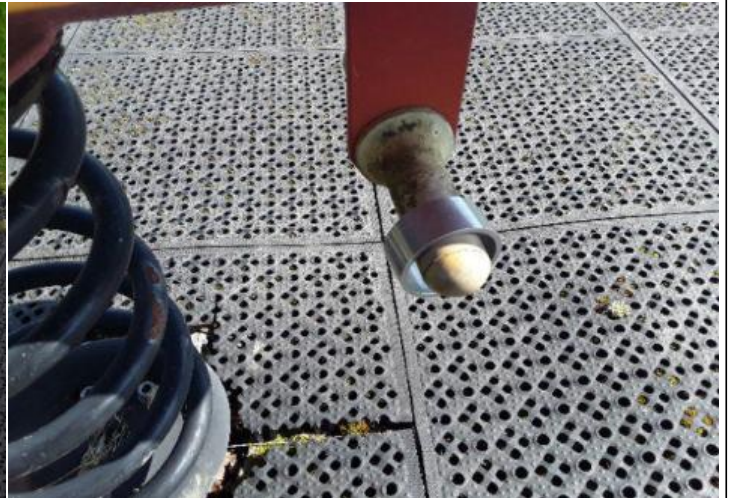
Risk Level: L - Low Risk
Surface: Matta

Finding: The end of handgrips and/or footrests have a cross section of less than 15cm² and fail to meet the requirements of BS EN 1176 Part 6
Action: Monitor - No remedial work recommended

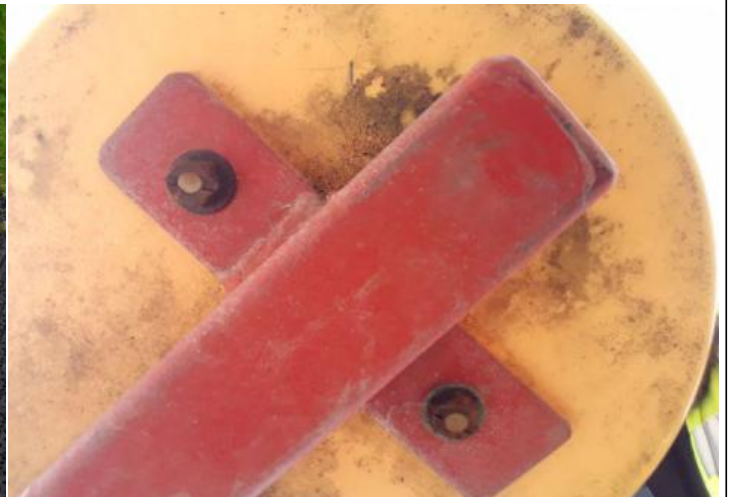
Risk Level: L - Low Risk
Surface: Matta

Finding: The fixings have corroded excessively
Action: Replace all corroded fixings
