the play inspection company

Annual Inspection

Torpoint Town Council

Borough Farm

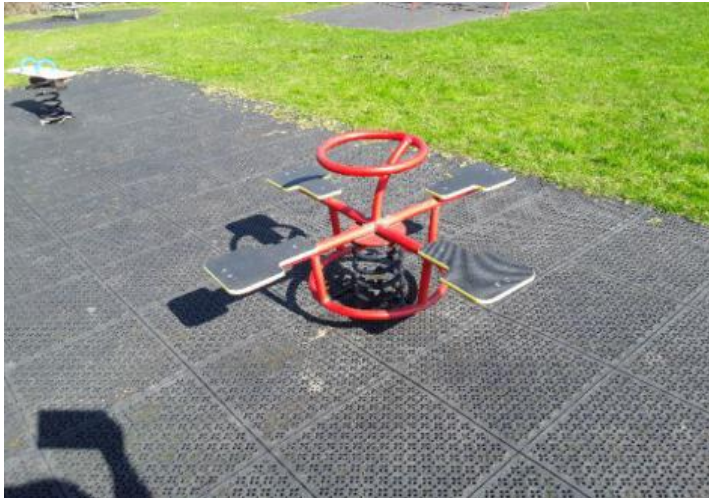
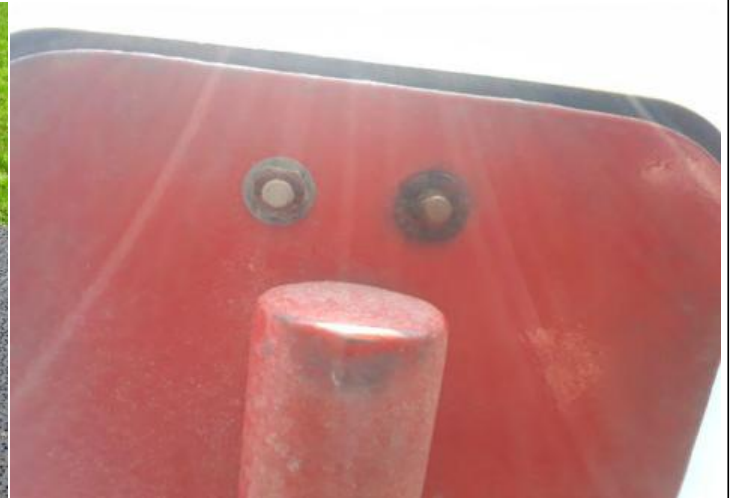
Risk Level: L - Low Risk
Surface: Matta

Finding: The fixings have corroded excessively

Action: Replace all corroded fixings

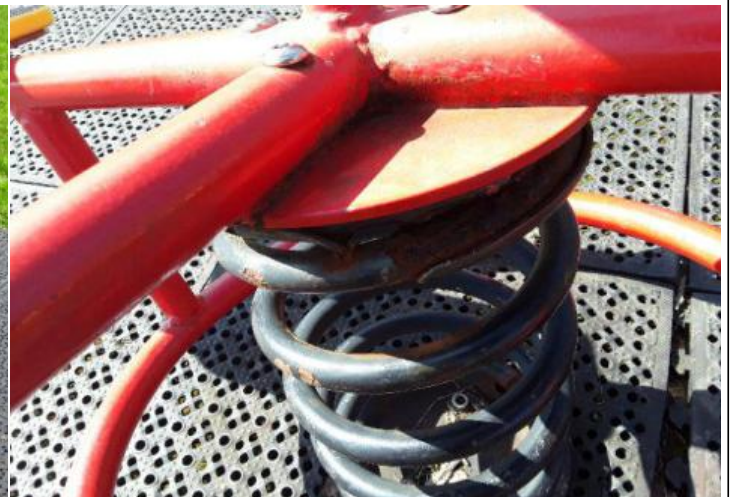
Risk Level: L - Low Risk
Surface: Matta

Finding: The paintwork on the spring has been damaged or worn exposing the metal underneath which is rusting

Action: Treat any rusting components and repaint

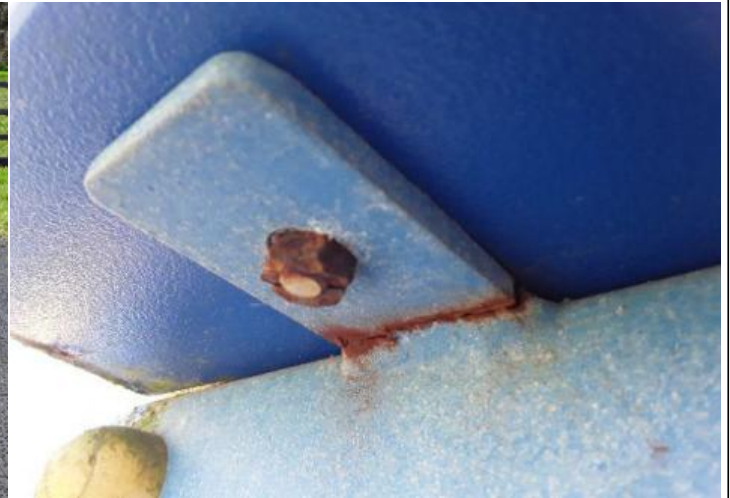
Risk Level: L - Low Risk
Surface: Matta

Finding: The weld(s) on this seat bracket have failed

Action: Repair item

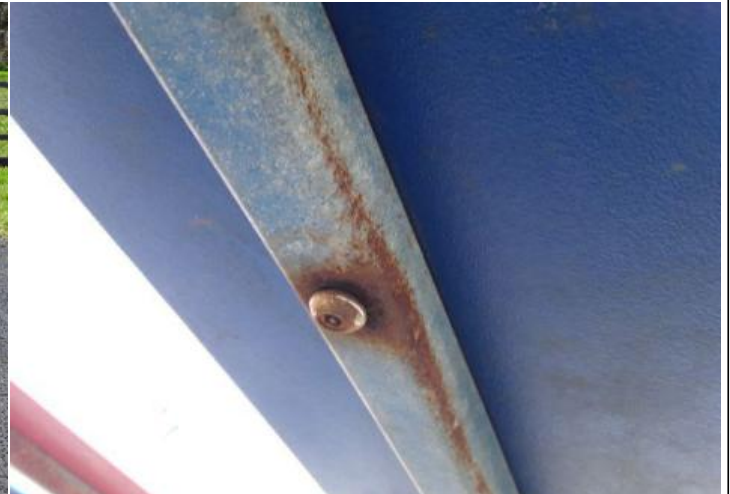
Risk Level: L - Low Risk
Surface: Matta

Finding: The paintwork on this item has been damaged or worn exposing the metal underneath which is rusting

Action: Treat any rusting components and repaint

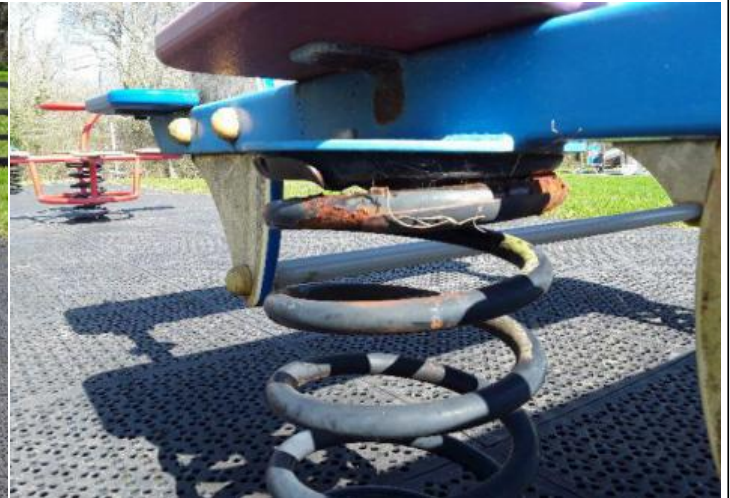
Risk Level: L - Low Risk
Surface: Matta

Finding: The paintwork on the spring has been damaged or worn exposing the metal underneath which is rusting
Action: Treat any rusting components and repaint

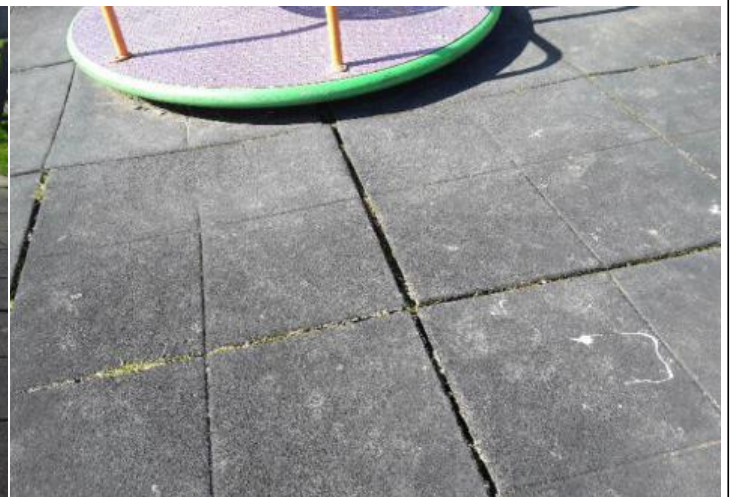
Risk Level: L - Low Risk
Surface: Rubber Tiles

Finding: There are gaps opening in between the tiles
Action: Monitor for any further deterioration and repair as required

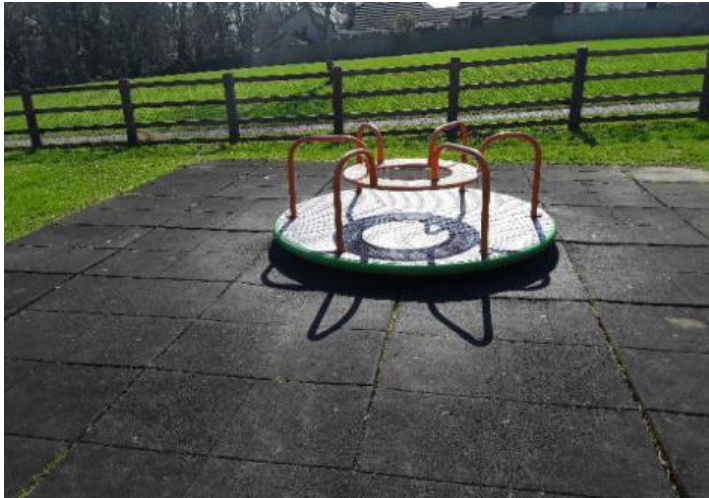
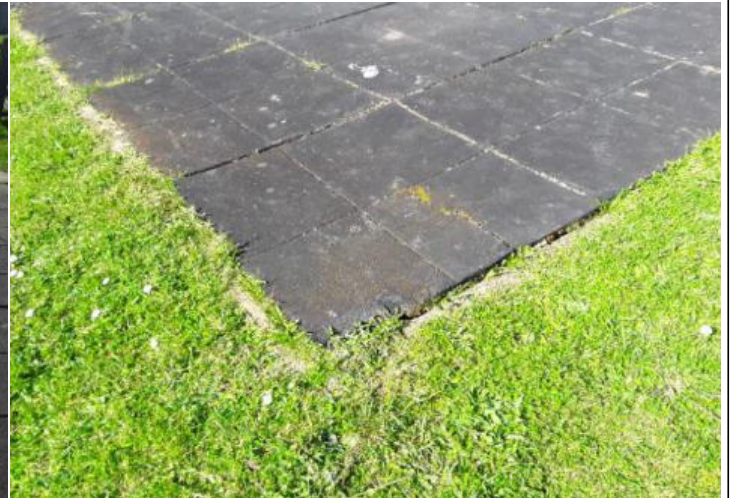
Risk Level: V - Very Low Risk
Surface: Rubber Tiles

Finding: There is some minor damage to the surface

Action: Monitor for any further deterioration and repair as required

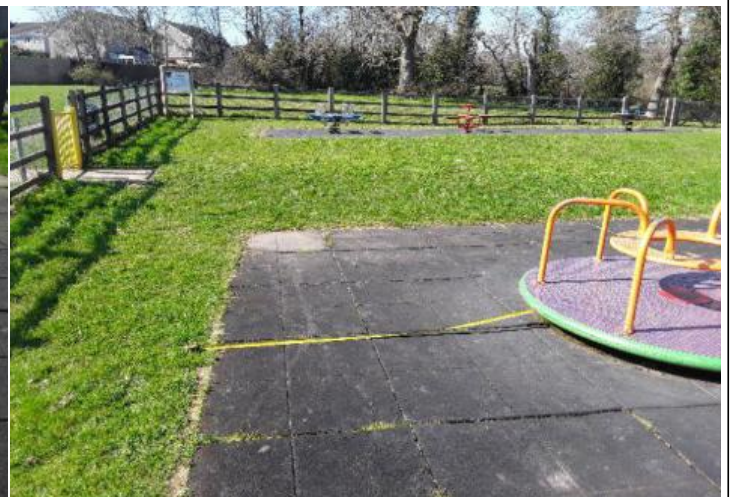
Risk Level: V - Very Low Risk
Surface: Rubber Tiles

Finding: The surfacing dimensions are short and do not meet with the requirements of the current applicable standard

Action: Monitor - no remedial action recommended

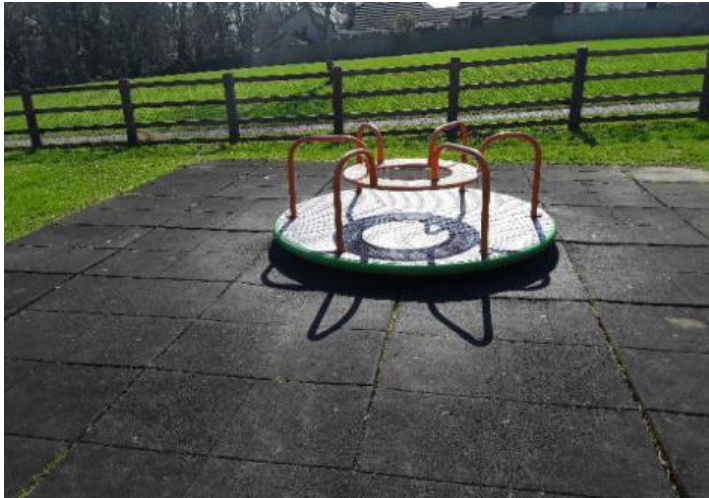
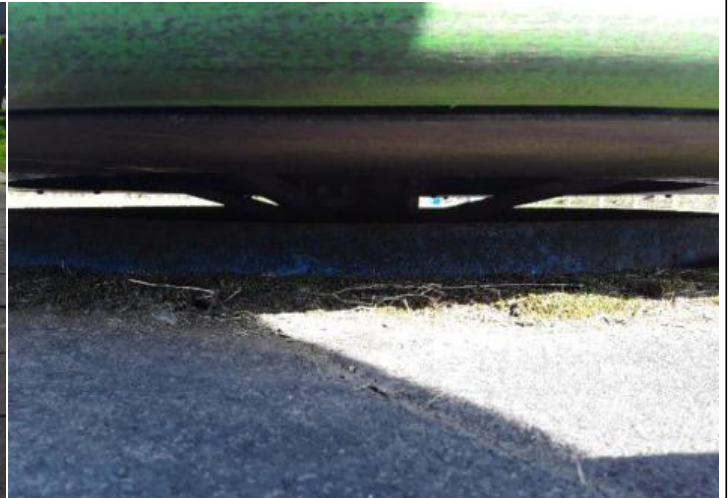
Risk Level: L - Low Risk
Surface: Rubber Tiles

Finding: The ground clearance is not maintained under the roundabout for 300mm without deviations as required by BS EN 1176 Part 5 Clause 5.2.3

Action: Monitor - No remedial work recommended
