the **play** inspection company

Annual Inspection

Torpoint Town Council

Chestnut Close, Torpoint, PL11 2NB

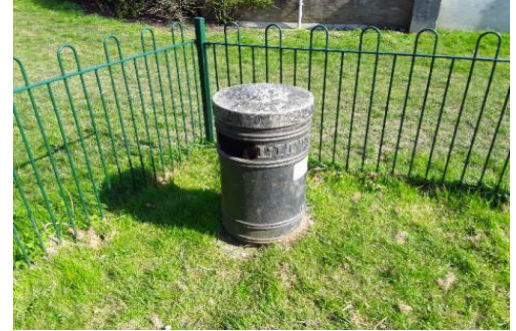
The paintwork on this item has been damaged or worn exposing the metal underneath which is rusting - Treat any rusting components and repaint

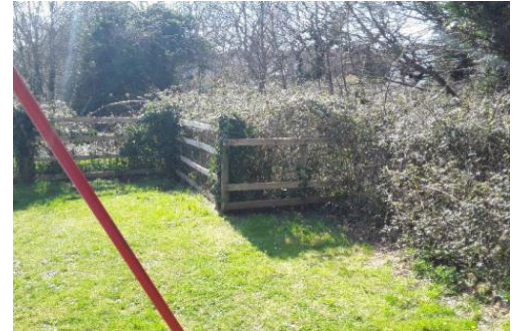
The item has missing timber rails - Consider replacing missing components

There appears to be a missing section of fence - Consider replacing missing components

There is some evidence of rot in the timber - Monitor for any further deterioration and replace as required

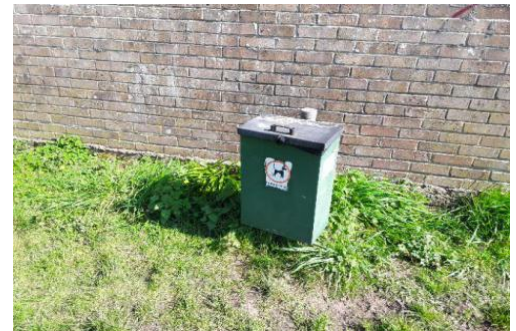
A number of fixing(s) have worked loose - Secure all loose fixings

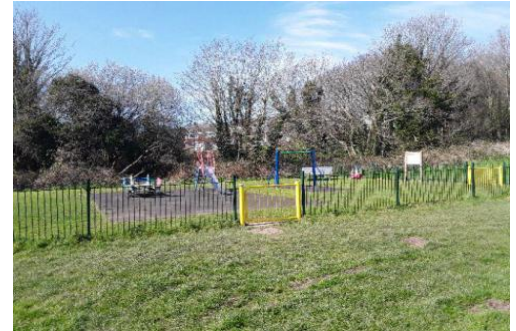
There is an accessible watercourse to the rear of the area - Ensure that an appropriate risk assessment is in place and monitor use. Consider providing additional fencing to segregate the play area from the watercourse

There is weed / vegetation growth on, between, or around the edges of the surfacing - Remove weed / vegetation growth

There are gaps opening in between the tiles - Monitor for any further deterioration and repair as required

There are some animal burrows in the area creating trip points - Reinstate the surface

There are trip hazards present due to the tiles being uneven - Reinstate surrounding surfaces to level to remove the trip points

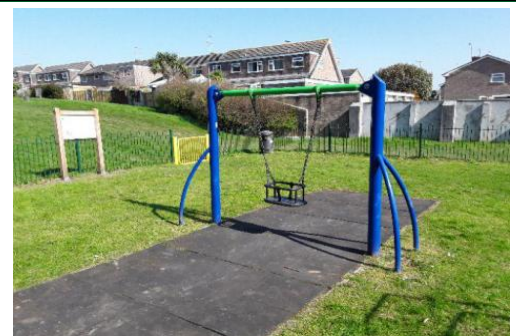
The fixings have corroded excessively - Replace all corroded fixings

The paintwork on this item has been damaged or worn exposing the metal underneath which is rusting - Treat any rusting components and repaint

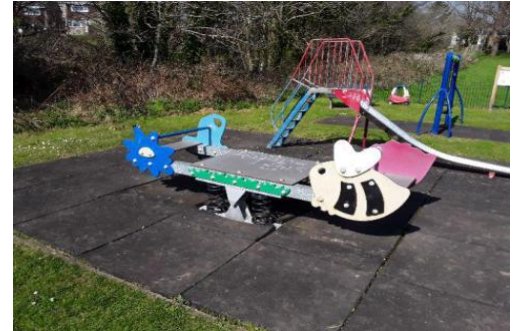
There is some minor damage to the hand grip - Monitor for any further deterioration and replace as required

There is some graffiti present - Remove the graffiti

There is/are several inserts missing - Replace missing inserts

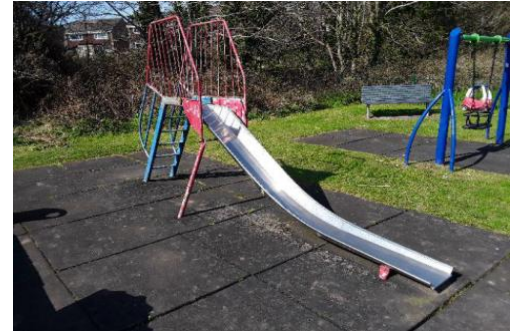
There are a number of dents in the slide surface - Monitor for any further deterioration and repair as required

The paintwork on this item has been damaged or worn exposing the metal underneath which is rusting - Treat any rusting components and repaint

There is/are finger entrapment/s in the frame and the item fails to meet the requirements of BS EN 1176 Part 1 4.2.7.6 Entrapment of fingers - Monitor - No remedial work recommended

The item fails to meet the requirements of BS EN 1176 Part 1 4.2.7.2 head and neck entrapment in the barriers and/or steps - Monitor - No remedial work recommended

There is some minor damage to the barrier - Monitor for any further deterioration and replace as required

There is some internal corrosion that is causing the steel tube to swell - Monitor for any further deterioration and replace as required

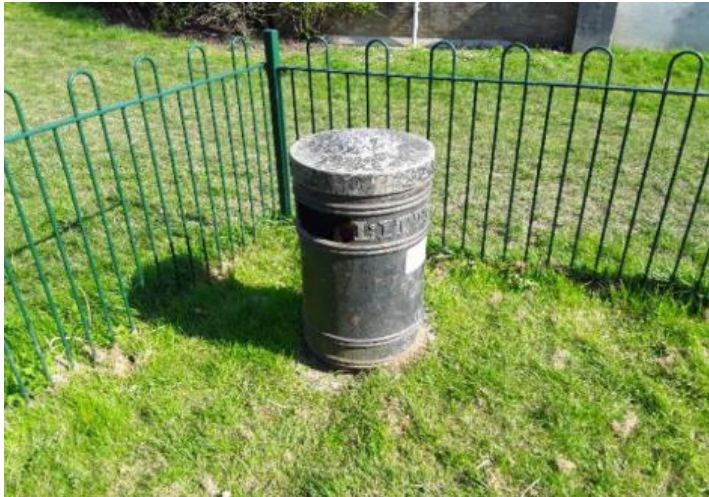
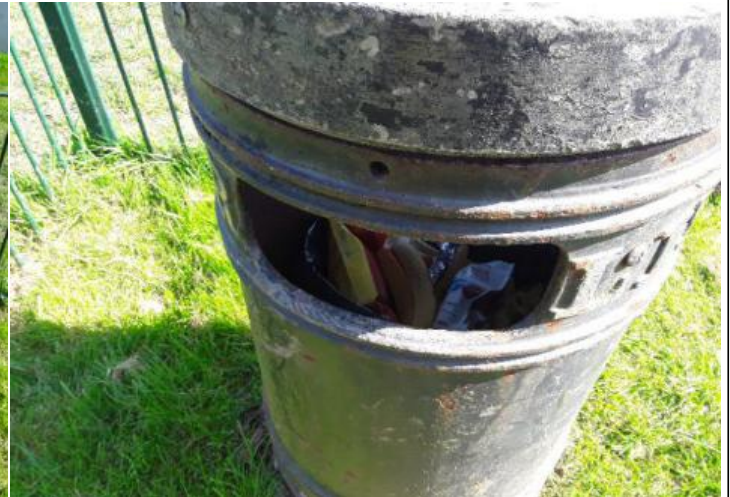
Finding: The paintwork on this item has been damaged or worn exposing the metal underneath which is rusting

Action: Treat any rusting components and repaint

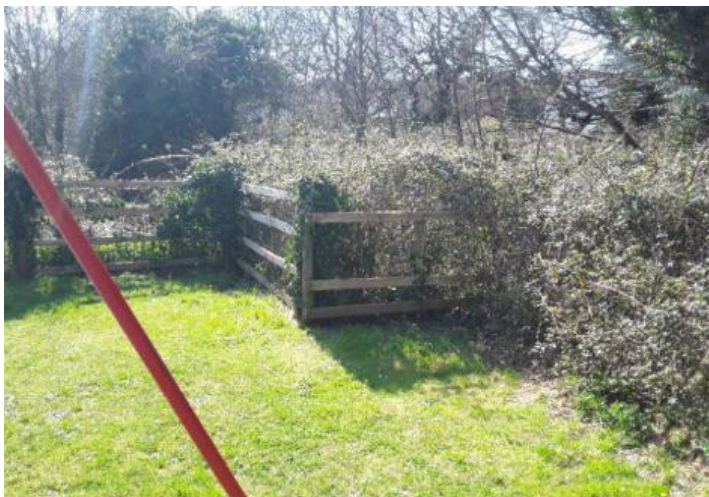
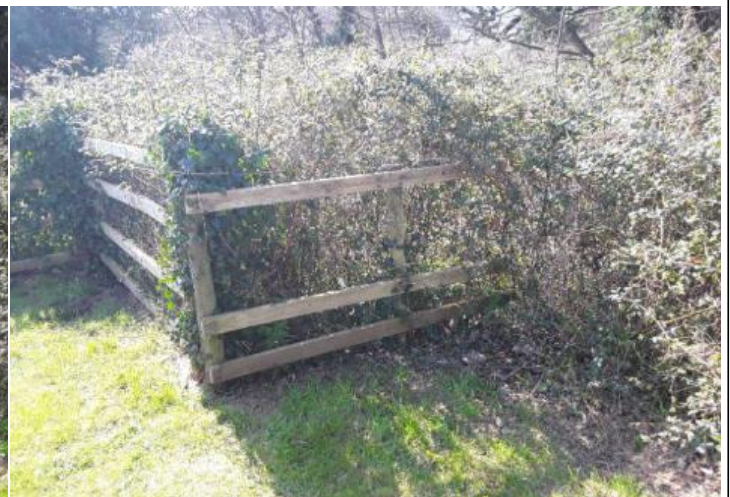
Finding: The item has missing timber rails

Action: Consider replacing missing components

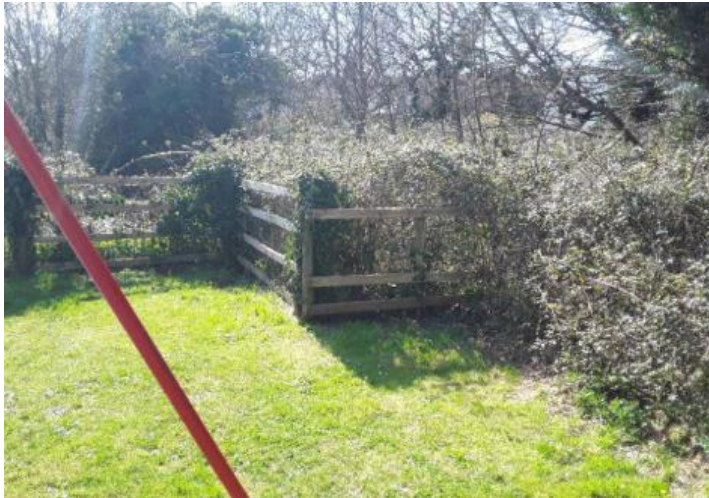
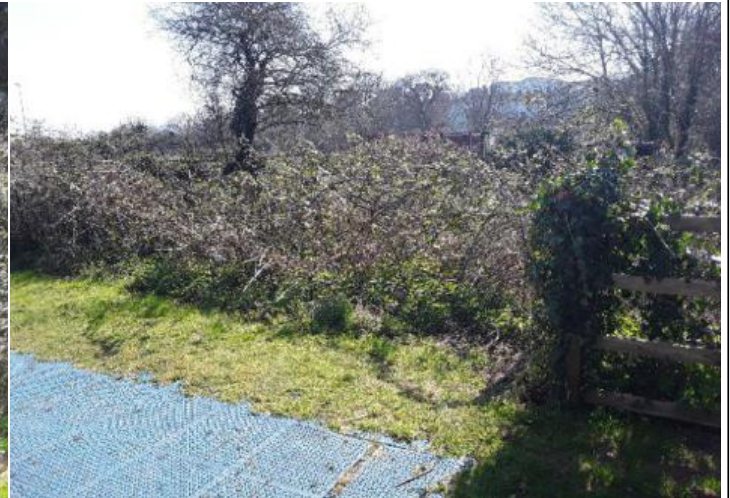
Finding: There appears to be a missing section of fence

Action: Consider replacing missing components

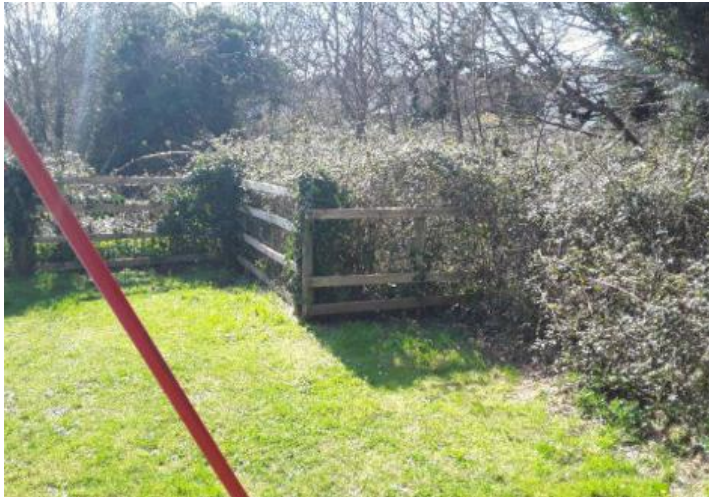
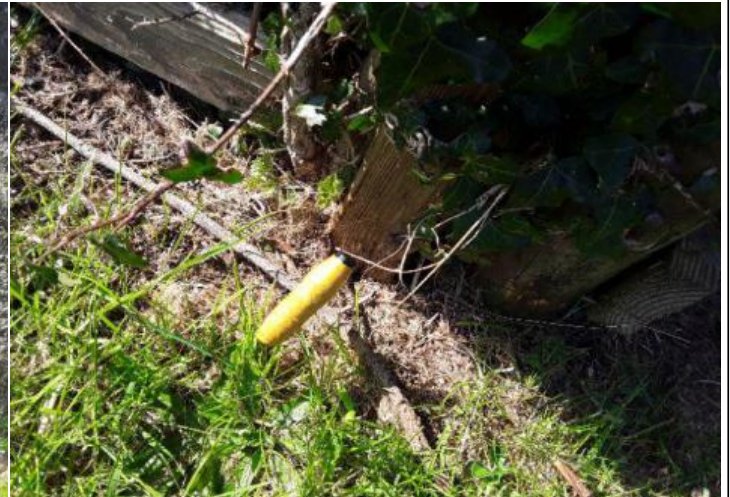
Finding: There is some evidence of rot in the timber

Action: Monitor for any further deterioration and replace as required

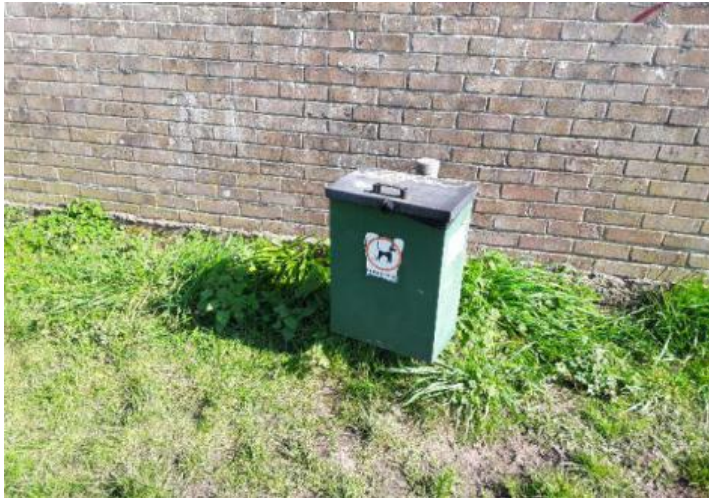
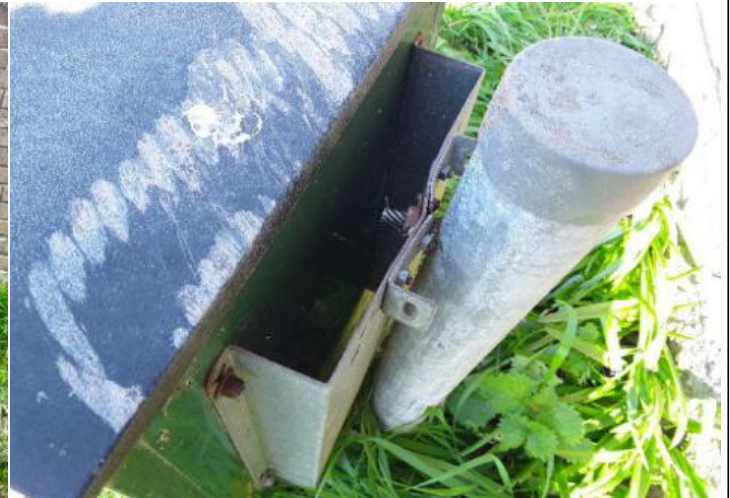
Finding: A number of fixing(s) have worked loose

Action: Secure all loose fixings

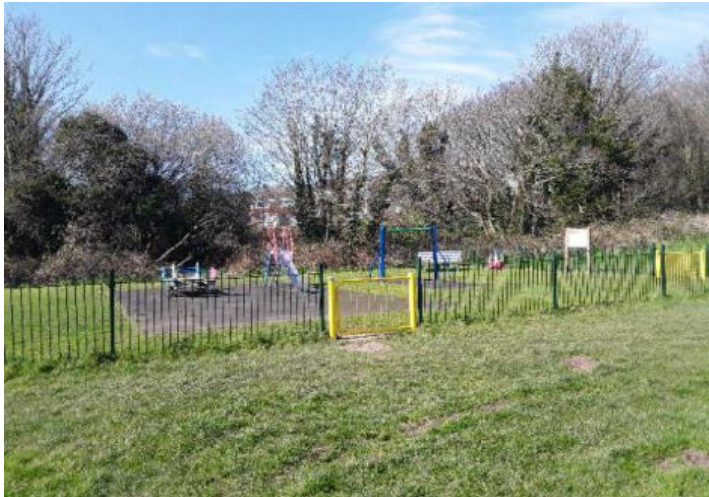
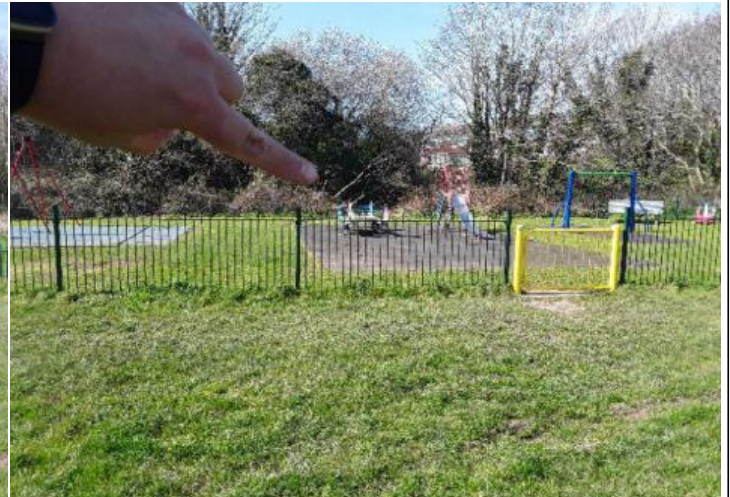
Finding: There is an accessible watercourse to the rear of the area

Action: Ensure that an appropriate risk assessment is in place and monitor use. Consider providing additional fencing to segregate the play area from the watercourse

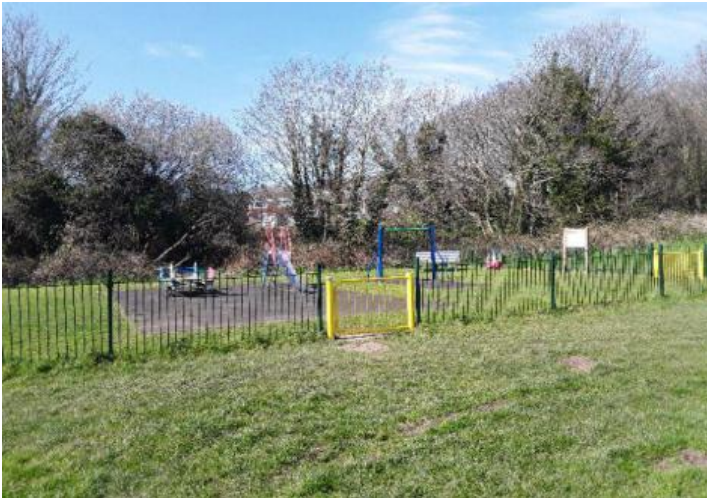
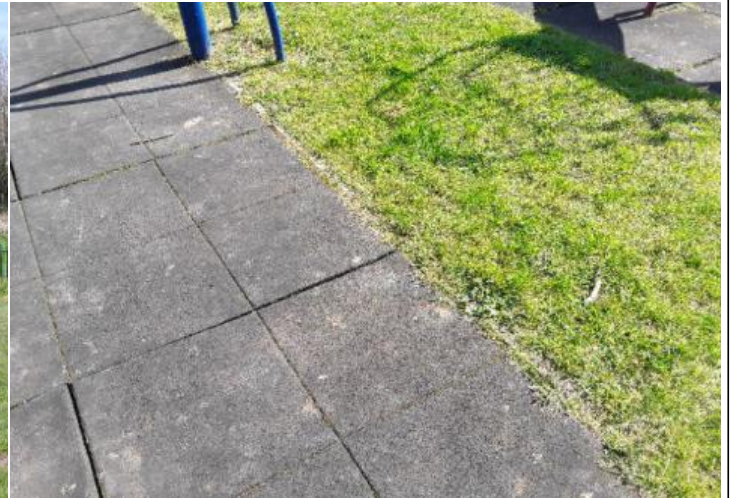
Finding: There is weed / vegetation growth on, between, or around the edges of the surfacing
Action: Remove weed / vegetation growth

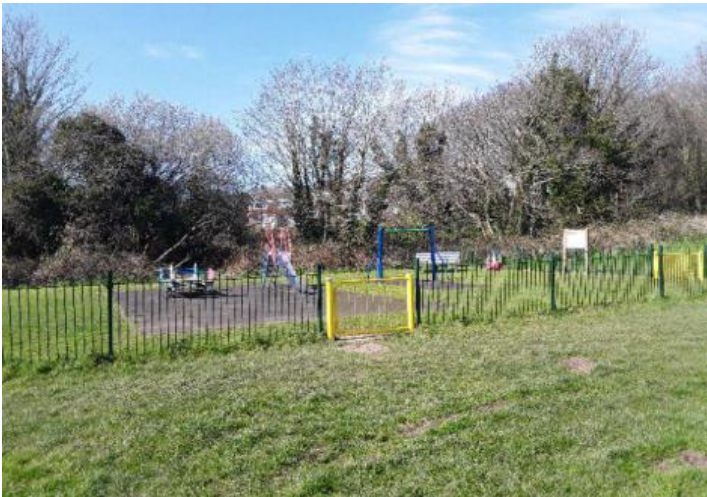
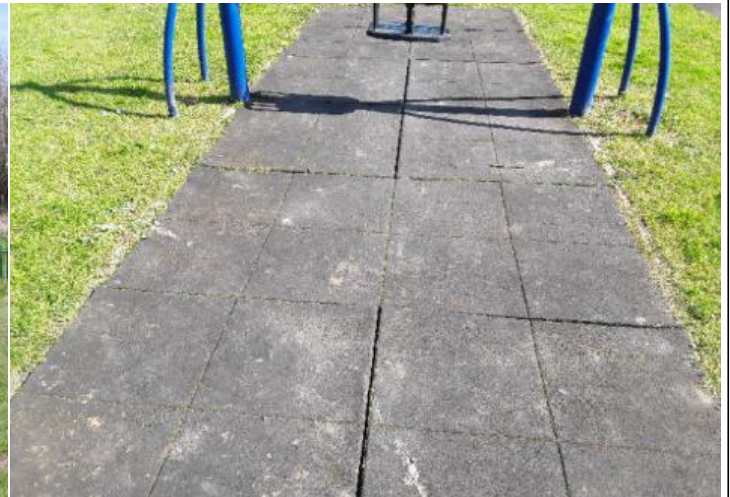
Finding: There are gaps opening in between the tiles
Action: Monitor for any further deterioration and repair as required

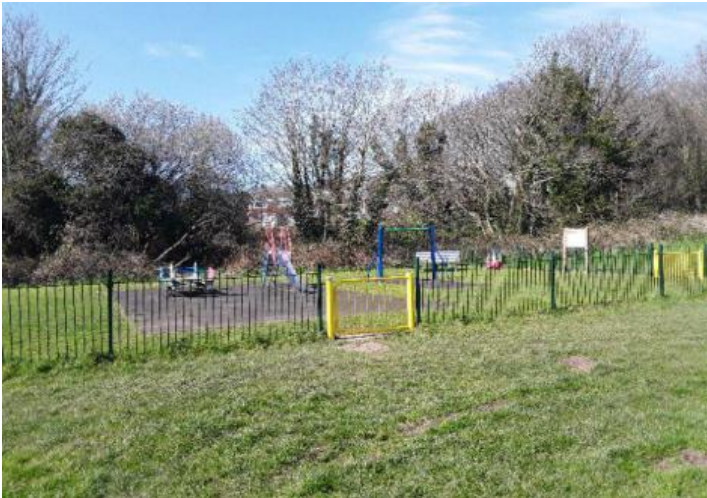
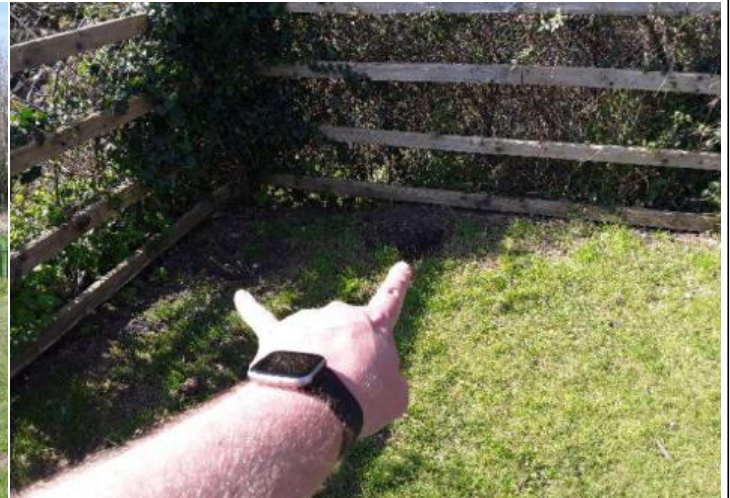
Finding: There are some animal burrows in the area creating trip points

Action: Reinstate the surface

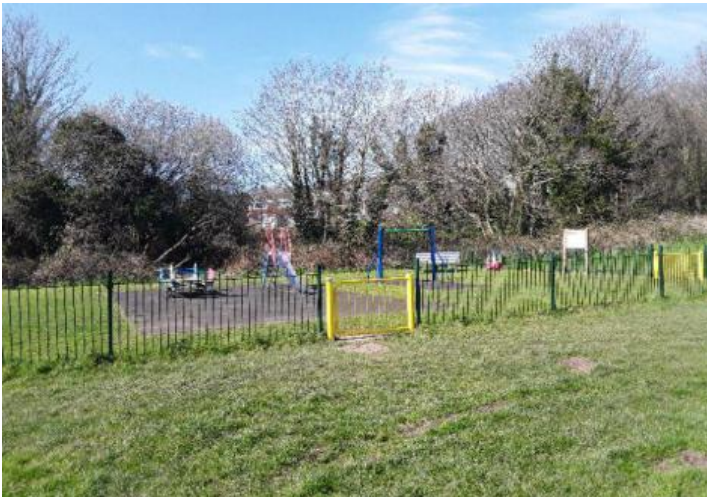
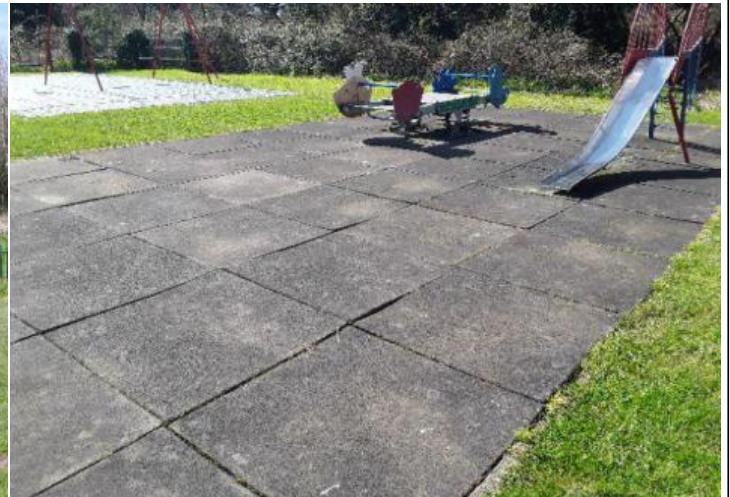
Finding: There are trip hazards present due to the tiles being uneven

Action: Reinstate surrounding surfaces to level to remove the trip points

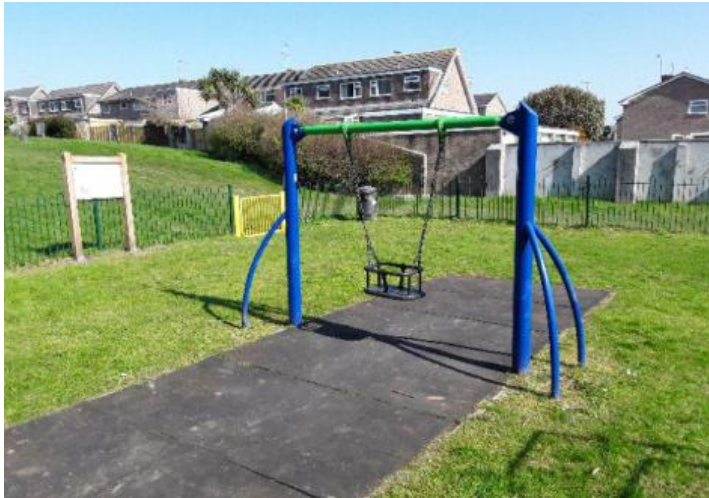
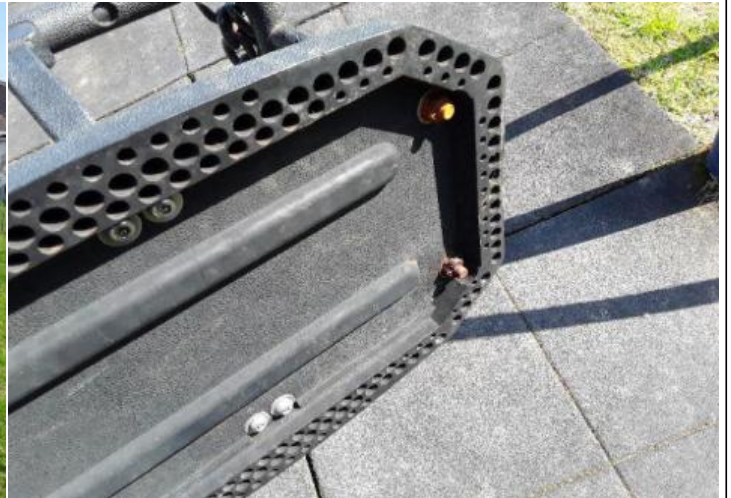
Finding: The fixings have corroded excessively

Action: Replace all corroded fixings

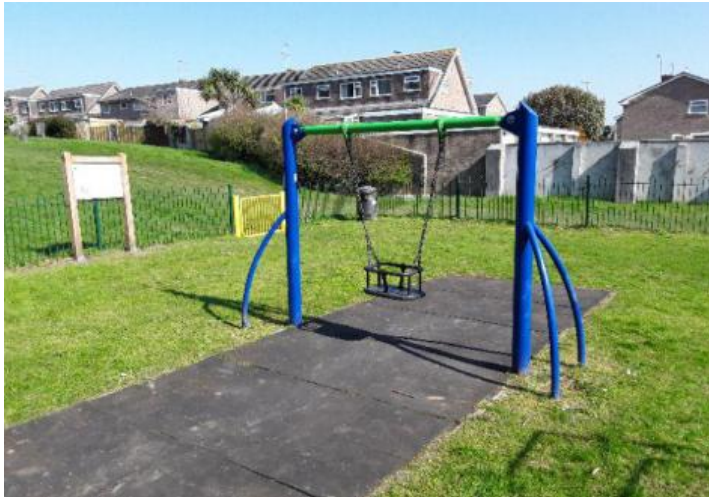
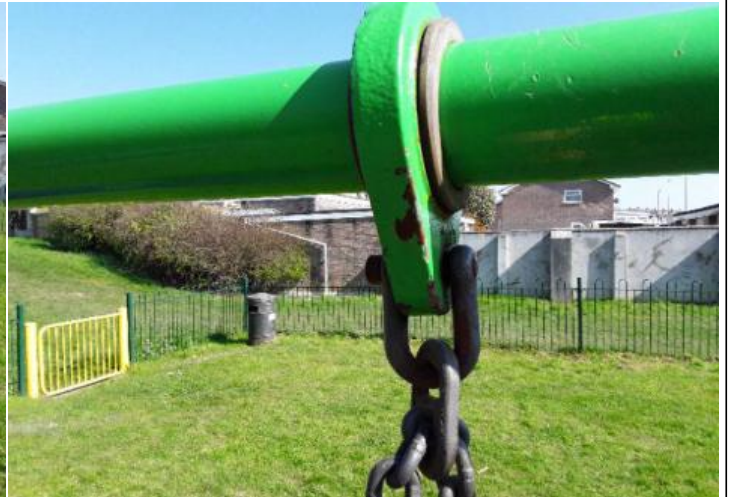
Finding: The paintwork on this item has been damaged or worn exposing the metal underneath which is rusting

Action: Treat any rusting components and repaint

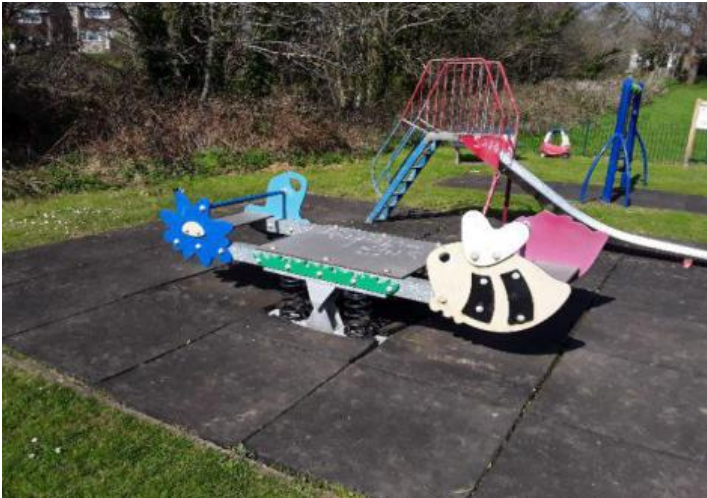
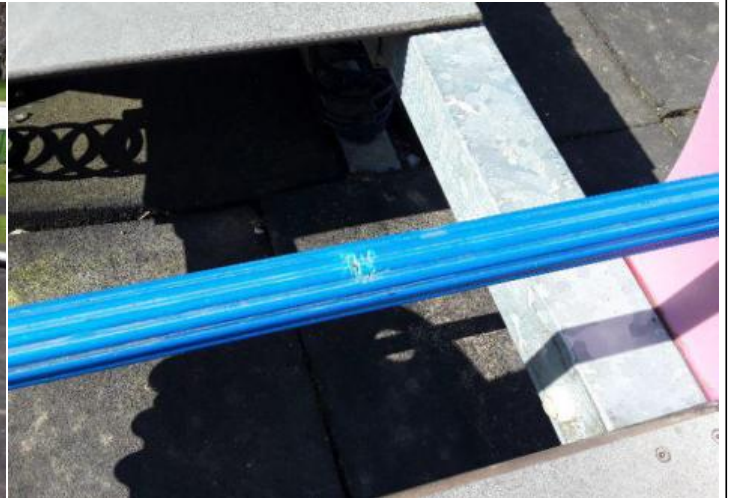
Finding: There is some minor damage to the hand grip

Action: Monitor for any further deterioration and replace as required

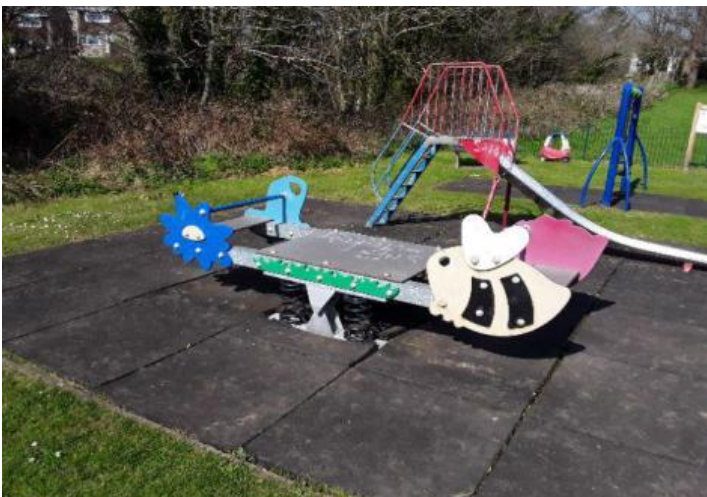
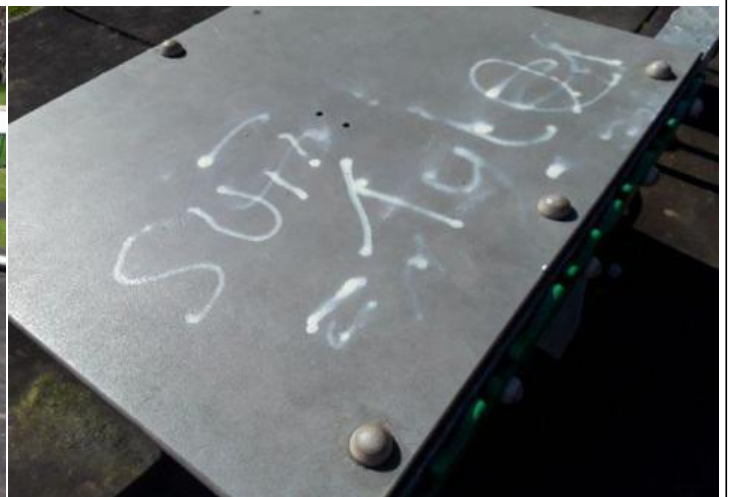
Finding: There is some graffiti present

Action: Remove the graffiti

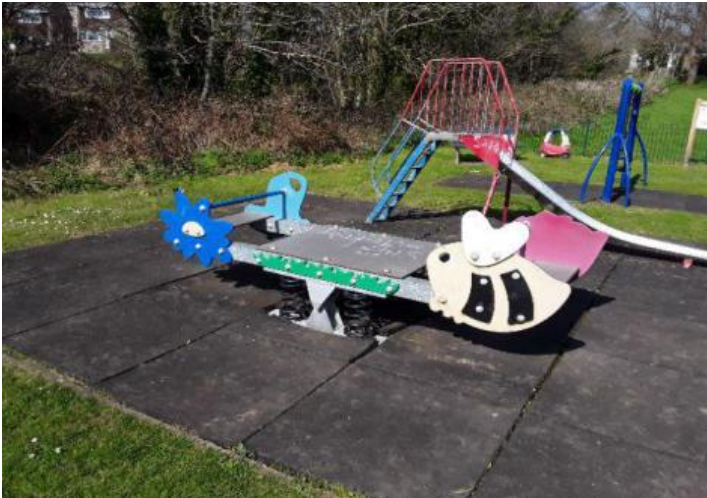
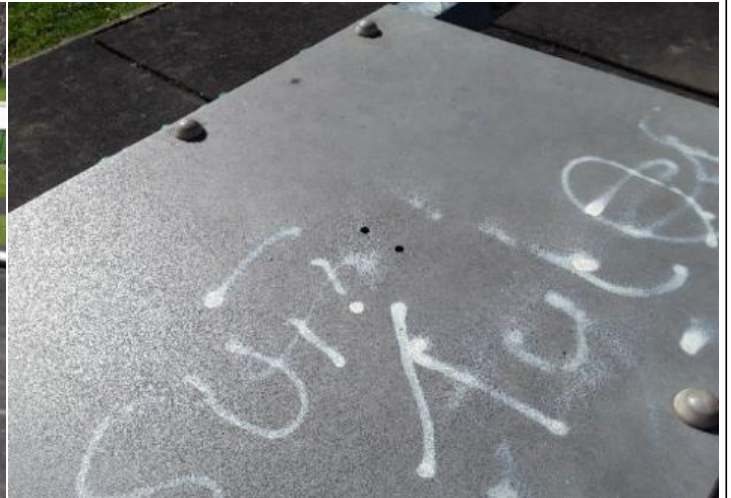
Finding: There is/are several inserts missing

Action: Replace missing inserts

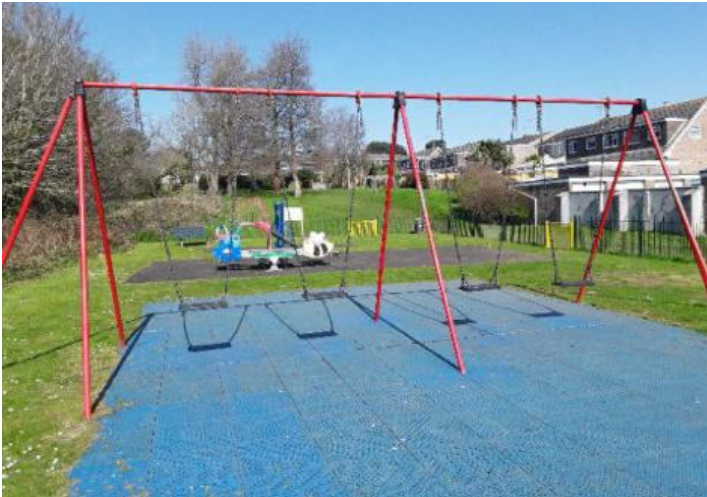
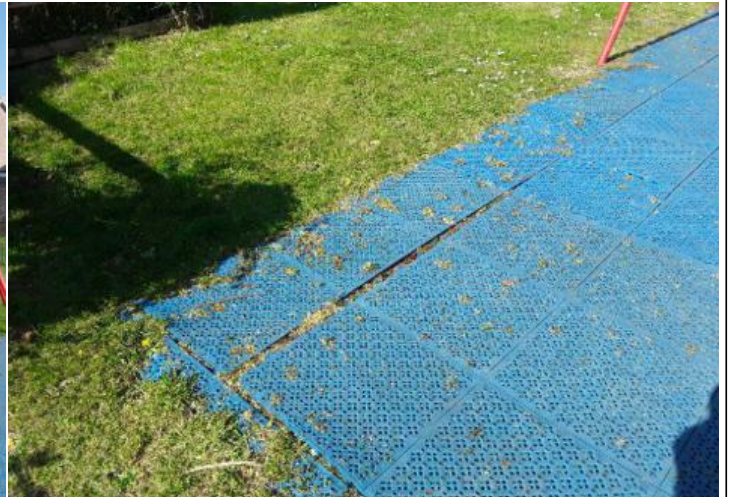
There are gaps opening between the grass mat tiles - Provide additional ties or secure / reinstate surface

Finding: There are gaps opening between the grass mat tiles

Action: Provide additional ties or secure / reinstate surface

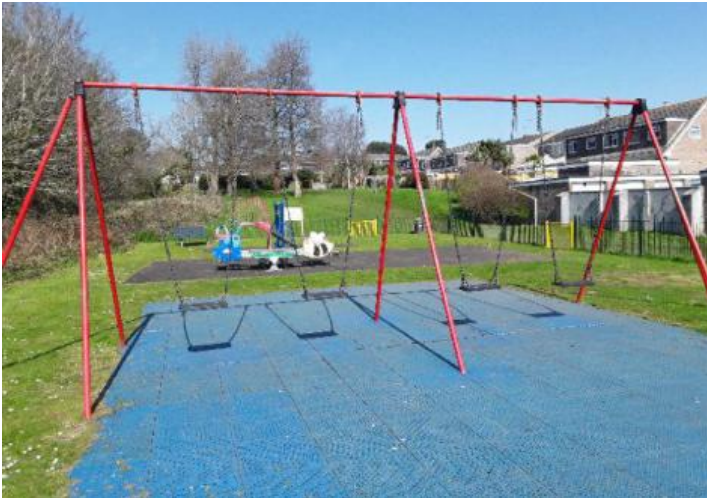
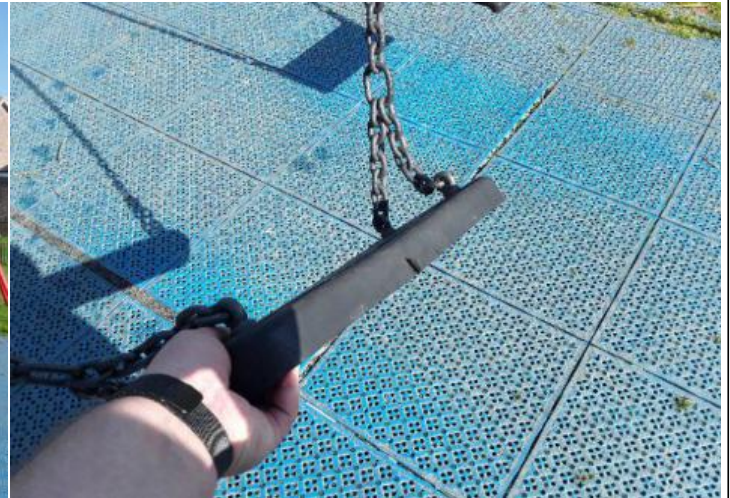
The seat has minor damage or wear - Monitor for any further deterioration and replace as required

Finding: The seat has minor damage or wear

Action: Monitor for any further deterioration and replace as required

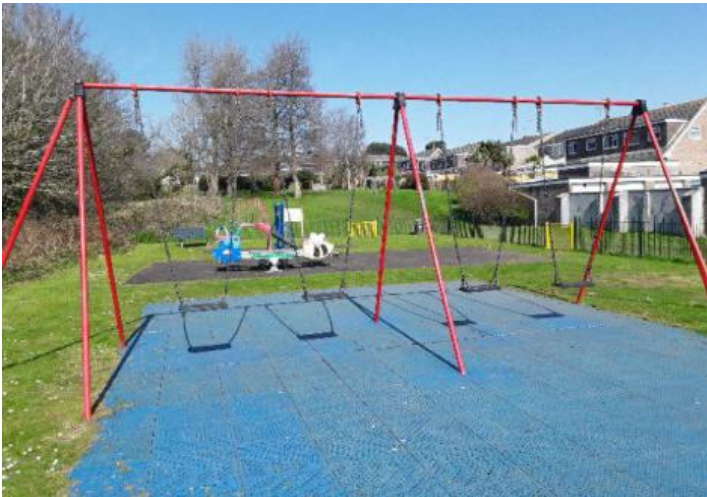
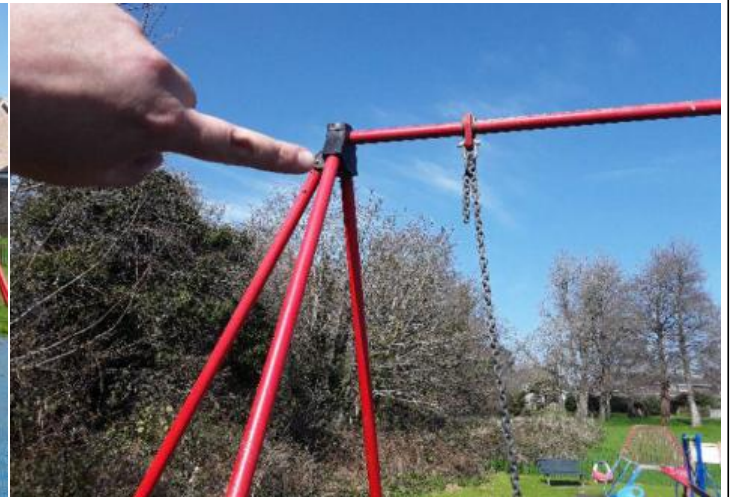
A number of fixing(s) have worked loose - Secure all loose fixings

Finding: A number of fixing(s) have worked loose

Action: Secure all loose fixings

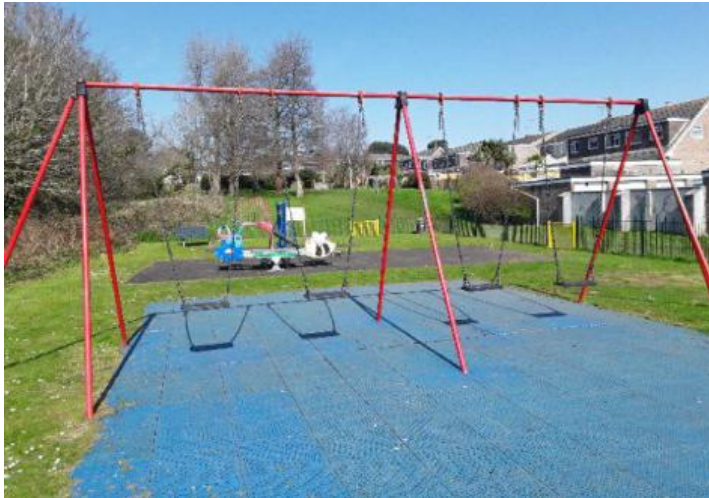
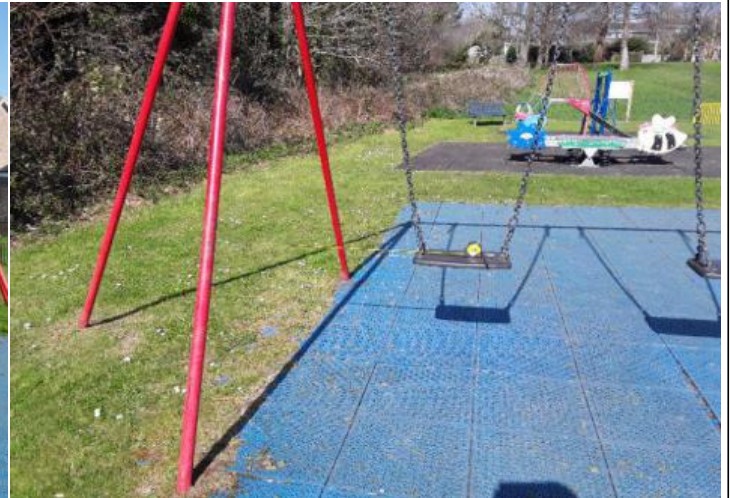
The seats are too close to the frame as defined in BS EN 1176 Part 2; this is a low risk failure and no remedial action is required - Monitor - No remedial work recommended

Finding: The seats are too close to the frame as defined in BS EN 1176 Part 2; this is a low risk failure and no remedial action is required

Action: Monitor - No remedial work recommended

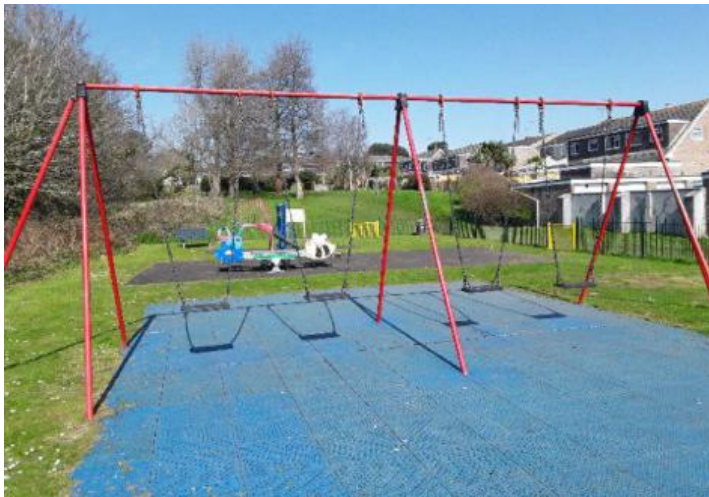
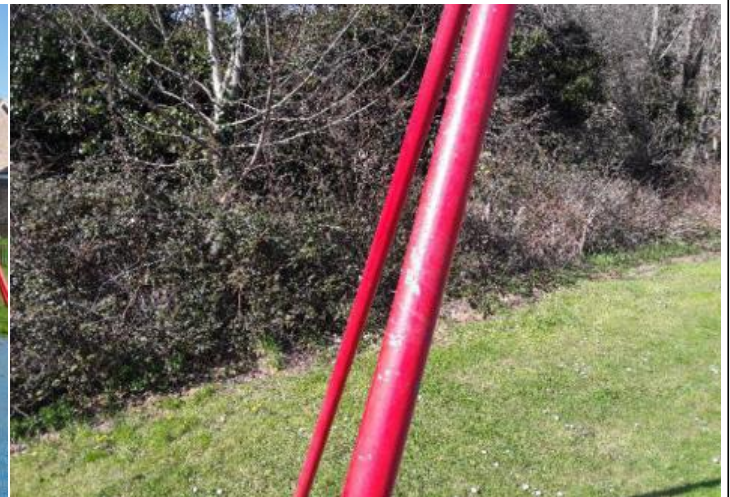
Finding: The paint is flaking off the metalwork

Action: Rub down and re-paint

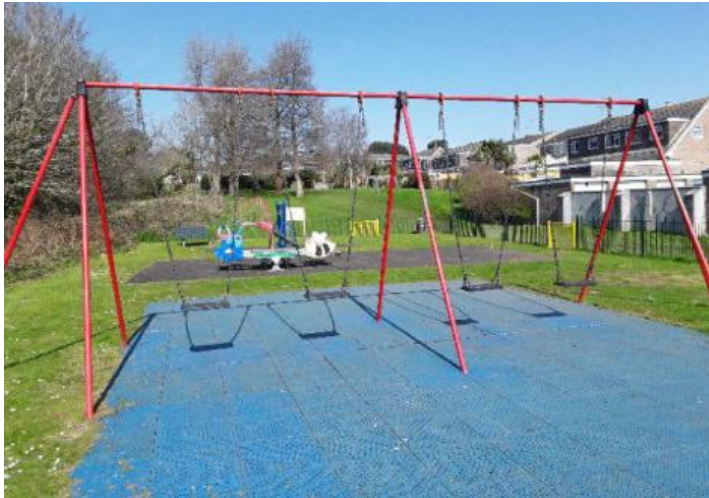
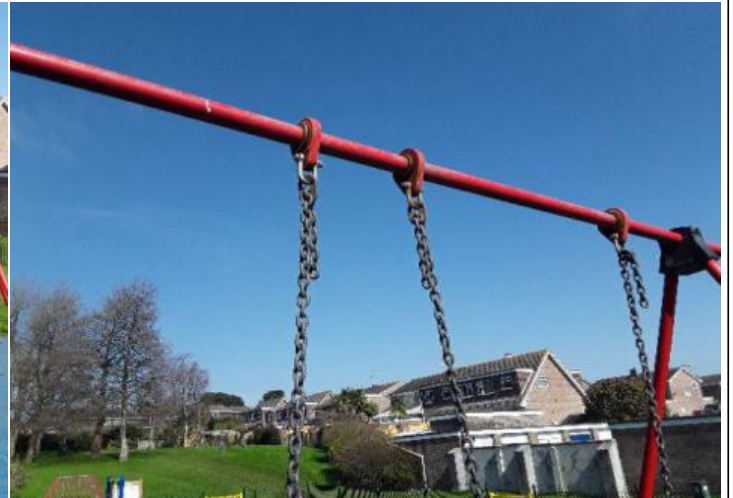
The bushes are showing signs of wear - Monitor for any further deterioration and replace as required

Finding: The bushes are showing signs of wear

Action: Monitor for any further deterioration and replace as required

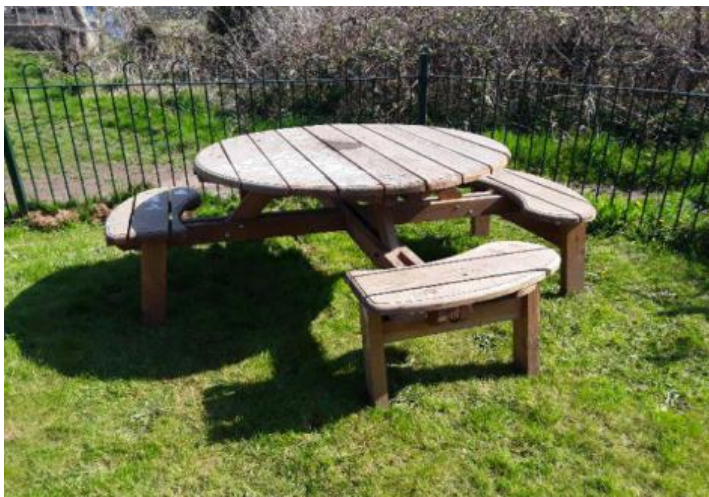
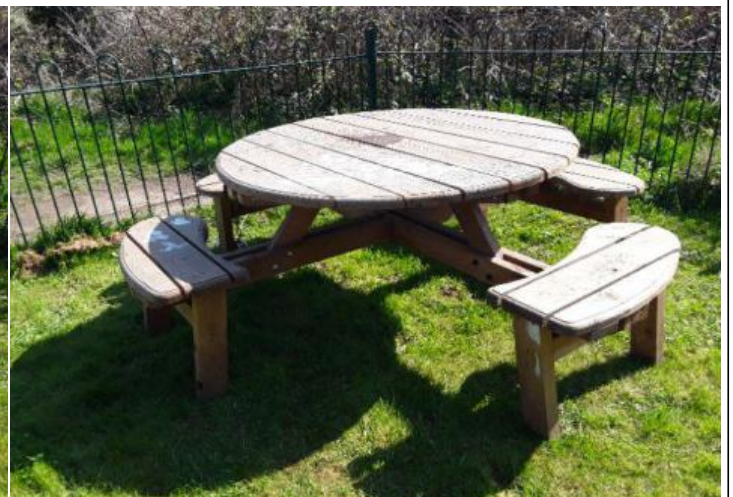
Finding: The table is not secured to the ground and there is some potential for the item to be moved within falling spaces of equipment

Action: Secure the item to the ground

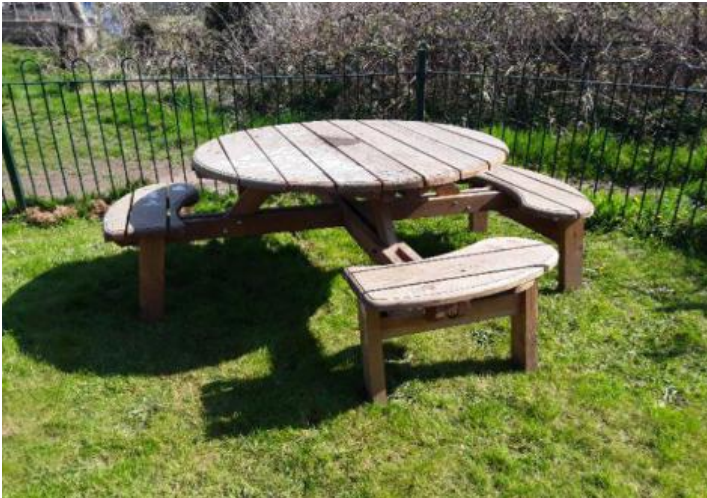
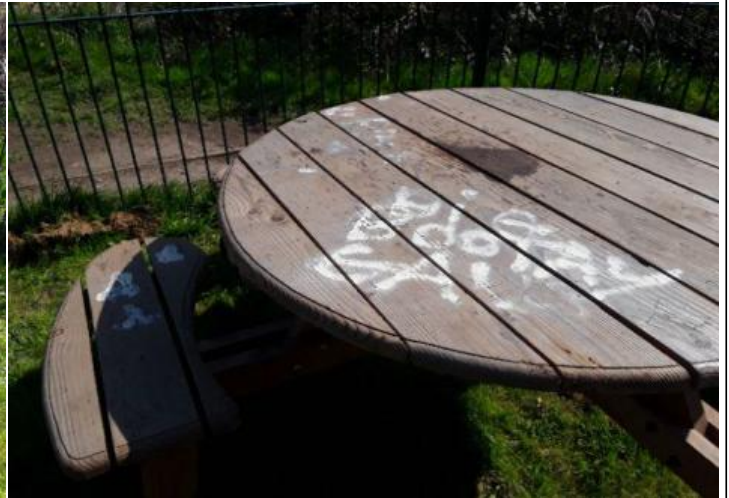
Finding: There is some graffiti present

Action: Remove the graffiti

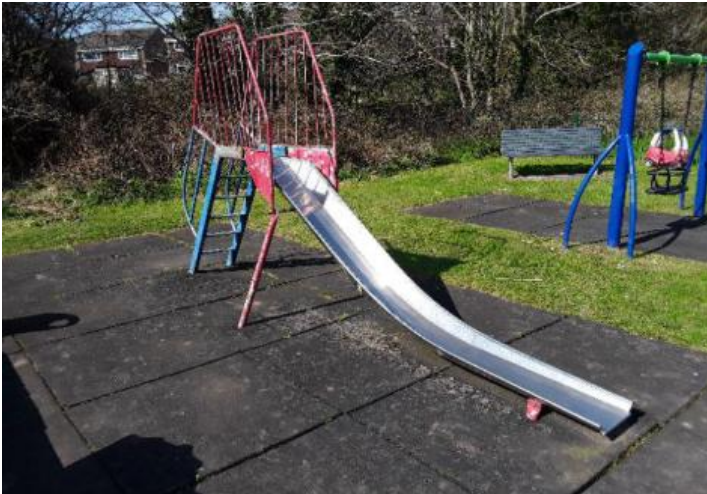
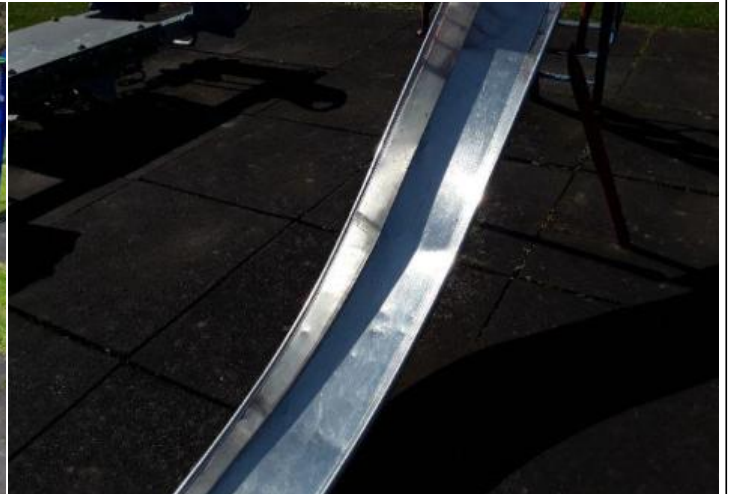
Finding: There are a number of dents in the slide surface

Action: Monitor for any further deterioration and repair as required

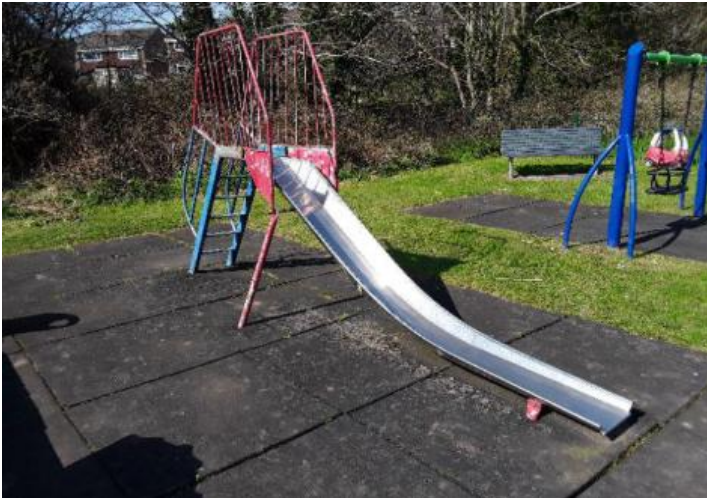
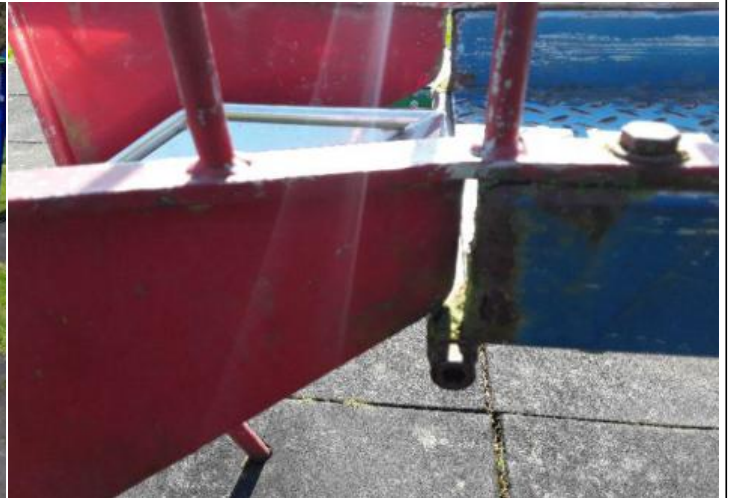
Finding: The paintwork on this item has been damaged or worn exposing the metal underneath which is rusting

Action: Treat any rusting components and repaint

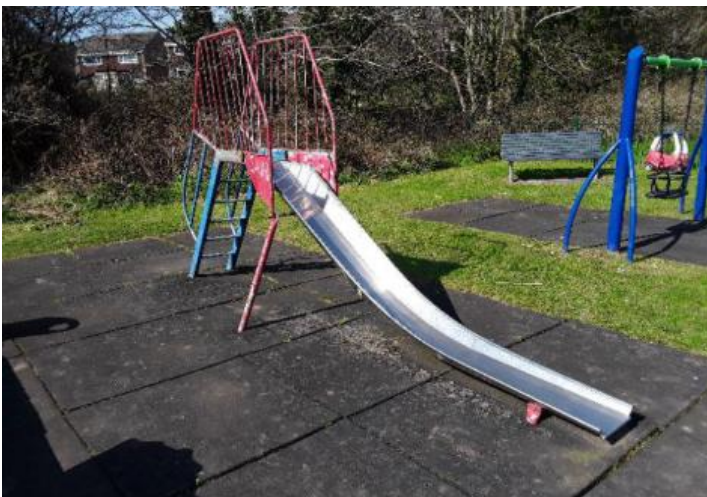
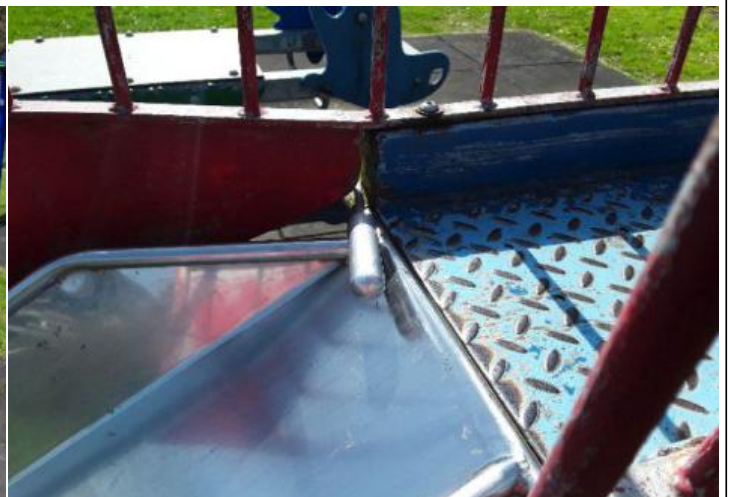
Finding: There is/are finger entrapment/s in the frame and the item fails to meet the requirements of BS EN 1176 Part 1 4.2.7.6 Entrapment of fingers

Action: Monitor - No remedial work recommended

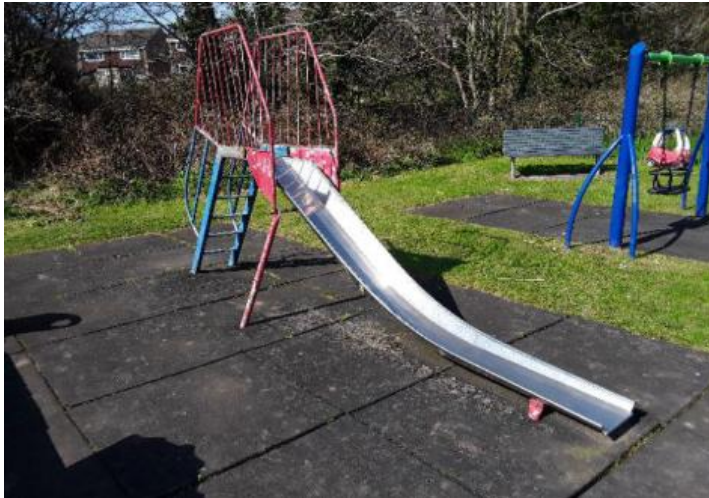
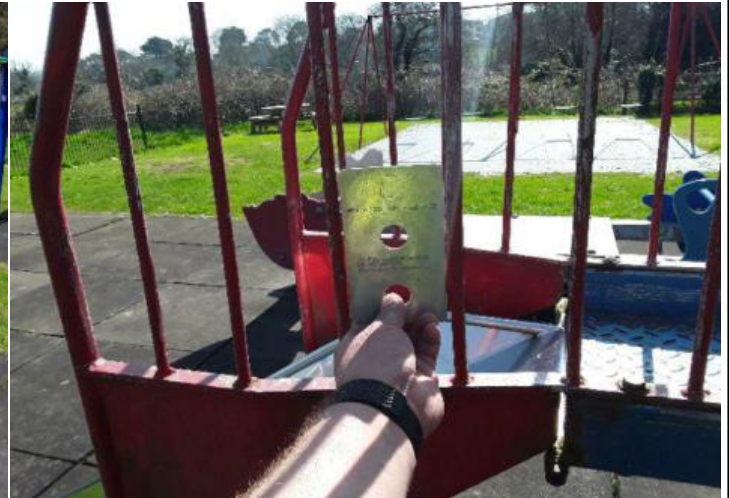
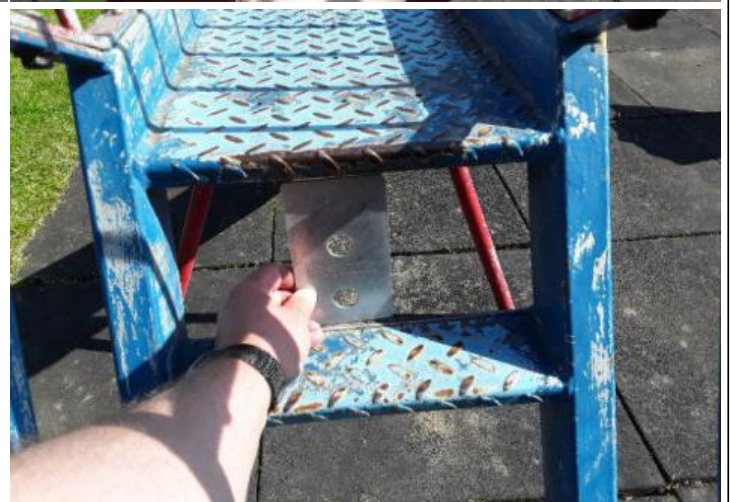
Finding: The item fails to meet the requirements of BS EN 1176 Part 1 4.2.7.2 head and neck entrapment in the barriers and/or steps

Action: Monitor - No remedial work recommended
