the **play** inspection company

Annual Inspection

Torpoint Town Council

Chestnut Close, Torpoint, PL11 2NB

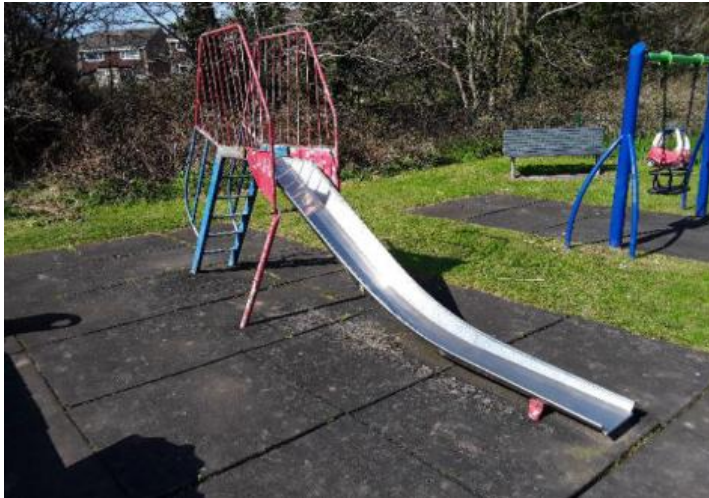
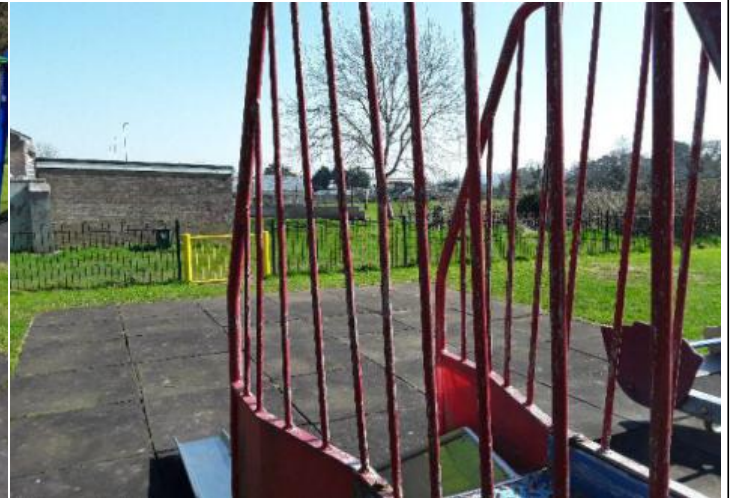
Finding: There is some minor damage to the barrier

Action: Monitor for any further deterioration and replace as required

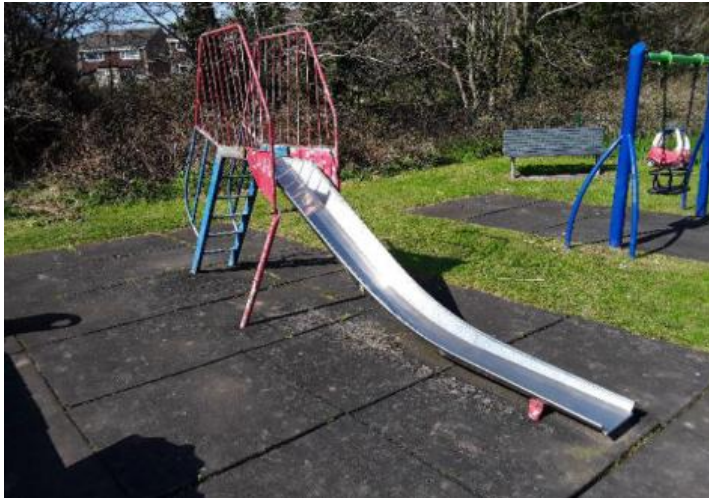
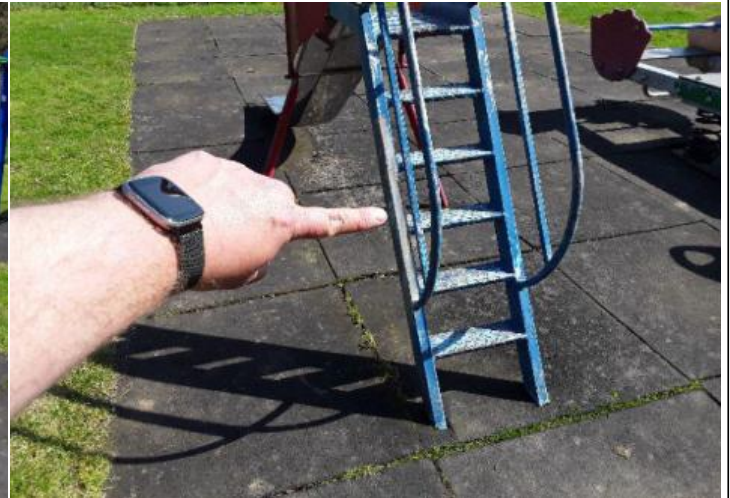
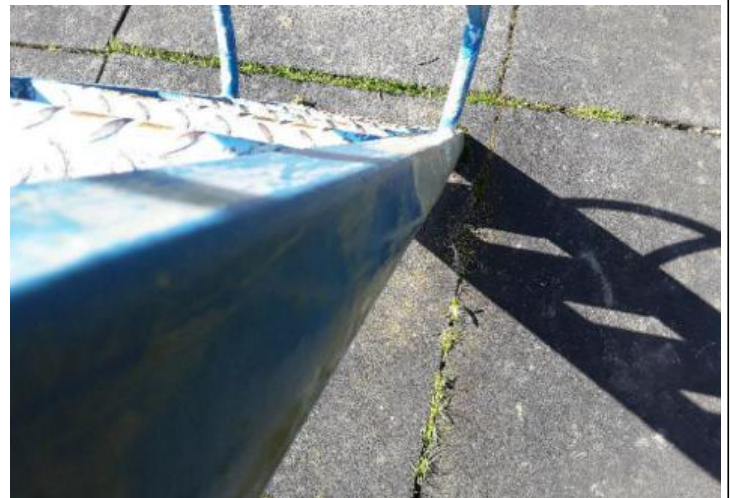
Finding: There is some internal corrosion that is causing the steel tube to swell
Action: Monitor for any further deterioration and replace as required
