the play inspection company

Annual Inspection

Torpoint Town Council

Thanckes Park Tennis Courts

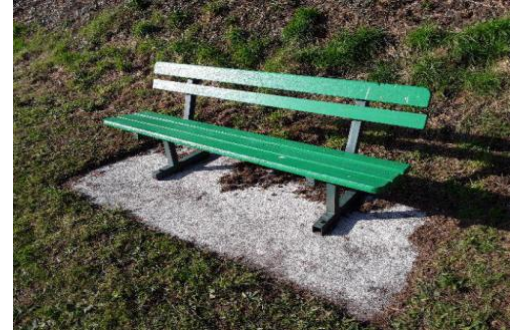
Item: Bench
Manufacturer: Not Identified
Surface Type: Concrete
Item Quantity: 1
Equipment Compliance: N/A
Surface Area Compliance: N/A

There are post / end caps missing from the item - Replace missing post caps

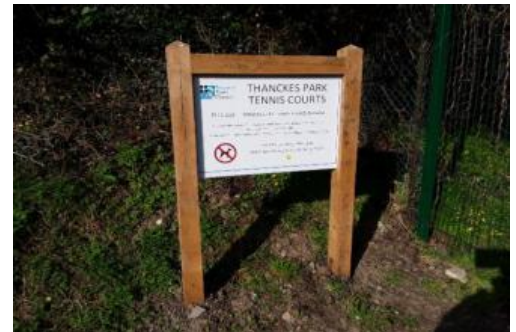
Item: Sign
Manufacturer: Owner/Operator
Surface Type: Grass
Item Quantity: 1
Equipment Compliance: N/A
Surface Area Compliance: N/A

This item is satisfactory - no work required -

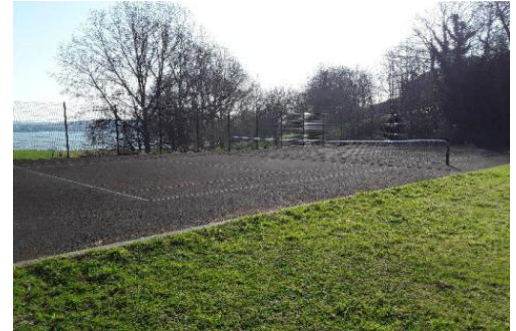
Item: Tennis Court
Manufacturer: Not Identified
Surface Type: Bitmac
Item Quantity: 1
Equipment Compliance: N/A
Surface Area Compliance: N/A
Life Expectancy: 5 -10 Years
Total Findings: 3

The bitumen surface is worn or damaged - Repair the bitumen to provide a uniform surface

There are trip hazards present at the edge of the court - Monitor use and consider adjusting the item to remove trip points

There is weed / vegetation growth on, between, or around the edges of the surfacing - Remove weed / vegetation growth

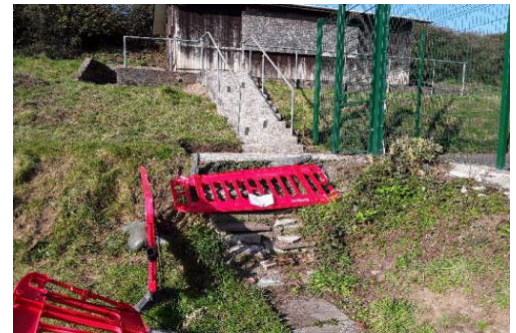
Item: Concrete
Manufacturer: Owner/Operator
Surface Type: Non-standard Surface
Item Part Number: 0
Item Quantity: 1
Equipment Compliance: N/A
Surface Area Compliance: N/A
Life Expectancy: 1 - 3 Years
Total Findings: 2

The steps on site has been isolated from use however the area is still accessible and the means of isolation has either introduced additional hazards that may cause harm in the event of users accessing the area or is insufficient to stop users from accessing the steps - Provide a more suitable isolation method

The concrete steps are severely damaged - Repair or replace

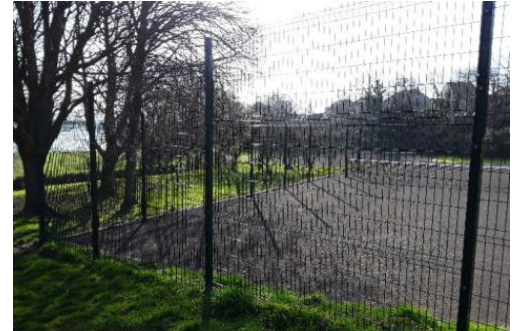
Item: Fence - Steel Mesh
Manufacturer: Not Identified
Surface Type: Grass
Item Quantity: 1
Equipment Compliance: N/A
Surface Area Compliance: N/A
Life Expectancy: 5 -10 Years
Total Findings: 1

There are openings that are less than 12mm that could trap or crush fingers - Where possible a 12mm gap should be maintained on both sides or between the gate leafs

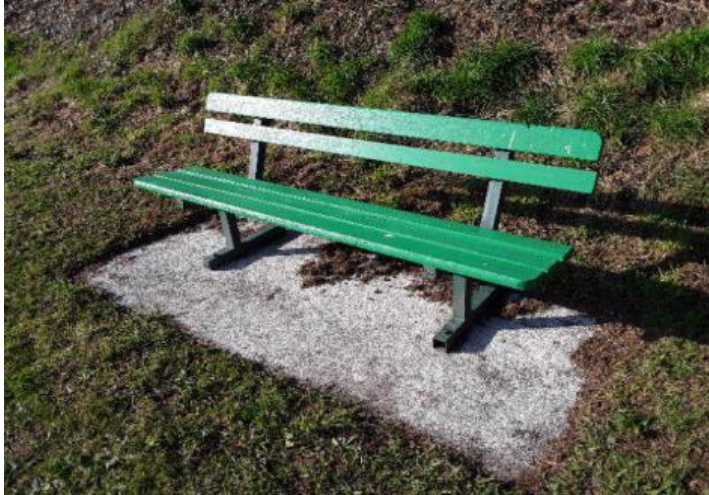
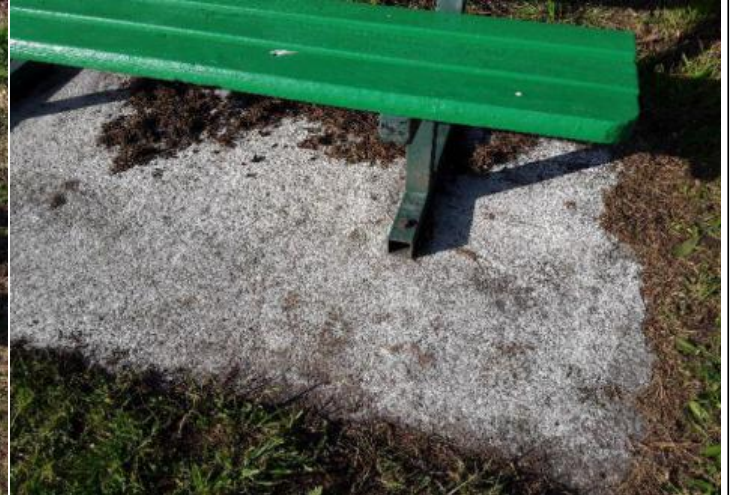
6 - Low Risk (Finding 1)

Item: Ancillary Items - Bench
Manufacturer: Not Identified

Finding: There are post / end caps missing from the item

Action: Replace missing post caps

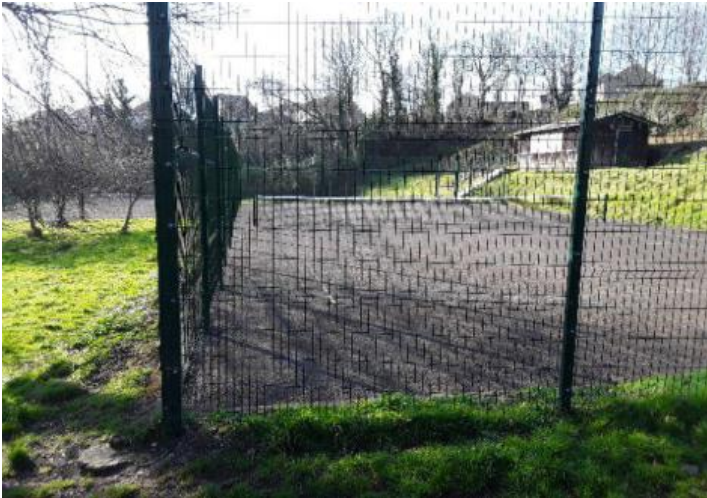
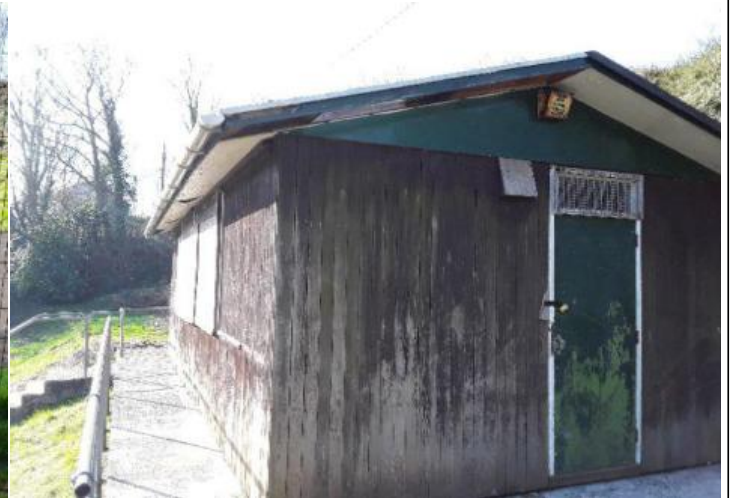
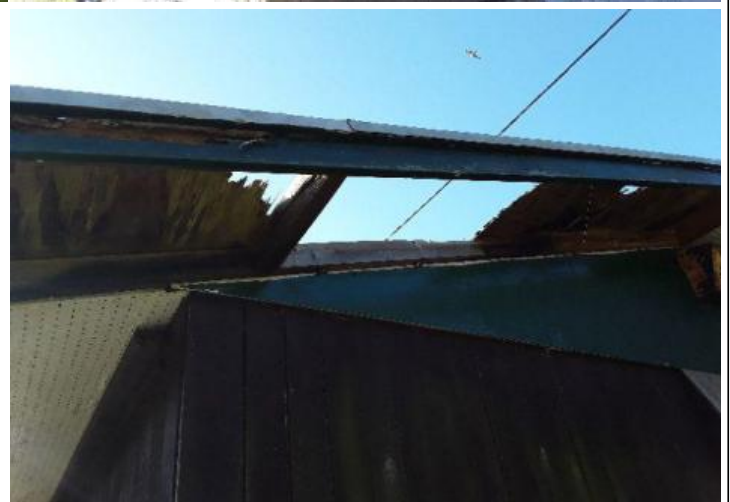
i 8 - Low Risk (Finding 1)

Item: Ancillary Items - Site General
Manufacturer: Owner/Operator

Finding: The adjacent building has significant exterior damage present

Action: Repair as required

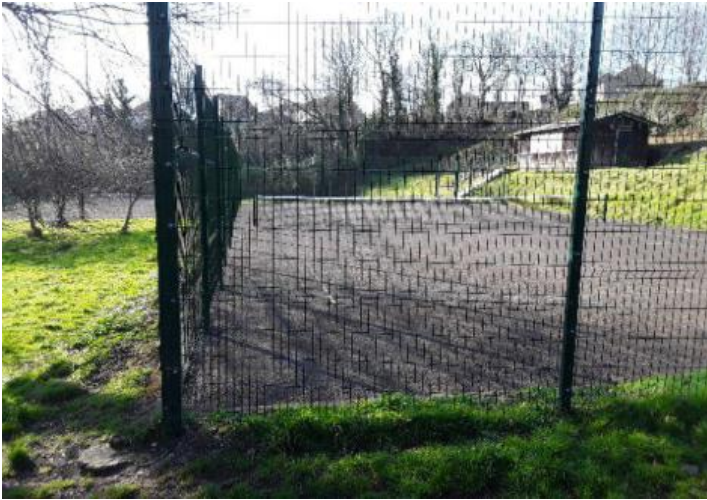
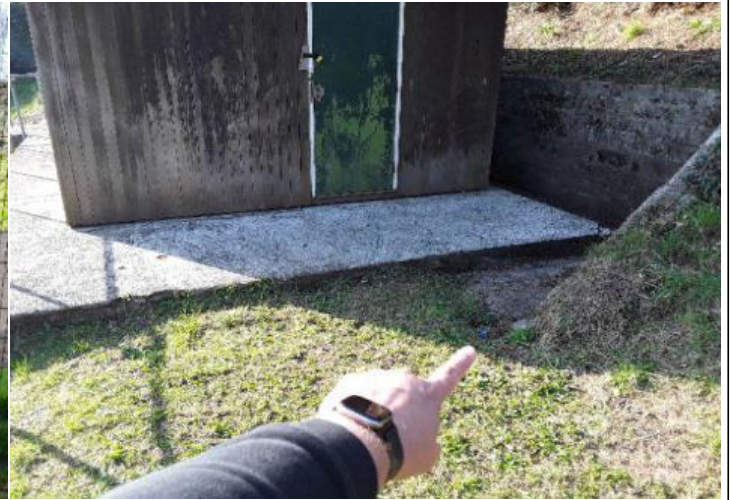
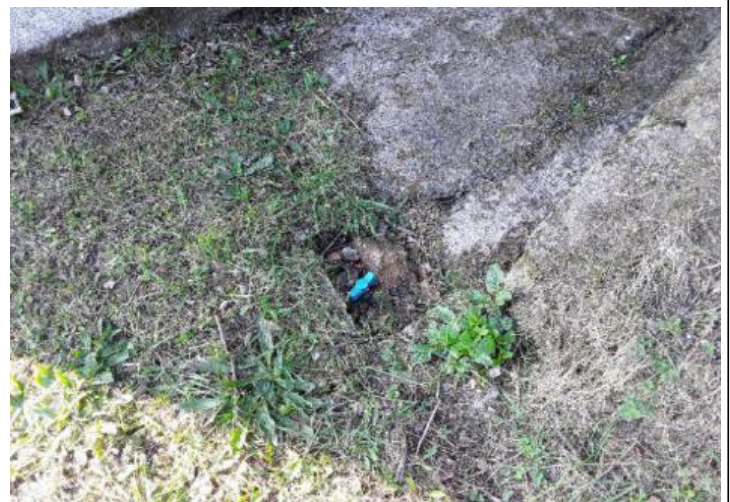
i 8 - Low Risk (Finding 2)

Item: Ancillary Items - Site General
Manufacturer: Owner/Operator

Finding: A manhole is exposed creating a trip point

Action: Provide a permanent, fixed cover

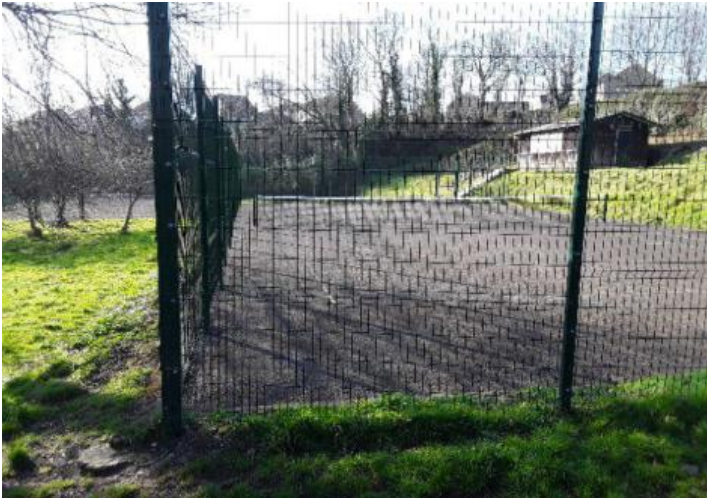
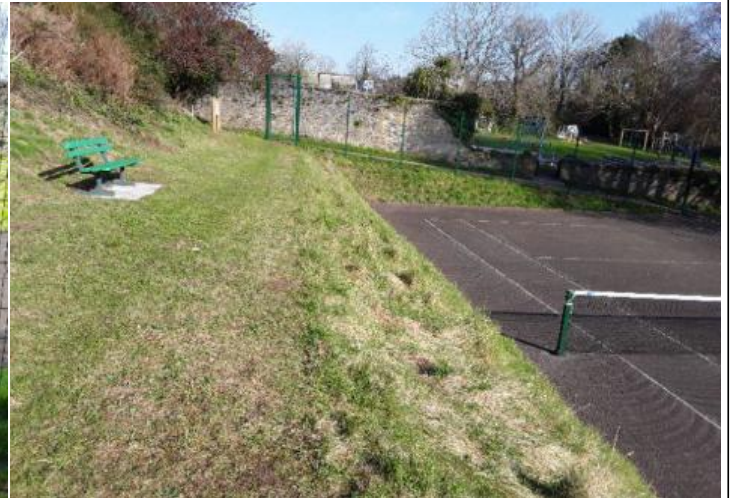
i 8 - Low Risk (Finding 3)

Item: Ancillary Items - Site General
Manufacturer: Owner/Operator

Finding: There are steep grass banks adjacent to the courts **Action:** Ensure that an appropriate risk assessment is in place and monitor use

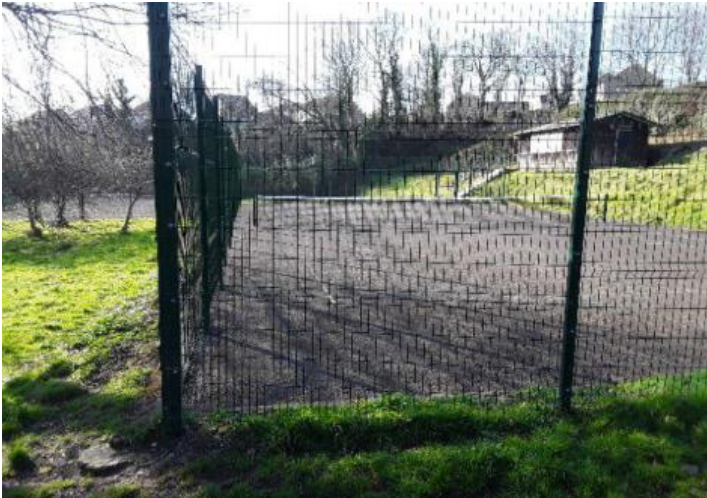
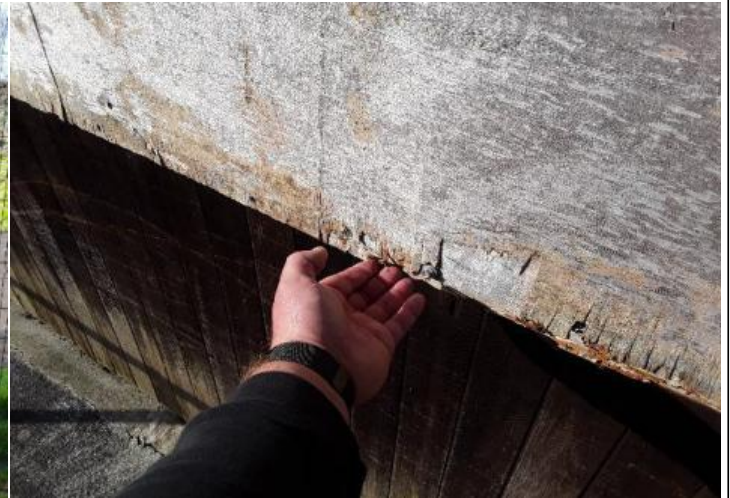
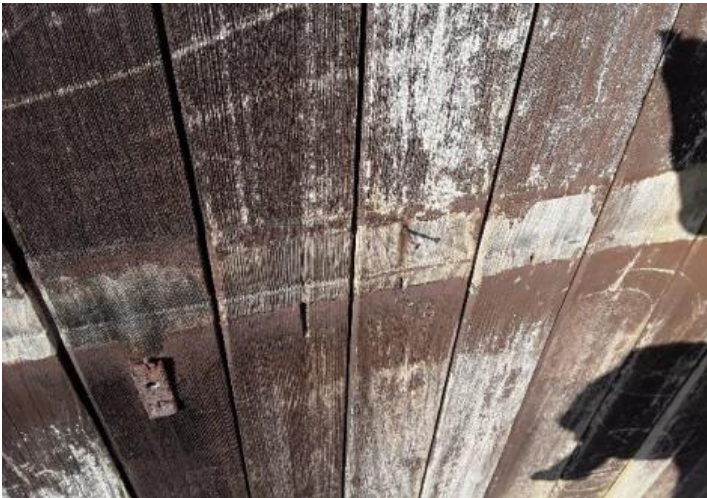
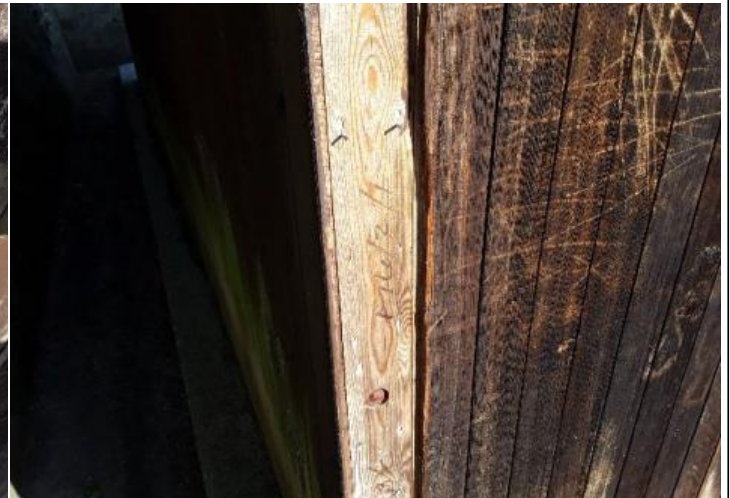
i 8 - Low Risk (Finding 4)

Item: Ancillary Items - Site General
Manufacturer: Owner/Operator

Finding: There are multiple projecting nails and sharp rough sections of timbers **Action:** Remove projecting nails and rough timbers

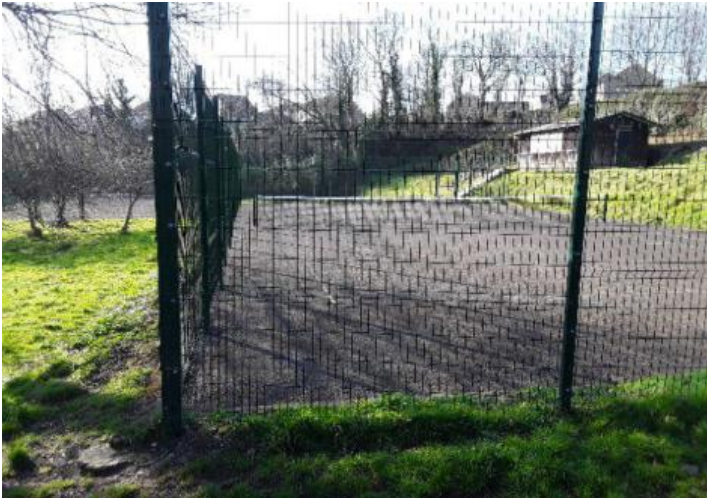
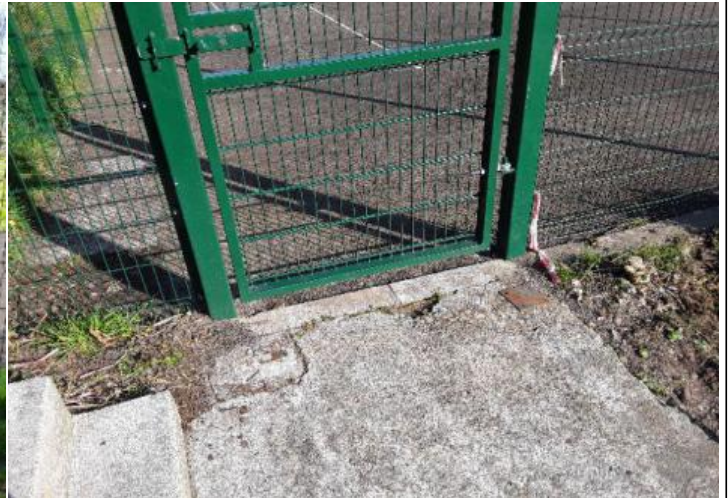
i 8 - Low Risk (Finding 5)

Item: Ancillary Items - Site General
Manufacturer: Owner/Operator

Finding: There is moderate damage to the concrete surface **Action:** Repair the damaged areas of surfacing near a gate

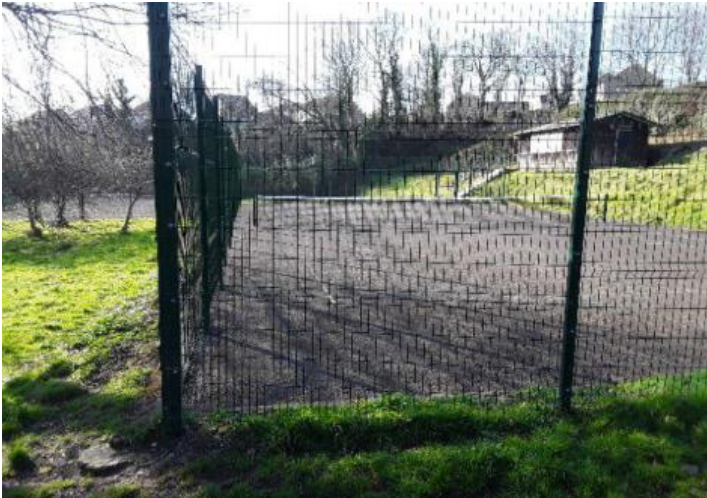
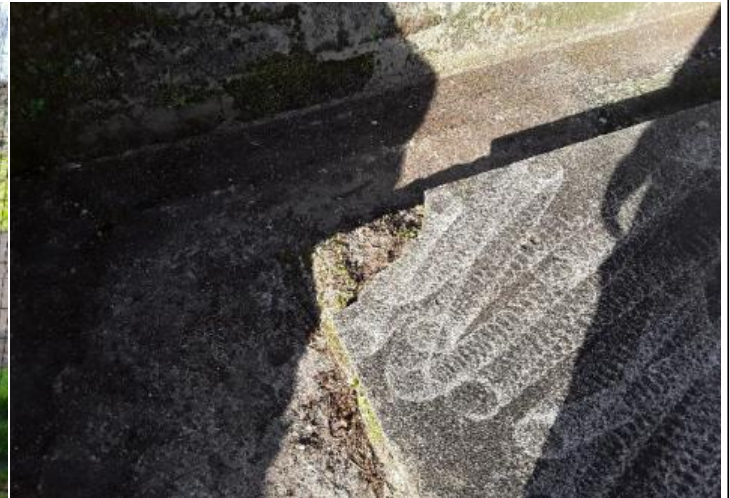
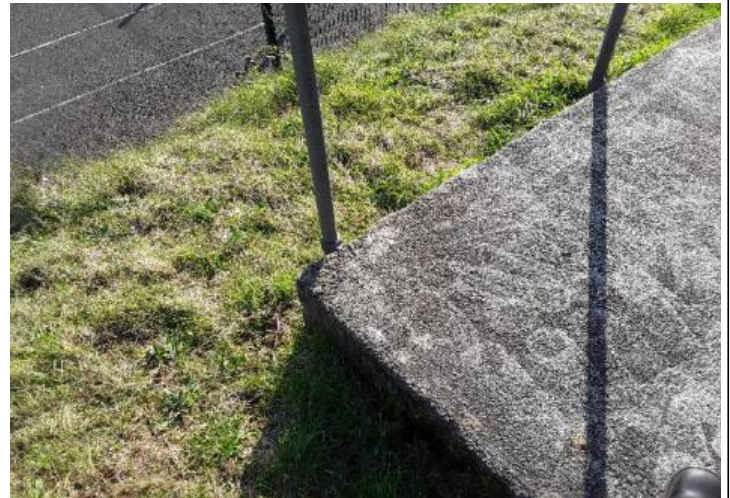
i 6 - Low Risk (Finding 6)

Item: Ancillary Items - Site General
Manufacturer: Owner/Operator

Finding: There is some damage to the concrete around the building
Action: Repair

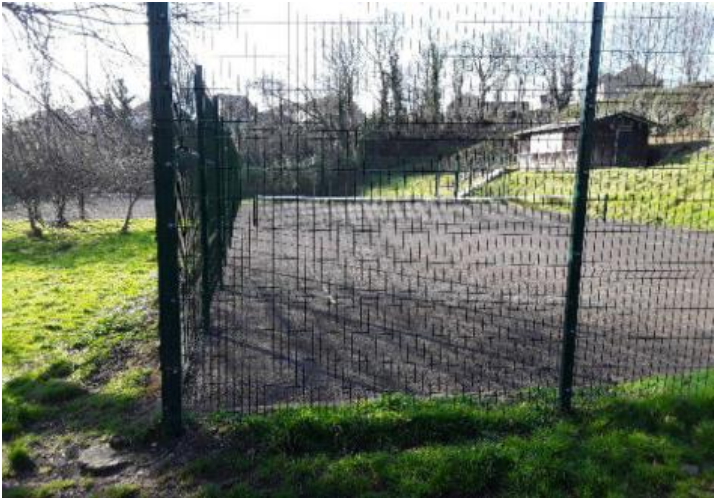
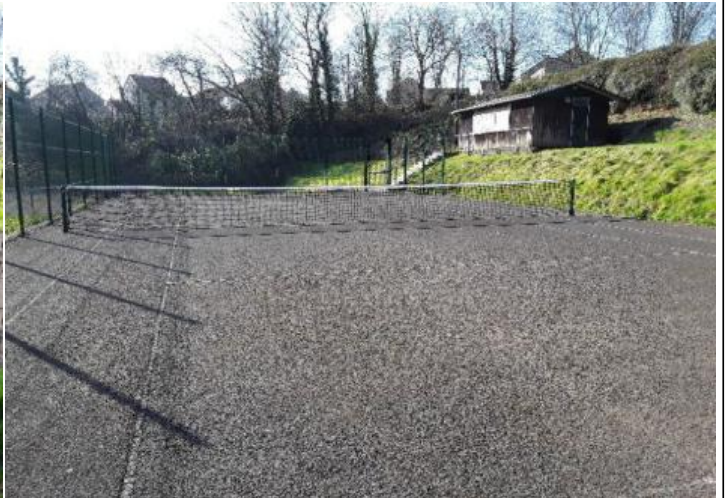
i 6 - Low Risk (Finding 7)

Item: Ancillary Items - Site General
Manufacturer: Owner/Operator

Finding: The bitmac surface is beginning to wear

Action: Monitor for any further deterioration and repair as required

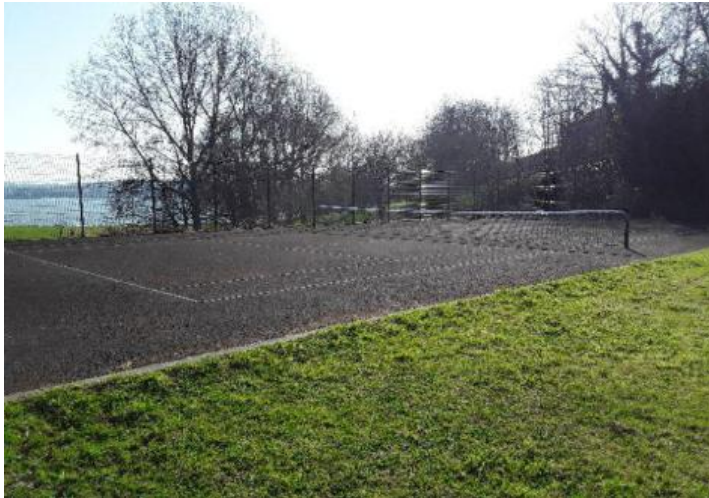
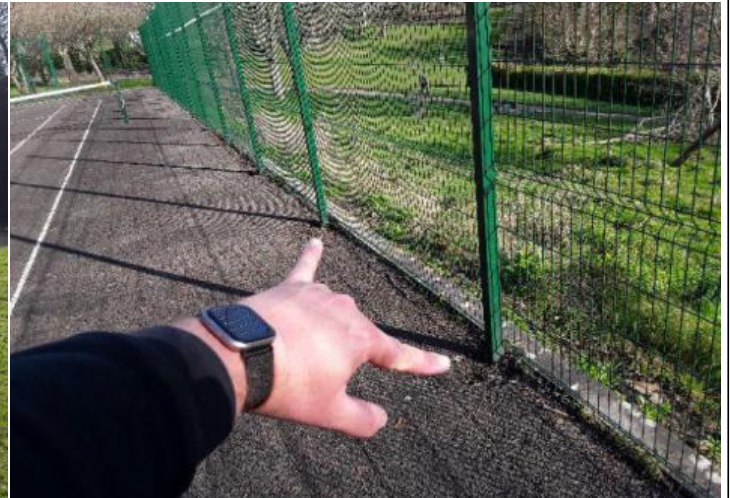
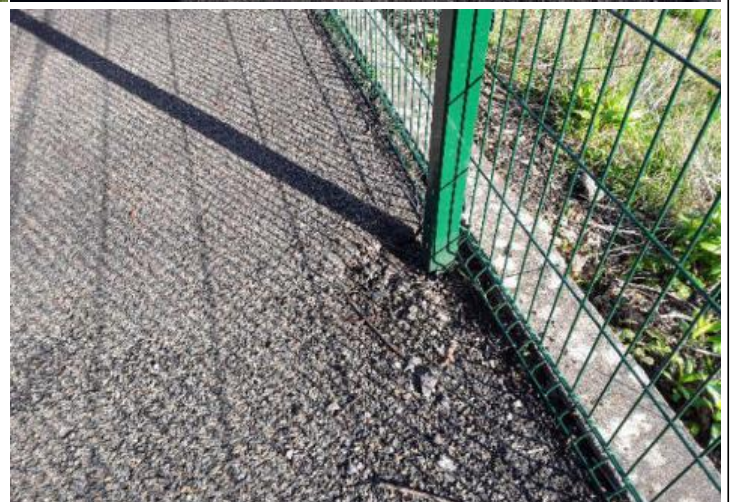
i 6 - Low Risk (Finding 1)

Item: Multi Use Games Area - Tennis Court
Manufacturer: Not Identified

Finding: The bitumen surface is worn or damaged

Action: Repair the bitumen to provide a uniform surface

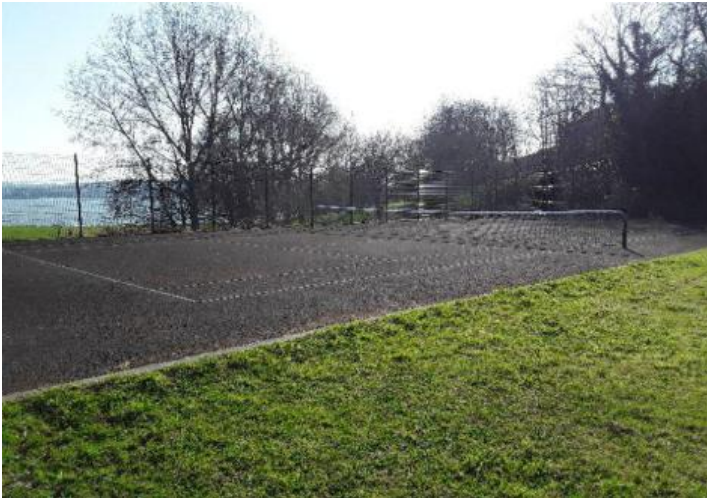
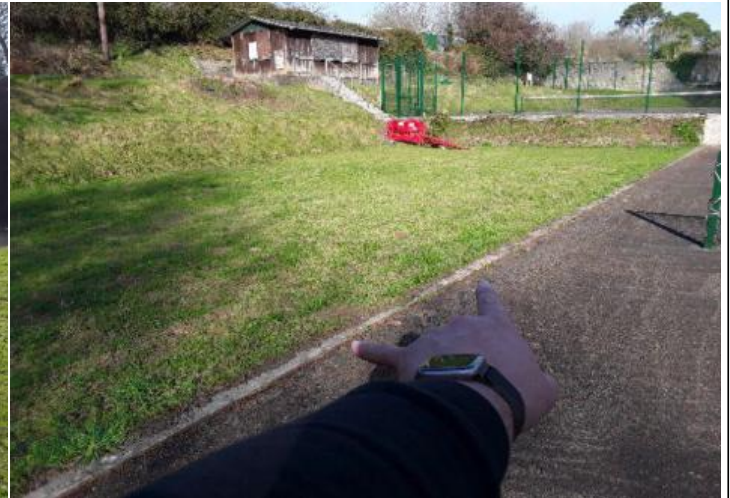
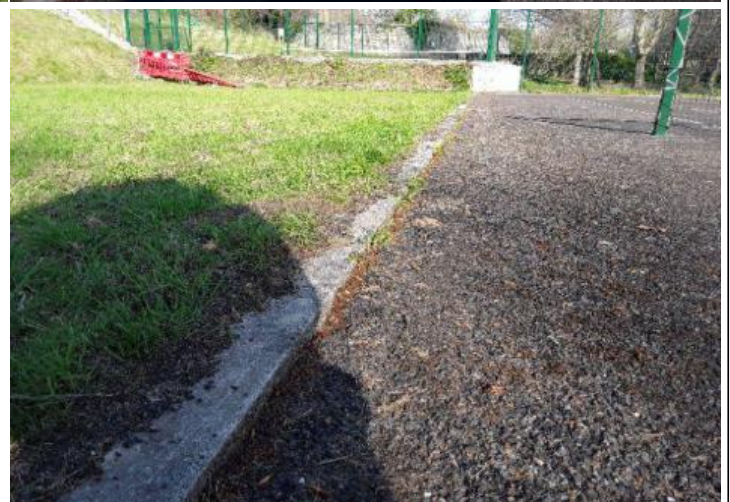
i 8 - Low Risk (Finding 2)

Item: Multi Use Games Area - Tennis Court
Manufacturer: Not Identified

Finding: There are trip hazards present at the edge of the court

Action: Monitor use and consider adjusting the item to remove trip points

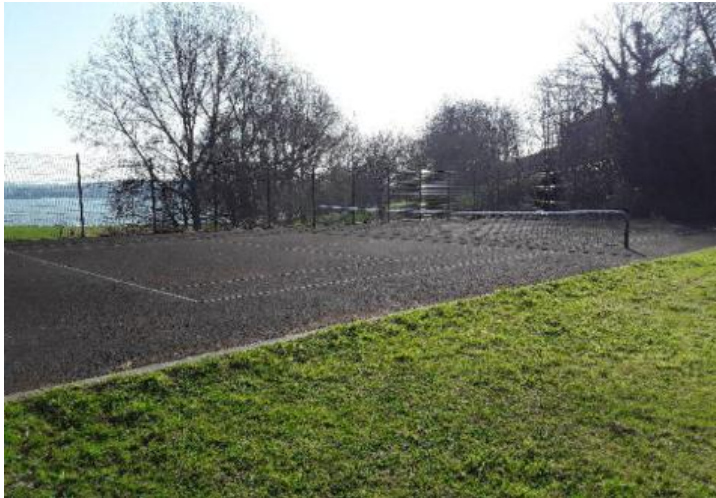
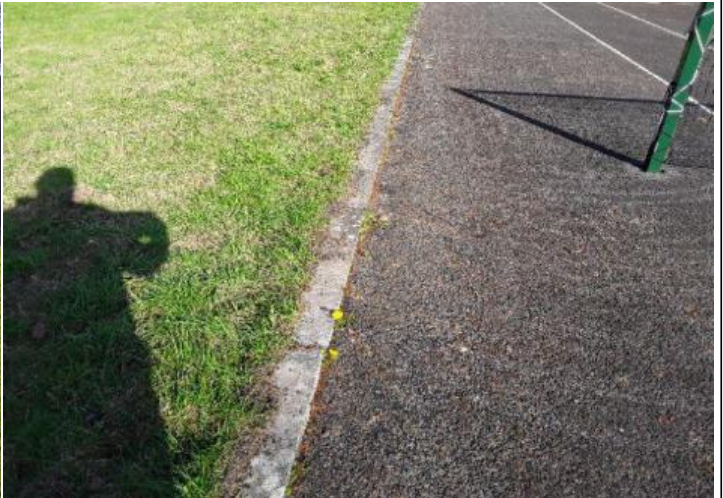
i 6 - Low Risk (Finding 3)

Item: Multi Use Games Area - Tennis Court
Manufacturer: Not Identified

Finding: There is weed / vegetation growth on, between, or around the edges of the surfacing **Action:** Remove weed / vegetation growth

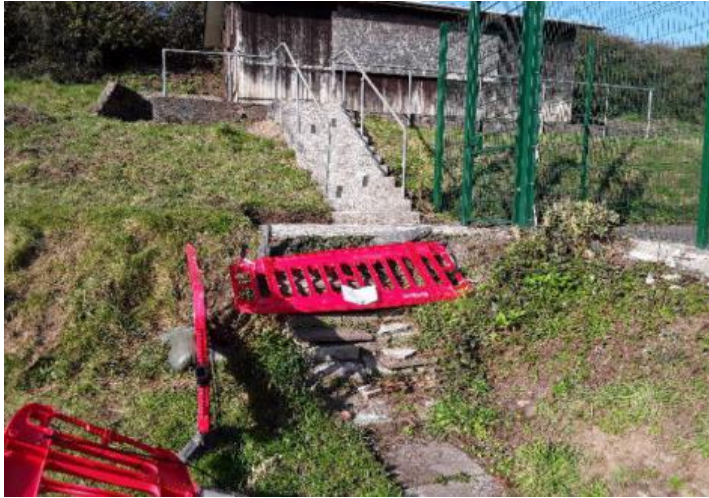
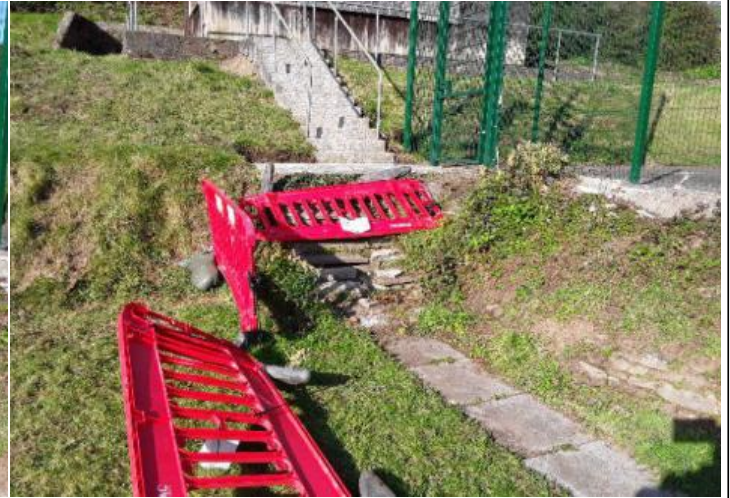
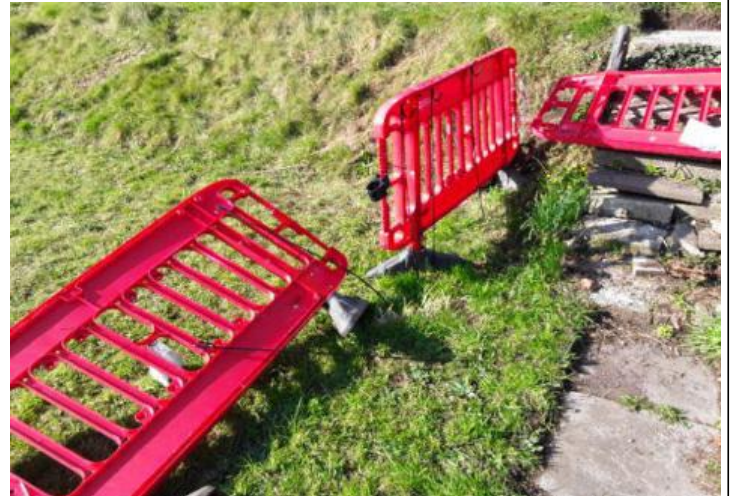
! 12 - Moderate Risk (Finding 1)

Item: Access Pathways - Concrete
Manufacturer: Owner/Operator

Finding: The steps on site has been isolated from use however the area is still accessible and the means of isolation has either introduced additional hazards that may cause harm in the event of users accessing the area or is insufficient to stop users from accessing the steps

Action: Provide a more suitable isolation method

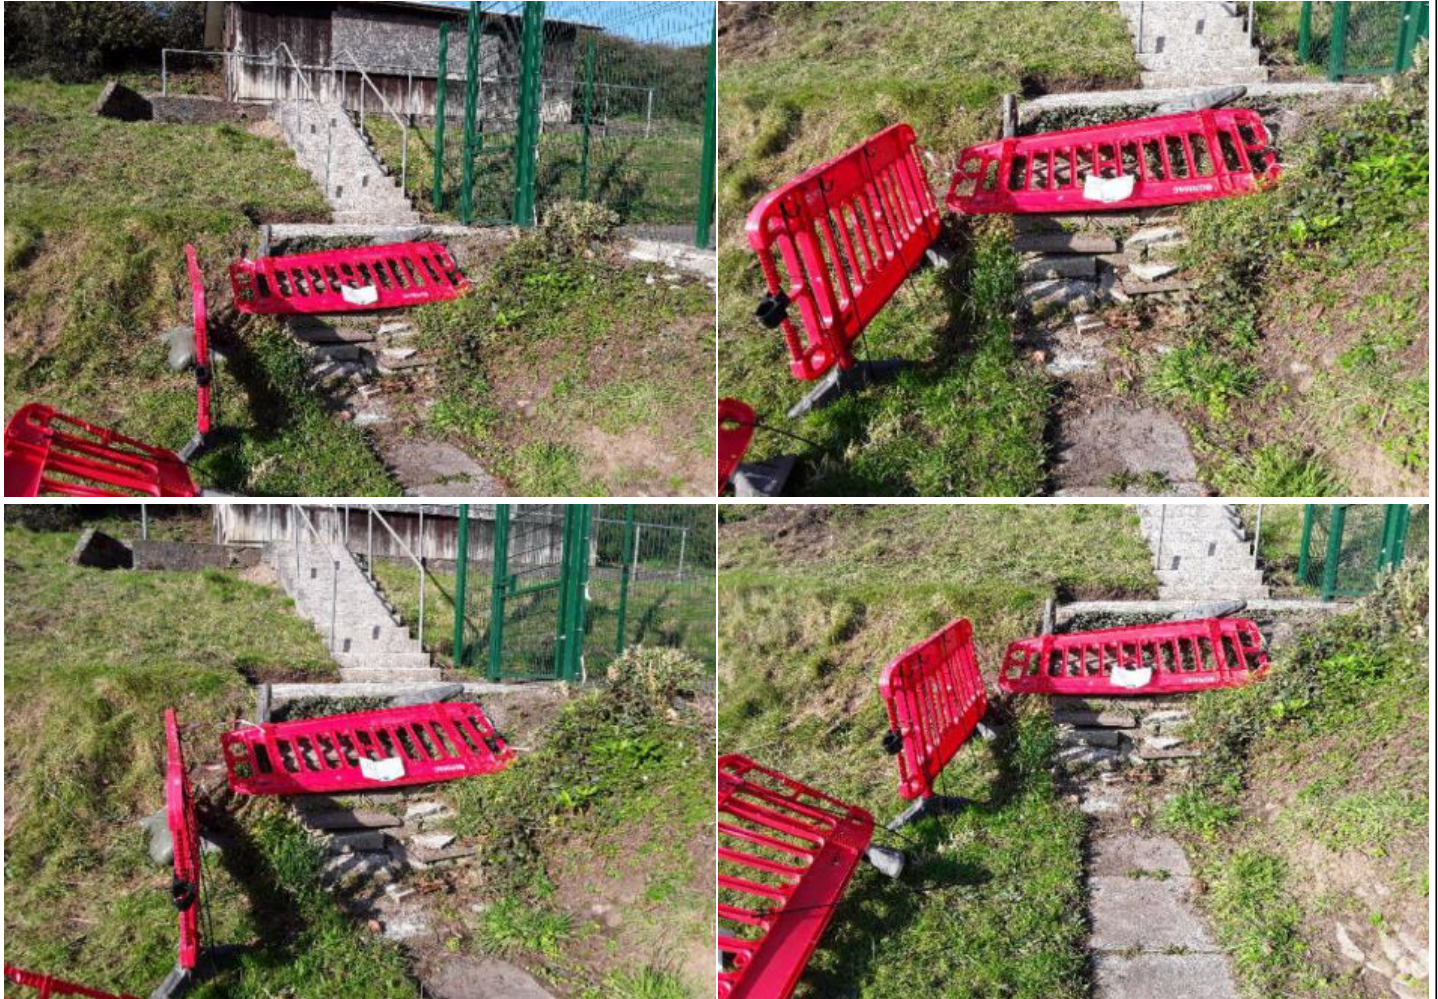
! 12 - Moderate Risk (Finding 2)

Item: Access Pathways - Concrete
Manufacturer: Owner/Operator

Finding: The concrete steps are severely damaged

Action: Repair or replace

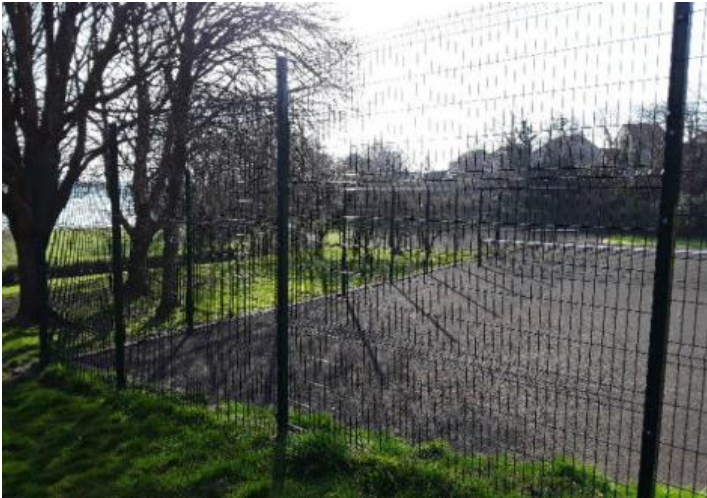
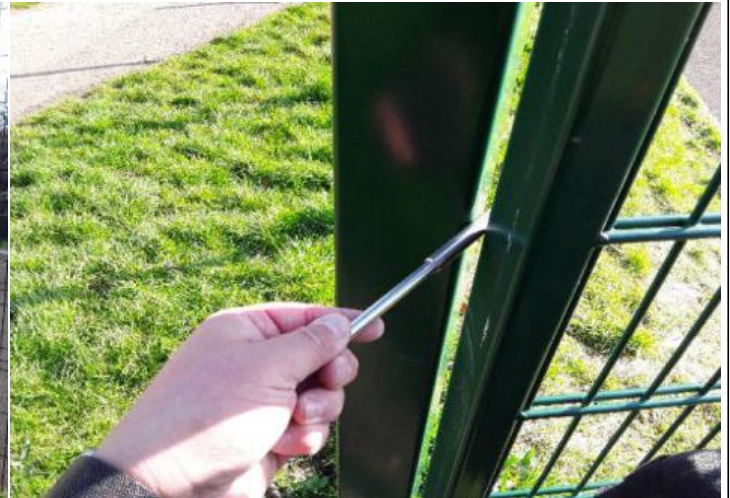
i 8 - Low Risk (Finding 1)

Item: Fences - Fence - Steel Mesh
Manufacturer: Not Identified

Finding: There are openings that are less than 12mm that could trap or crush fingers

Action: Where possible a 12mm gap should be maintained on both sides or between the gate leafs
