## Annual Inspection

Torpoint Town Council

Torpoint Skateboard Park

Inspection Ref: 1610375

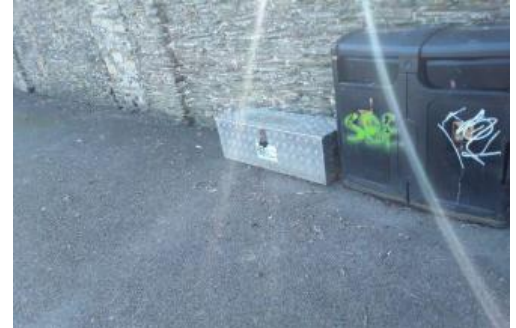
**Item:** Storage Area  
**Manufacturer:** Unknown  
**Surface Type:** Steel  
**Item Part Number:** Aluminium storage box  
**Item Quantity:** 1  
**Equipment Compliance:** N/A  
**Surface Area Compliance:** N/A  
**Life Expectancy:** 1 - 3 Years  
**Total Findings:** 1

This item is satisfactory - no work required -

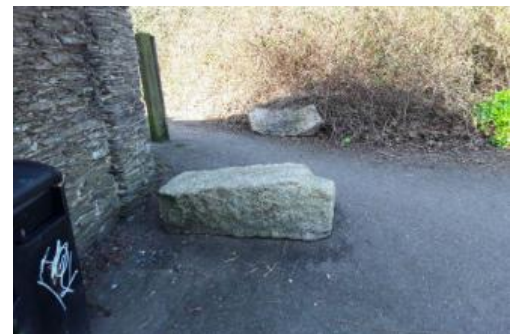
**Item:** Boulders  
**Manufacturer:** Natural Feature  
**Surface Type:** Bitmac  
**Item Quantity:** 2  
**Equipment Compliance:** N/A  
**Surface Area Compliance:** N/A

This item is satisfactory - no work required -

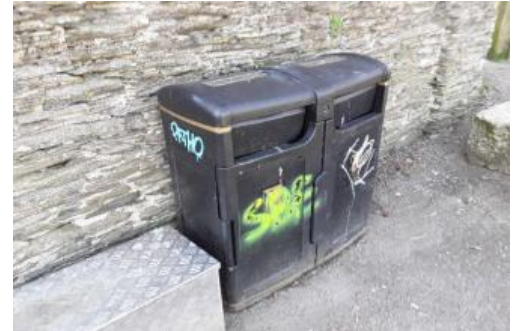
**Item:** Litter Bin  
**Manufacturer:** Not Identified  
**Surface Type:** Bitmac  
**Item Quantity:** 1  
**Equipment Compliance:** N/A  
**Surface Area Compliance:** N/A

This item is satisfactory - no work required -

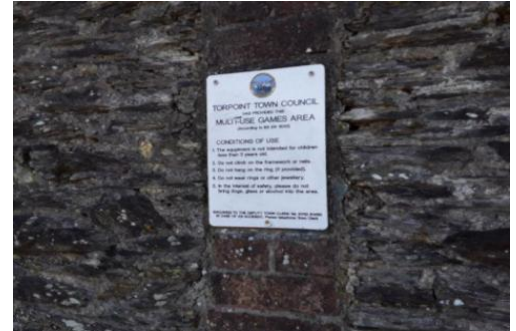
**Item:** Sign  
**Manufacturer:** Owner/Operator  
**Surface Type:** N/A  
**Item Quantity:** 1  
**Equipment Compliance:** N/A  
**Surface Area Compliance:** N/A

There are projecting bolt thread(s) present - Remove excess thread length and deburr or provide cap

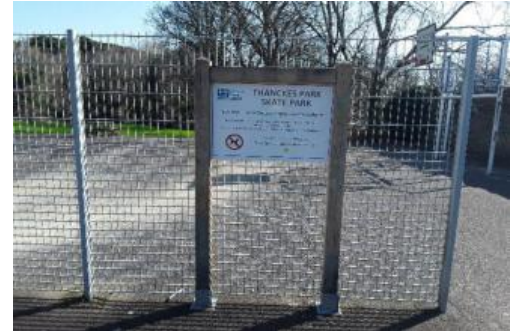
**Item:** Playground Sign  
**Manufacturer:** Owner/Operator  
**Surface Type:** Tarmac  
**Item Part Number:** made by council  
**Item Quantity:** 1  
**Equipment Compliance:** N/A  
**Surface Area Compliance:** N/A  
**Life Expectancy:** 1 - 3 Years  
**Total Findings:** 1

This item is satisfactory - no work required -
