the play inspection company

Annual Inspection

Torpoint Town Council

Cambridge Field

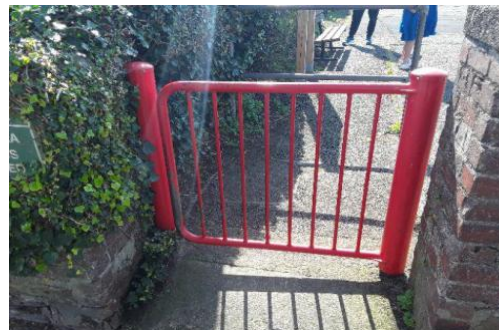
Item: Gate - Self Closing
Manufacturer: Mono Gate Ltd
Surface Type: Concrete
Item Quantity: 1
Equipment Compliance: N/A
Surface Area Compliance: N/A

The gate is closing too quickly (less than 4 seconds) - Take corrective action to ensure that the gate closes in 4-8 seconds

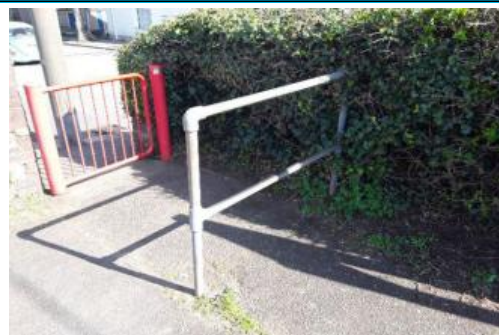
Item: Barrier
Manufacturer: Not Identified
Surface Type: Bitmac
Item Quantity: 1
Equipment Compliance: N/A
Surface Area Compliance: N/A

This item is satisfactory - no work required -

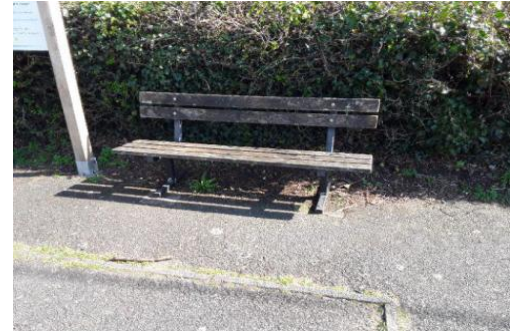
Item: Bench
Manufacturer: Not Identified
Surface Type: Bitmac
Item Quantity: 3
Equipment Compliance: N/A
Surface Area Compliance: N/A

Parts of the timber are rough or splintered - Remove all rough or sharp edges

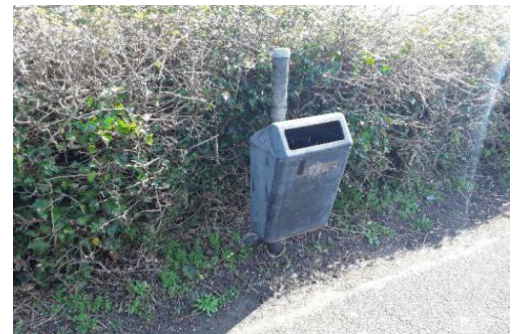
Item: Litter Bin
Manufacturer: Not Identified
Surface Type: Grass
Item Quantity: 2
Equipment Compliance: N/A
Surface Area Compliance: N/A

The item is slightly loose in its foundations - Monitor for any further deterioration and repair as required

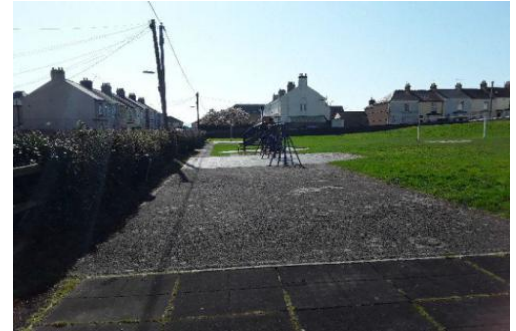
Item: Site General
Manufacturer: Owner/Operator
Surface Type: N/A
Item Quantity: 1
Equipment Compliance: N/A
Surface Area Compliance: N/A

There are post / end caps missing from the item - Replace missing post caps

The bitumen surface is worn or damaged in places - Repair the bitumen to provide a uniform surface

There are trip hazards present - Reinstate surrounding surfaces to level to remove the trip points

There are some redundant items of equipment in the area - Repair or remove the remaining structures

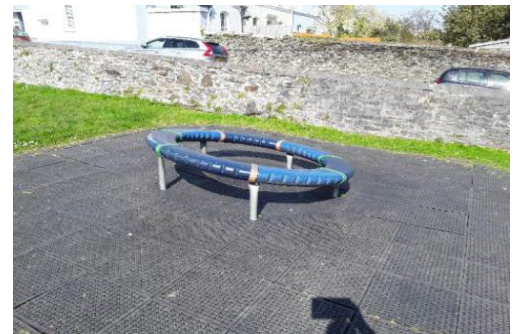
Item: Supernova
Manufacturer: Kompan Ltd
Surface Type: Grass Matrix Tiles
Item Quantity: 1
Equipment Compliance: Yes
Surface Area Compliance: Yes
Life Expectancy: 5 -10 Years
Total Findings: 3

There are gaps opening between the grass mat tiles - Provide additional ties or secure / reinstate surface

There is or are fixings missing on the item - Replace all missing fixings

There are large cracks in the body of the unit - Repair or replace the item

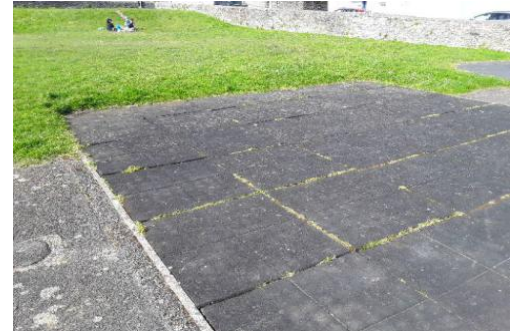
Item: Rubber Tiles
Manufacturer: Not Identified
Surface Type: Rubber Tiles
Item Quantity: 1
Equipment Compliance: N/A
Surface Area Compliance: N/A
Life Expectancy: 5 -10 Years
Total Findings: 5

There is some minor damage to the surface - Monitor for any further deterioration and repair as required

There are gaps opening in between the tiles - Monitor for any further deterioration and repair as required

There are significant gaps (over 30mm) between the surface and the edging or between the joints in the surface; these are large enough for a small foot to enter - Repair surfacing

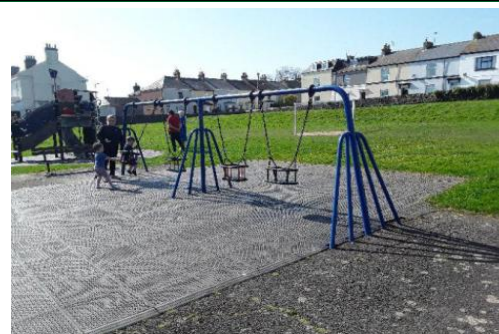
Item: 2 Bay 4 Seat (Cradle)
Manufacturer: Wicksteed Playgrounds
Surface Type: Matta
Item Quantity: 1
Equipment Compliance: No
Surface Area Compliance: Yes
Life Expectancy: 5 -10 Years
Total Findings: 6

There is some minor damage to the surface - Monitor for any further deterioration and repair as required

There are caps missing from the underside of the seats - Replace missing caps under the seats

The bushes are showing signs of wear - Monitor for any further deterioration and replace as required

The anti wrap mechanism is damaged - Replace

The Anti Wrap bearings are dry and not moving freely - Lubricate bearings in accordance with the manufacturers recommendations

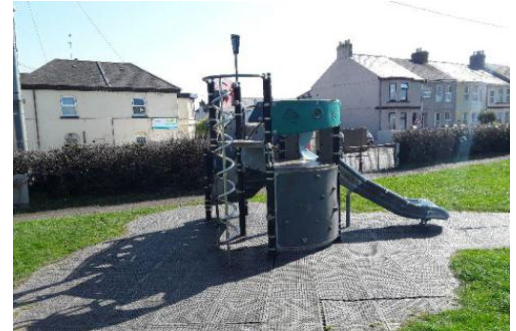
Item: Multi Play (Junior)
Manufacturer: Kompan Ltd
Surface Type: Wet Pour
Item Quantity: 1
Equipment Compliance: No
Surface Area Compliance: Yes
Life Expectancy: 5 -10 Years
Total Findings: 9

There are gaps opening between the grass mat tiles - Provide additional ties or secure / reinstate surface

There is some evidence of fire damage to the item - Monitor for any further deterioration and repair as required

There is/are finger entrapment/s in the frame and the item fails to meet the requirements of BS EN 1176 Part 1 4.2.7.6 Entrapment of fingers - Monitor - No remedial work recommended

There are post / end caps missing from the item - Replace missing post caps

There is an opening in the barriers exceeding the width allowed (500mm) in BS EN 1176, this is a low risk failure and no remedial action is required - Monitor - No remedial work recommended

There is excessive movement in the corkscrew due to loose or missing fixings - Repair or replace

There is some minor damage to the slide surface - Monitor for any further deterioration and replace as required

There is/are several inserts missing - Replace missing inserts

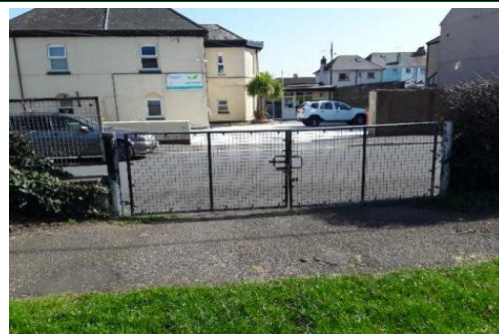
Item: Gate - Maintenance
Manufacturer: Not Identified
Surface Type: Bitmac
Item Quantity: 1
Equipment Compliance: N/A
Surface Area Compliance: N/A

The paintwork on this item has been damaged or worn exposing the metal underneath which is rusting - Treat any rusting components and repaint

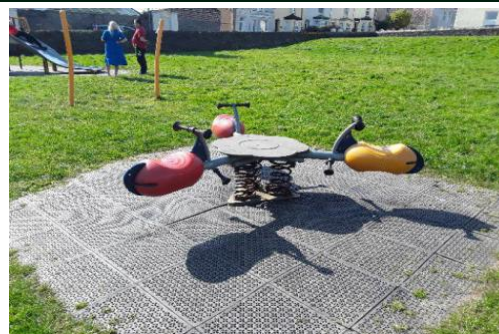
Item: Three Way Springer
Manufacturer: Kompan Ltd
Surface Type: Rubber Tiles
Item Quantity: 1
Equipment Compliance: Yes
Surface Area Compliance: Yes
Life Expectancy: 5 -10 Years
Total Findings: 8

The end caps are missing on the Handgrips/Footrests - Replace missing end caps

The spring clamps are loose - Tighten all loose fixings

There is minor damage to the hand grips - Monitor for any further deterioration and replace as required

The spring clamp fixings have corroded excessively - Replace all corroded fixings

The plastic panels are damaged on the unit - Repair or replace the item

The paintwork on the spring has been damaged or worn exposing the metal underneath which is rusting - Treat any rusting components and repaint

There is/are several inserts missing - Replace missing inserts

There is some minor damage to the surface - Monitor for any further deterioration and repair as required

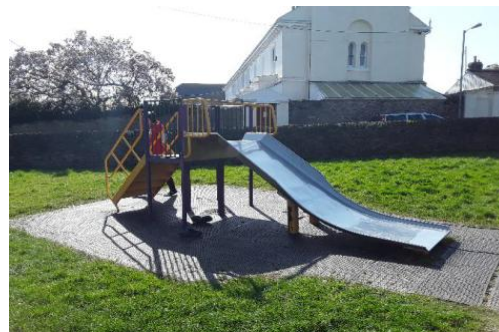
Item: Multi Play (Junior)
Manufacturer: Wicksteed Playgrounds
Surface Type: Wet Pour
Item Quantity: 1
Equipment Compliance: Yes
Surface Area Compliance: Yes
Life Expectancy: 5 -10 Years
Total Findings: 8

The paintwork on this item has been damaged or worn exposing the metal underneath which is rusting - Treat any rusting components and repaint

There are fractures or cracks in the slide start section - Repair or replace

There is some evidence of fire damage to the surfacing - Monitor for any further deterioration and repair as required

There are a number of dents in the slide surface - Monitor for any further deterioration and repair as required

The weld(s) on this item have failed - Repair item

There is/are several inserts missing - Replace missing inserts

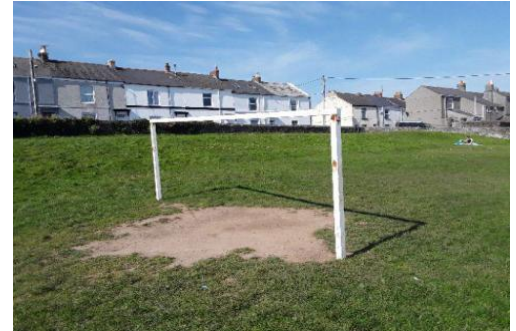
Item: 5 a side Goals
Manufacturer: Not Identified
Surface Type: Grass
Item Quantity: 1
Equipment Compliance: N/A
Surface Area Compliance: N/A
Life Expectancy: 5 -10 Years
Total Findings: 5

NB: We have undertaken a maintenance inspection only of the football goal(s); full load testing falls outside the scope of our inspection. - Implement load testing as required

There is or are fixings missing on the item - Replace all missing fixings

A number of fixing(s) have worked loose - Secure all loose fixings

The paintwork on this item has been damaged or worn exposing the metal underneath which is rusting - Treat any rusting components and repaint

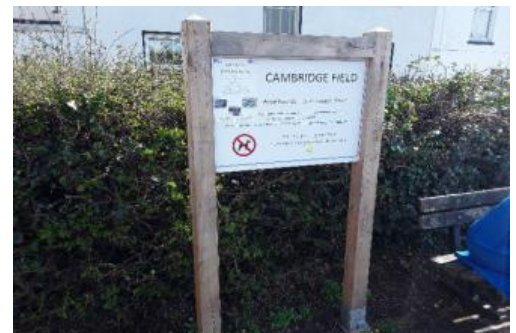
Item: Sign
Manufacturer: Owner/Operator
Surface Type: Tarmac
Item Part Number: 0
Item Quantity: 1
Equipment Compliance: N/A
Surface Area Compliance: N/A
Life Expectancy: 3 - 5 Years
Total Findings: 1

This item is satisfactory - no work required -

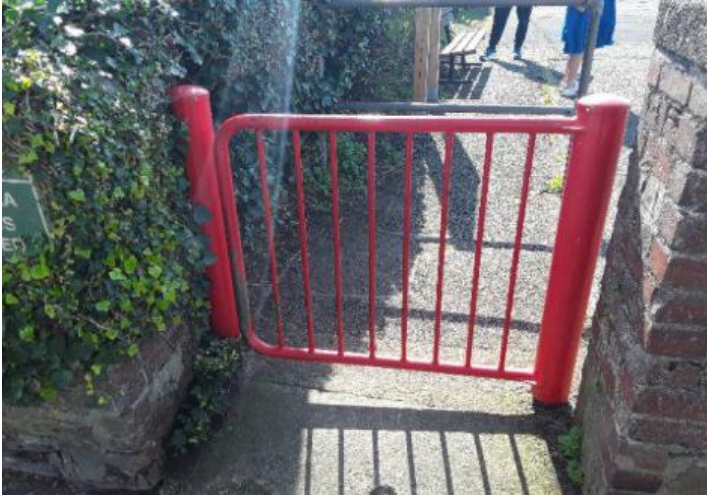
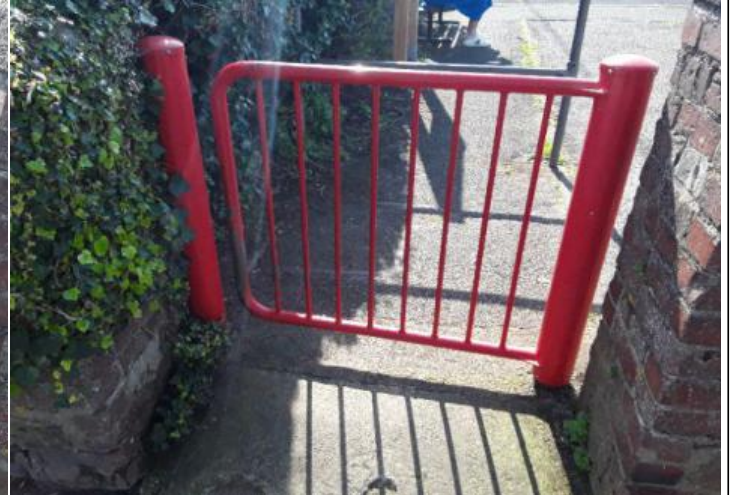
Item: Gates - Gate - Self Closing
Manufacturer: Mono Gate Ltd

Finding: The gate is closing too quickly (less than 4 seconds)

Action: Take corrective action to ensure that the gate closes in 4-8 seconds

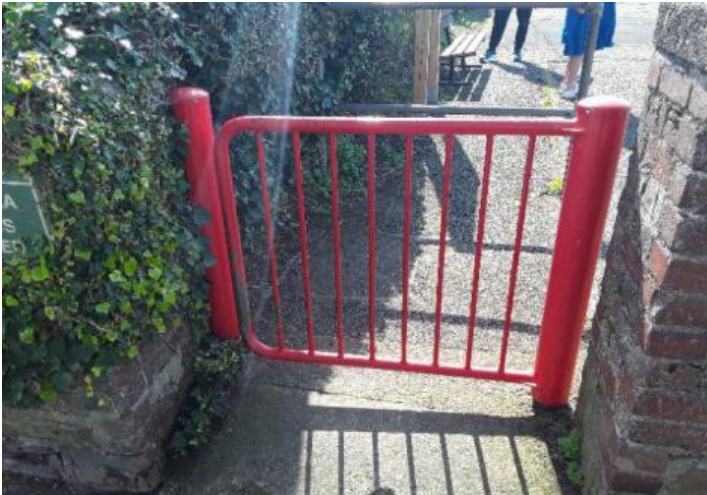
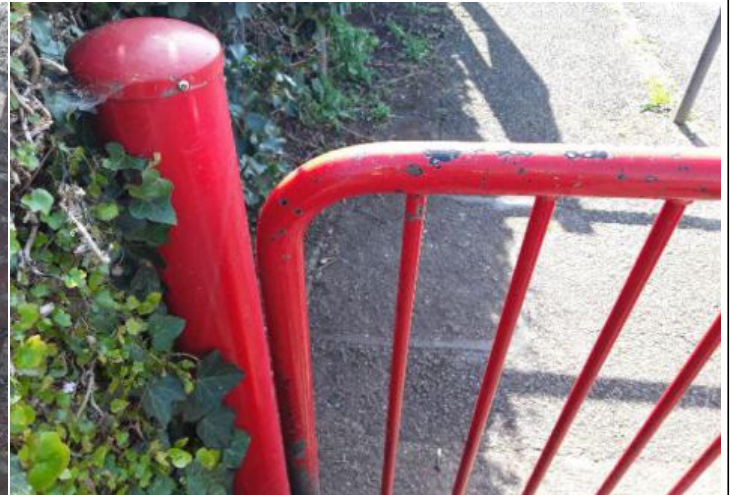
Item: Gates - Gate - Self Closing
Manufacturer: Mono Gate Ltd

Finding: The paint is flaking off the metalwork

Action: Rub down and re-paint

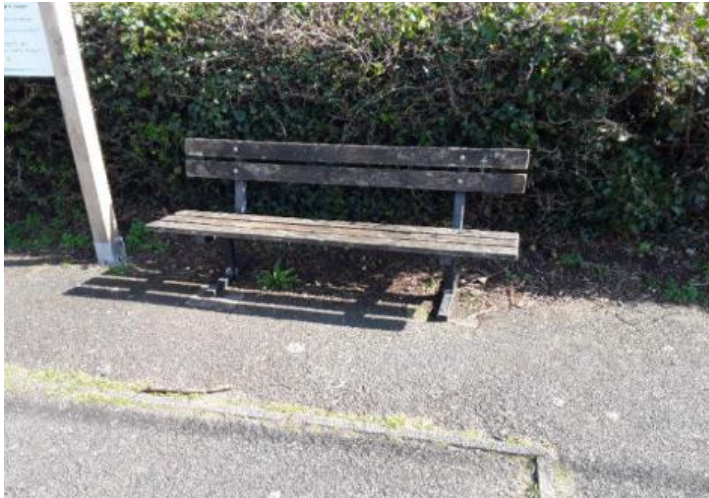
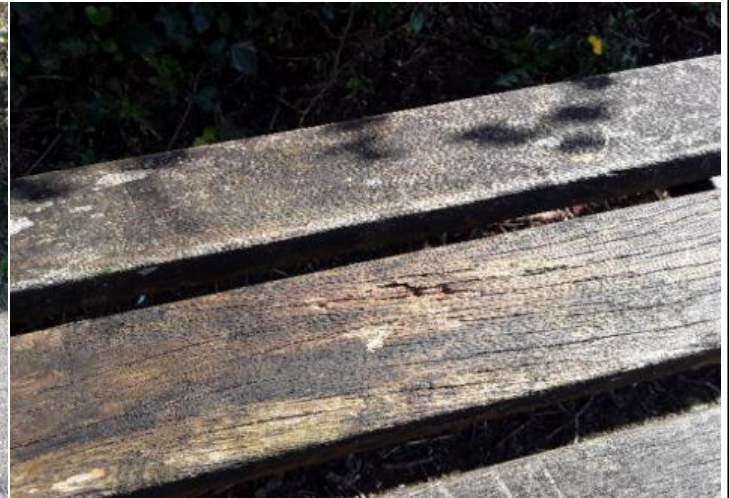
Item: Ancillary Items - Bench
Manufacturer: Not Identified

Finding: Parts of the timber are rough or splintered

Action: Remove all rough or sharp edges

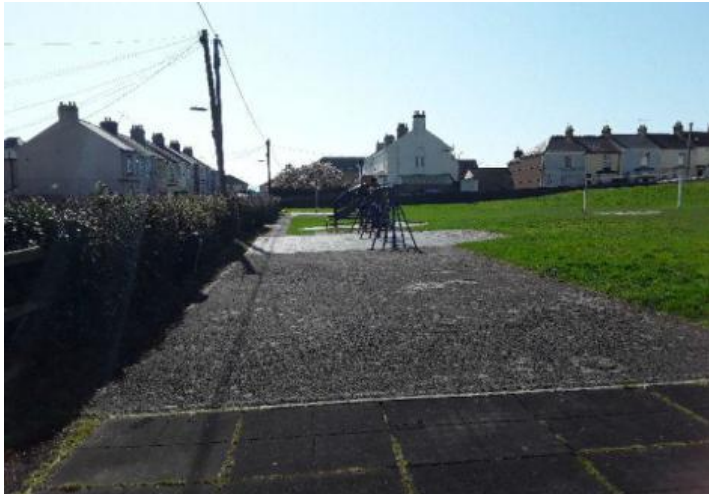
Item: Ancillary Items - Site General
Manufacturer: Owner/Operator

Finding: There are trip hazards present

Action: Reinstate surrounding surfaces to level to remove the trip points

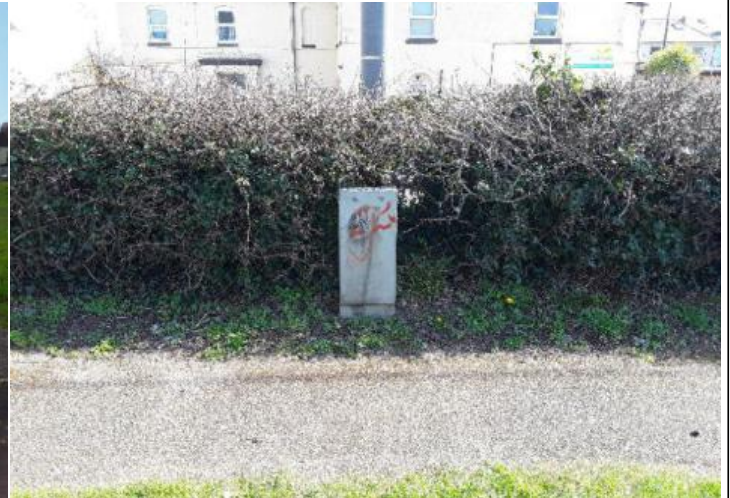
Item: Ancillary Items - Site General
Manufacturer: Owner/Operator

Finding: There is a locked junction box present on site

Action: Ensure that an appropriate risk assessment is in place and monitor use

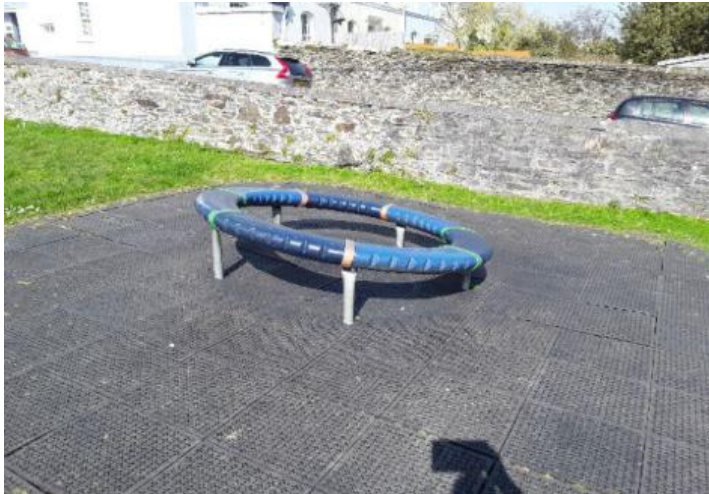
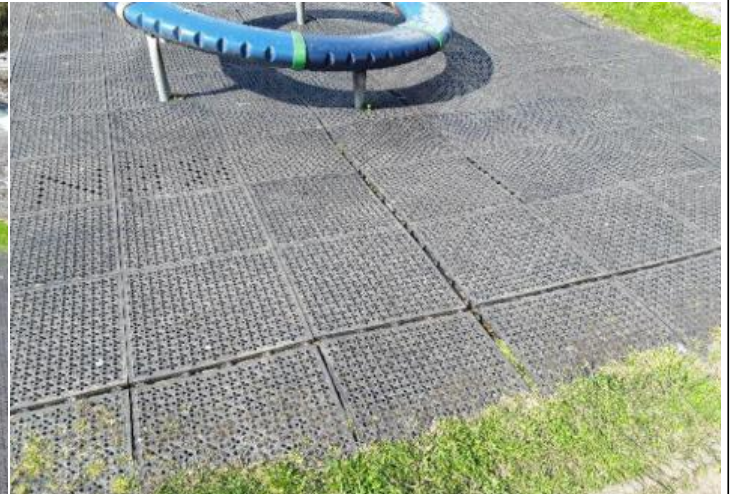
Item: Rotor Play - Supernova
Manufacturer: Kompan Ltd

Finding: There are gaps opening between the grass mat tiles **Action:** Provide additional ties or secure / reinstate surface

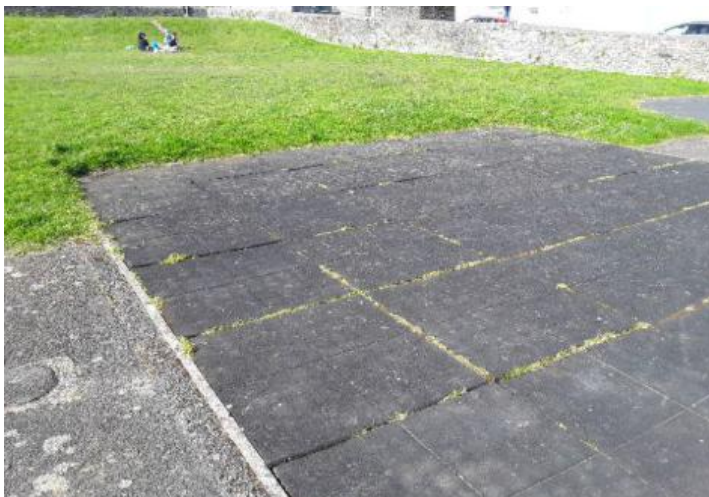
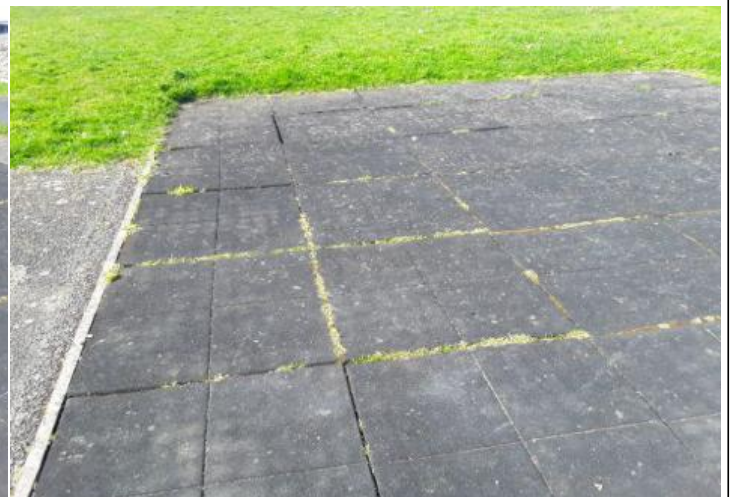
Item: Surface - Rubber Tiles
Manufacturer: Not Identified

Finding: There is weed / vegetation growth on, between, or around the edges of the surfacing

Action: Remove weed / vegetation growth

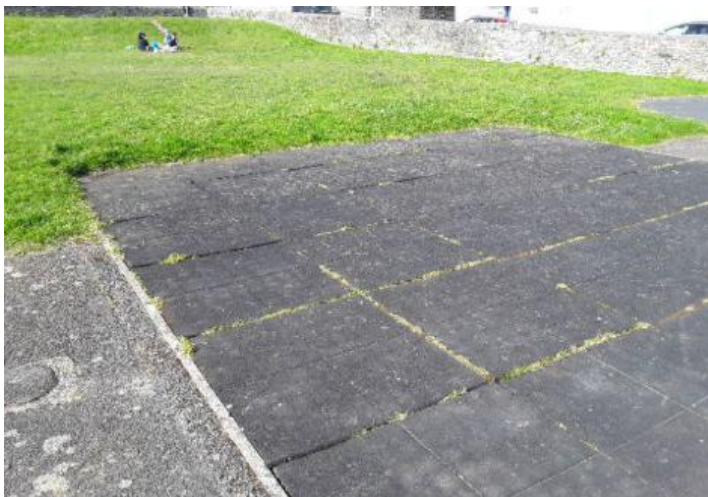
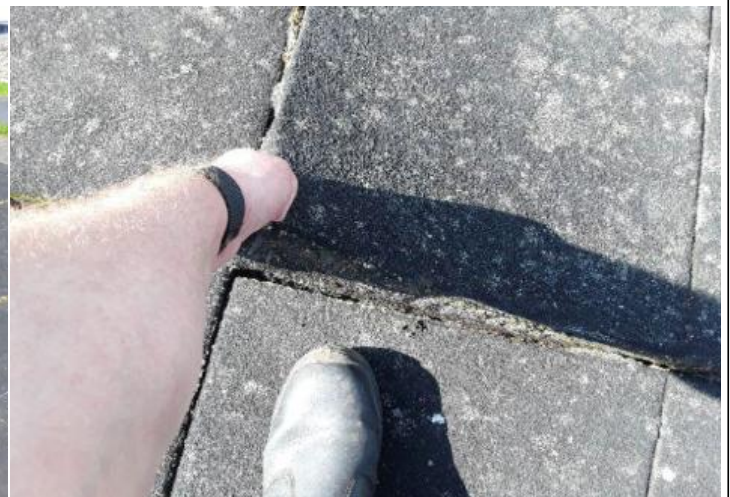
Item: Surface - Rubber Tiles
Manufacturer: Not Identified

Finding: The tiles can easily be lifted or are lifting along the edges of the area

Action: Lift and re-glue tiles to secure

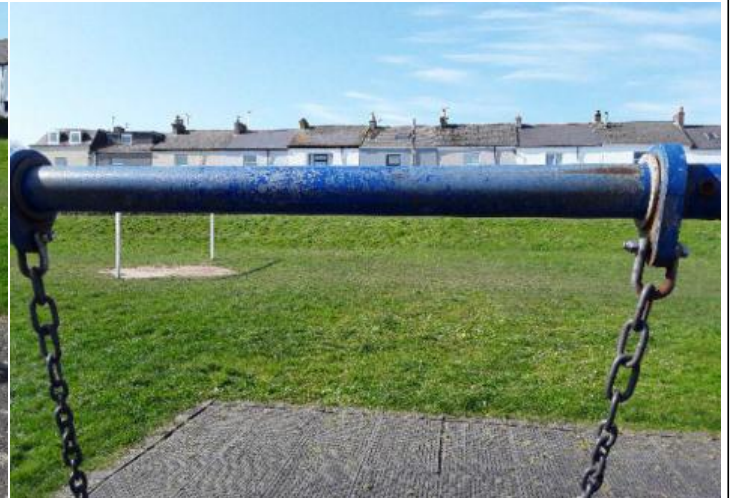
Item: Swings - 2 Bay 4 Seat (Cradle)
Manufacturer: Wicksteed Playgrounds

Finding: The paint is flaking off the metalwork

Action: Rub down and re-paint

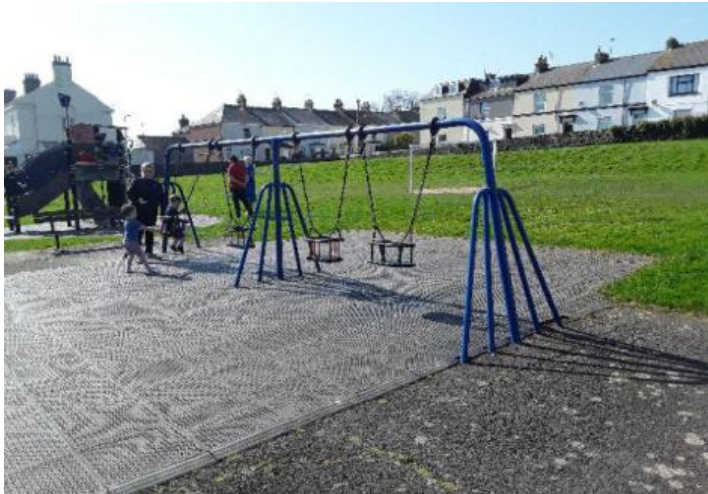
Item: Swings - 2 Bay 4 Seat (Cradle)
Manufacturer: Wicksteed Playgrounds

Finding: The bushes are showing signs of wear

Action: Monitor for any further deterioration and replace as required

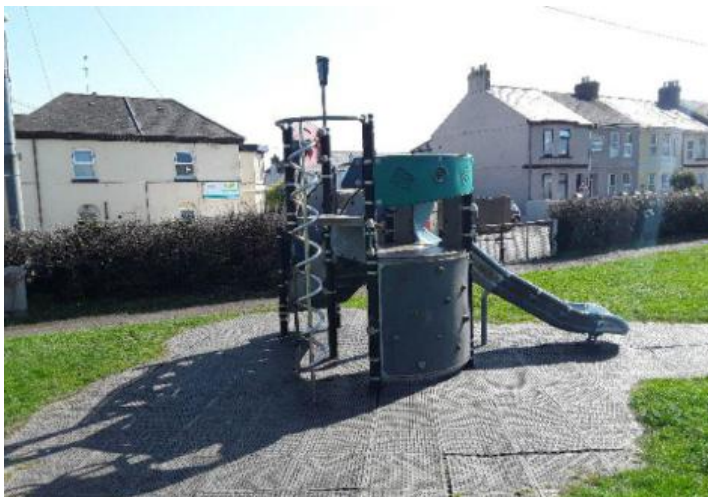
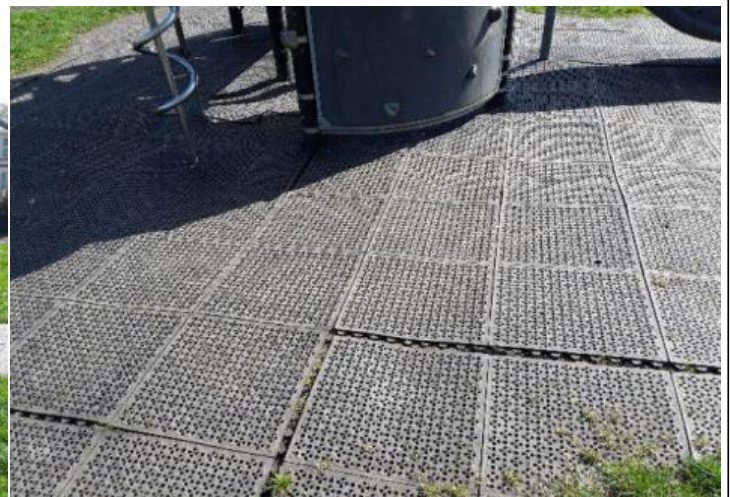
Item: Activity Equipment - Multi Play (Junior)
Manufacturer: Kompan Ltd

Finding: There are gaps opening between the grass mat tiles

Action: Provide additional ties or secure / reinstate surface

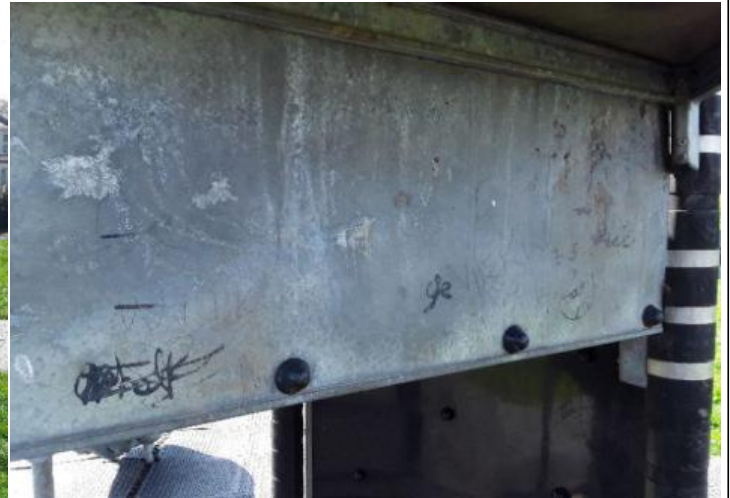
Item: Activity Equipment - Multi Play (Junior)
Manufacturer: Kompan Ltd

Finding: There is some graffiti present

Action: Remove the graffiti

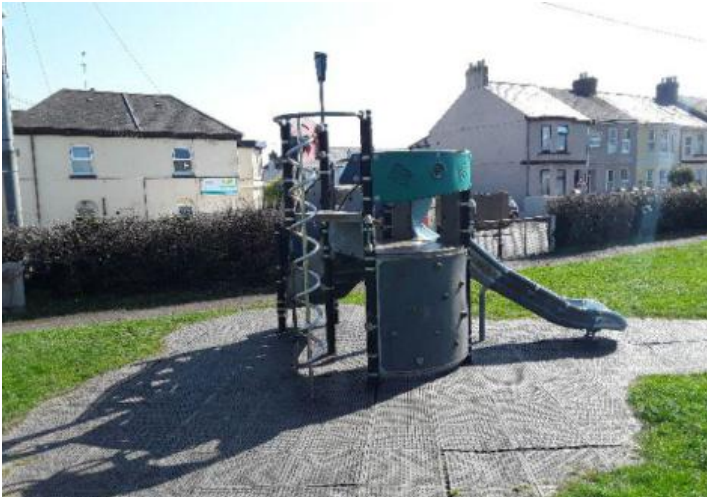
Item: Activity Equipment - Multi Play (Junior)
Manufacturer: Kompan Ltd

Finding: There is some evidence of fire damage to the item

Action: Monitor for any further deterioration and repair as required

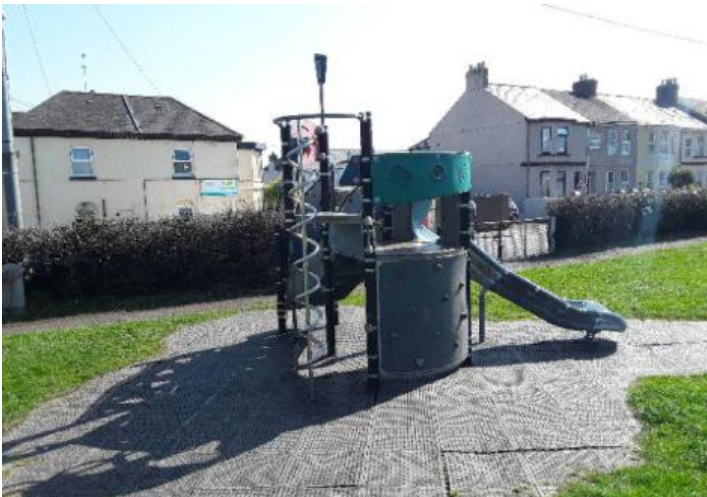
Item: Activity Equipment - Multi Play (Junior)
Manufacturer: Kompan Ltd

Finding: There is some minor damage to the slide surface

Action: Monitor for any further deterioration and replace as required

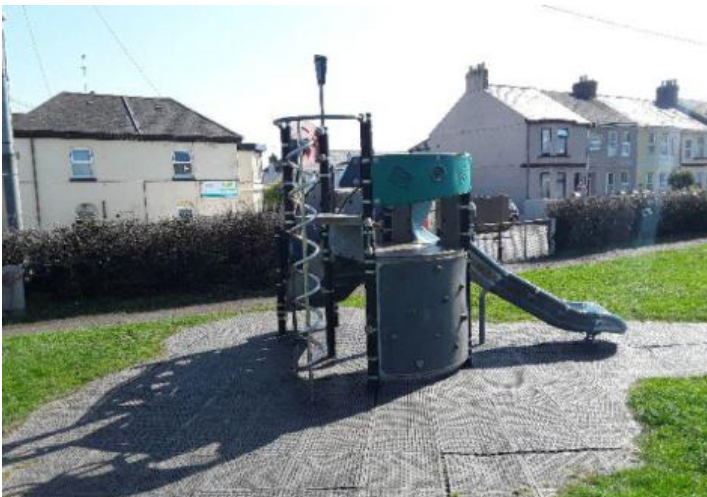
Item: Activity Equipment - Multi Play (Junior)
Manufacturer: Kompan Ltd

Finding: There is/are several inserts missing

Action: Replace missing inserts

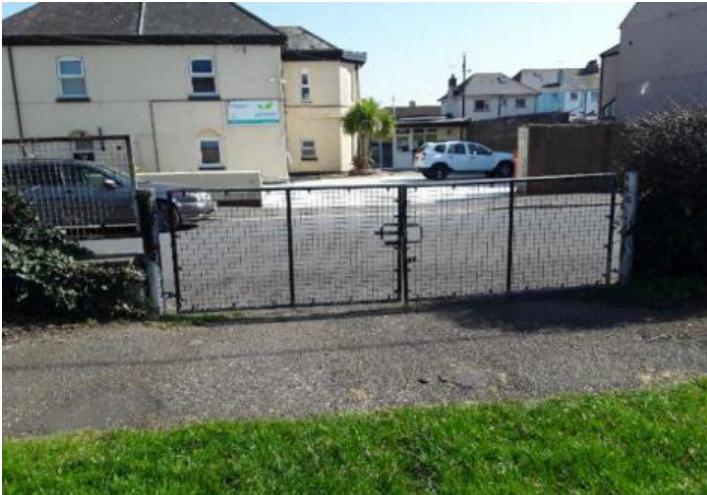
Item: Gates - Gate - Maintenance
Manufacturer: Not Identified

Finding: The paintwork on this item has been damaged or worn exposing the metal underneath which is rusting

Action: Treat any rusting components and repaint

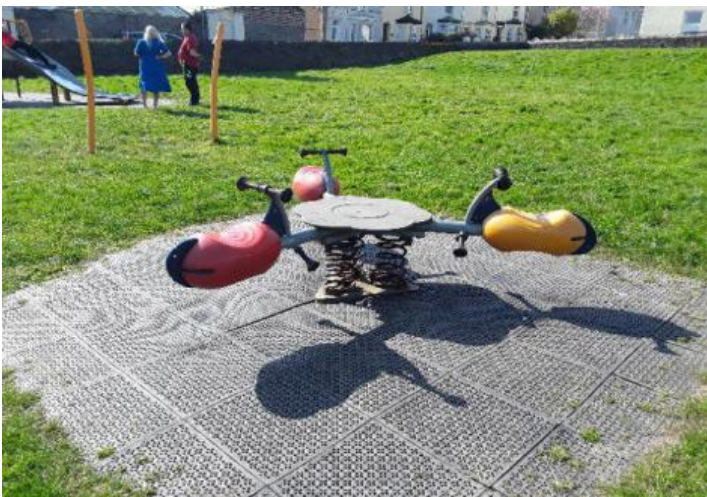
Item: Rocking Equipment - Three Way Springer
Manufacturer: Kompan Ltd

Finding: The end caps are missing on the Handgrips/Footrests

Action: Replace missing end caps

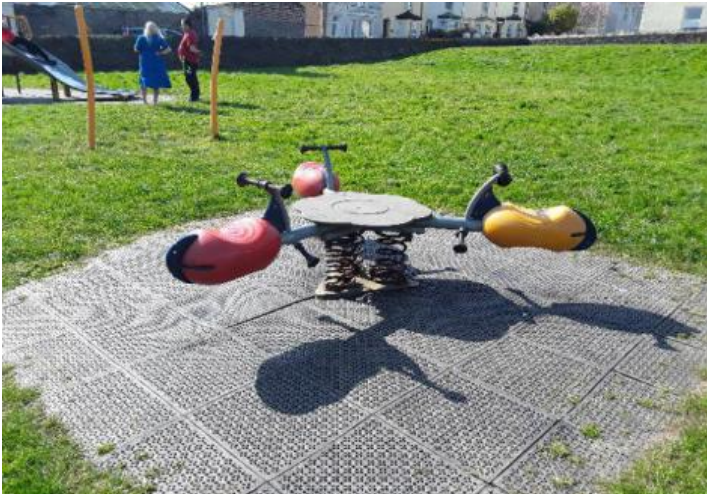
Item: Rocking Equipment - Three Way Springer
Manufacturer: Kompan Ltd

Risk Level: L - Low Risk
Surface: Rubber Tiles

Finding: The spring clamps are loose

Action: Tighten all loose fixings

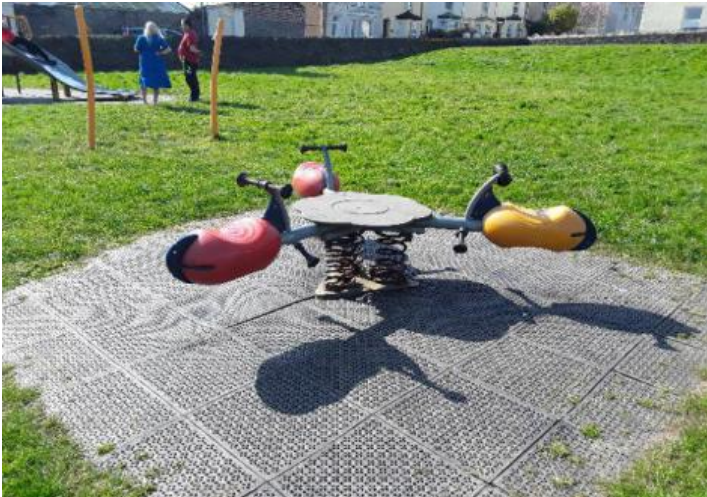
Item: Rocking Equipment - Three Way Springer
Manufacturer: Kompan Ltd

Risk Level: L - Low Risk
Surface: Rubber Tiles

Finding: The spring clamp fixings have corroded excessively

Action: Replace all corroded fixings

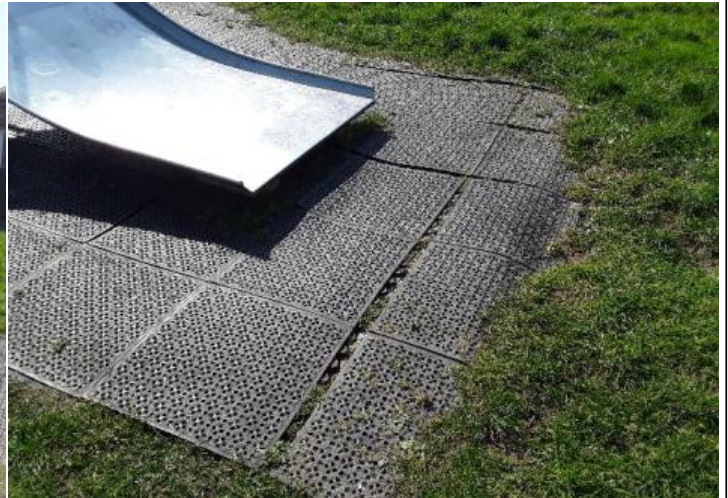
Item: Activity Equipment - Multi Play (Junior)
Manufacturer: Wicksteed Playgrounds

Risk Level: L - Low Risk
Surface: Wet Pour

Finding: There are gaps opening between the grass mat tiles

Action: Provide additional ties or secure / reinstate surface tiles

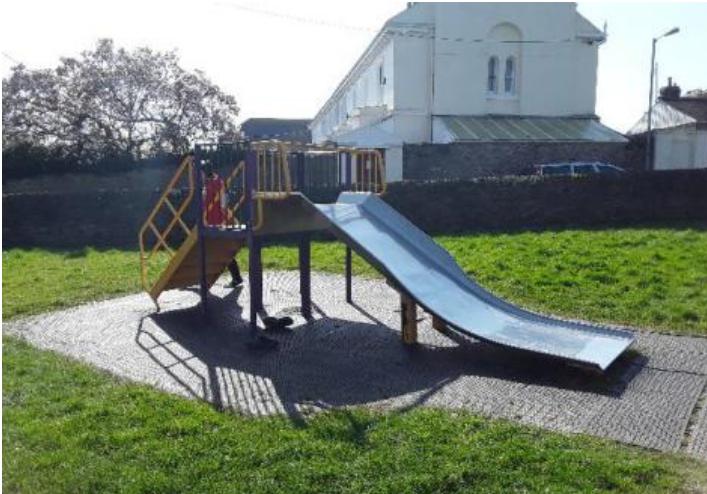
Item: Activity Equipment - Multi Play (Junior)
Manufacturer: Wicksteed Playgrounds

Risk Level: L - Low Risk
Surface: Wet Pour

Finding: There is some evidence of fire damage to the surfacing

Action: Monitor for any further deterioration and repair as required

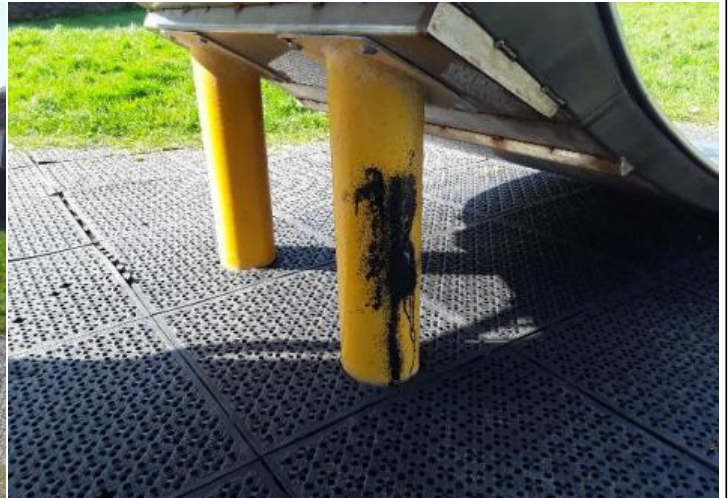
Item: Activity Equipment - Multi Play (Junior)
Manufacturer: Wicksteed Playgrounds

Risk Level: V - Very Low Risk
Surface: Wet Pour

Finding: There is some graffiti present

Action: Remove the graffiti

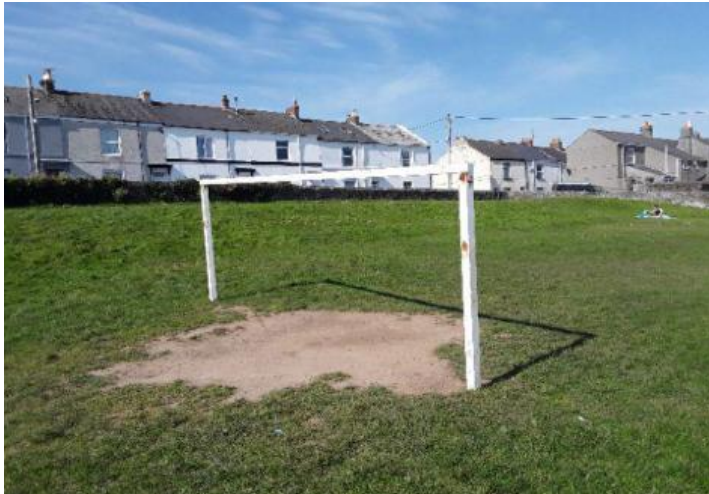
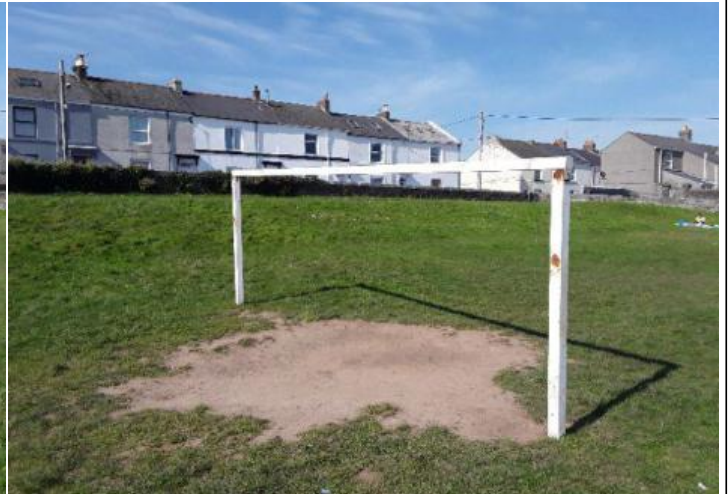
Item: Multi Use Games Area - 5 a side Goals
Manufacturer: Not Identified

Risk Level: N - Risk Assessment not Undertaken
Surface: Grass

Finding: NB: We have undertaken a maintenance inspection only of the football goal(s); full load testing falls outside the scope of our inspection.

Action: Implement load testing as required

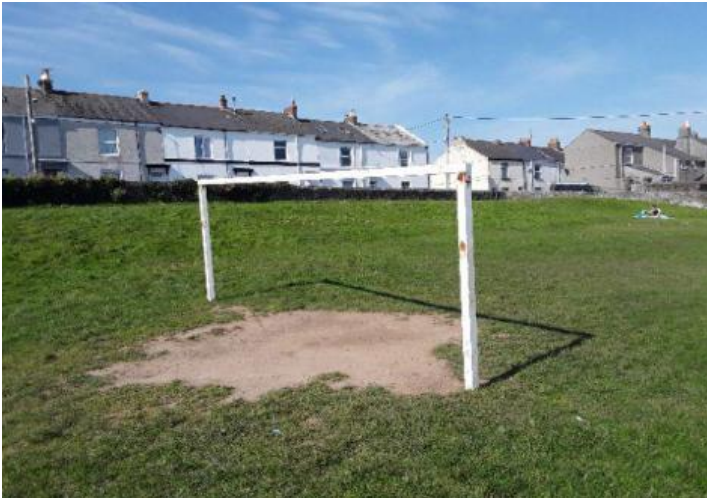
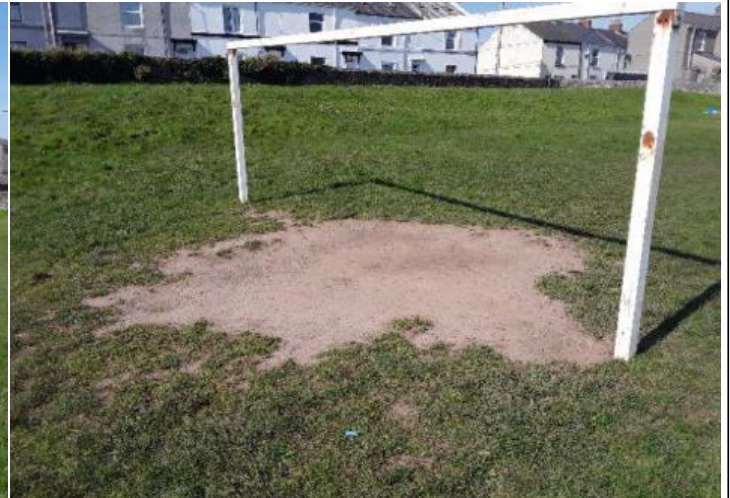
Item: Multi Use Games Area - 5 a side Goals
Manufacturer: Not Identified

Risk Level: L - Low Risk
Surface: Grass

Finding: The surface has eroded in some areas

Action: Reinstate the surface

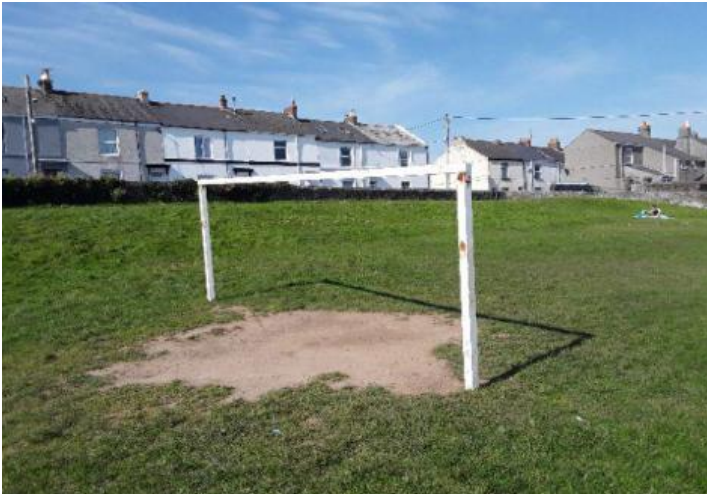
Item: Multi Use Games Area - 5 a side Goals
Manufacturer: Not Identified

Risk Level: L - Low Risk
Surface: Grass

Finding: There is or are fixings missing on the item

Action: Replace all missing fixings
