the play inspection company

Annual Inspection

Torpoint Town Council

Borough Farm

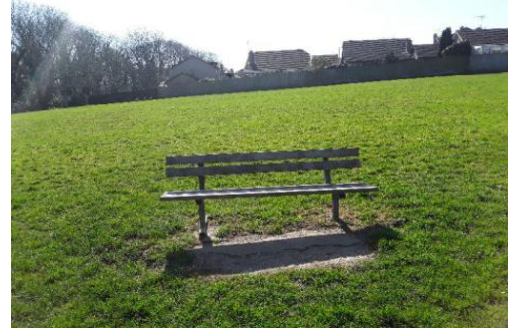
Item: Bench
Manufacturer: Not Identified
Surface Type: Concrete
Item Quantity: 2
Equipment Compliance: N/A
Surface Area Compliance: N/A

Total Findings: 5

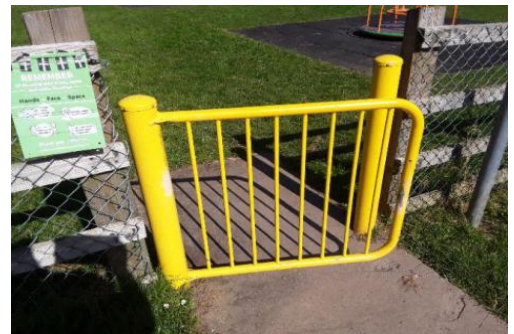
Item: Gate - Self Closing
Manufacturer: Mono Gate Ltd
Surface Type: Concrete
Item Quantity: 2
Equipment Compliance: N/A
Surface Area Compliance: N/A

Total Findings: 2

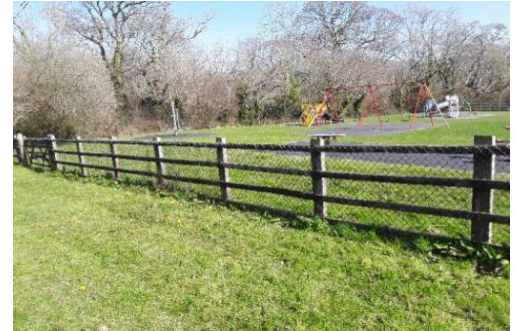
Item: Fence - Timber & Mesh Infill
Manufacturer: Not Identified
Surface Type: Grass
Item Quantity: 1
Equipment Compliance: N/A
Surface Area Compliance: N/A

Total Findings: 3

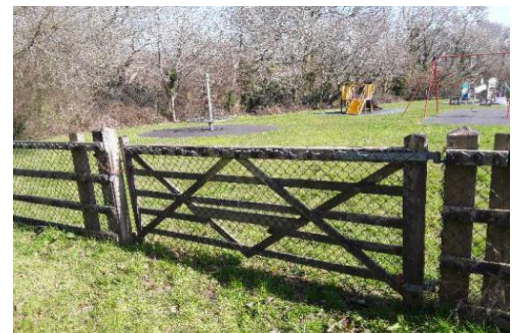
Item: Gate - Maintenance
Manufacturer: Not Identified
Surface Type: Grass
Item Quantity: 1
Equipment Compliance: N/A
Surface Area Compliance: N/A

Total Findings: 2

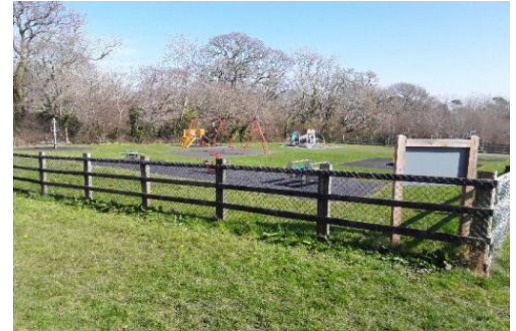
Item: Site General
Manufacturer: Owner/Operator
Surface Type: N/A
Item Quantity: 1
Equipment Compliance: N/A
Surface Area Compliance: N/A

Total Findings: 5

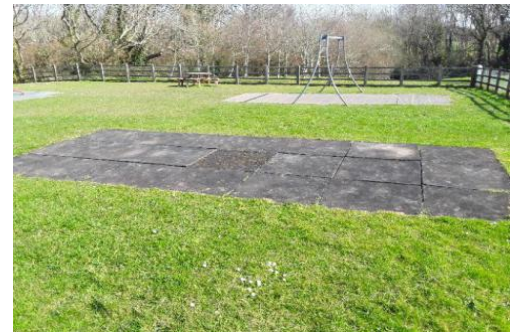
Item: Rubber Tiles
Manufacturer: Not Identified
Surface Type: Rubber Tiles
Item Quantity: 1
Equipment Compliance: N/A
Surface Area Compliance: N/A
Life Expectancy: 3 - 5 Years
Total Findings: 3

The tiles can easily be lifted or are lifting along the edges of the area - Lift and re-glue tiles to secure

There are significant gaps (over 30mm) between the surface and the edging or between the joints in the surface; these are large enough for a small foot to enter - Repair surfacing

There are gaps opening in between the tiles - Monitor for any further deterioration and repair as required

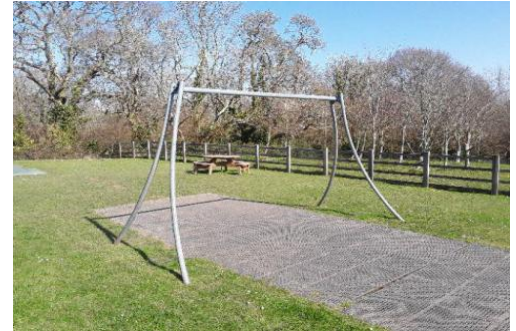
Item: 1 Bay Swing
Manufacturer: Kompan Ltd
Surface Type: Matta
Item Quantity: 1
Equipment Compliance: N/A
Surface Area Compliance: N/A
Life Expectancy: 3 - 5 Years
Total Findings: 2

The seat(s) and suspension were missing at the time of inspection and the inspector was unable to make a full compliance assessment - Replace missing seat(s) and suspension

There is moderate damage to the surface - Repair the damaged areas of surfacing

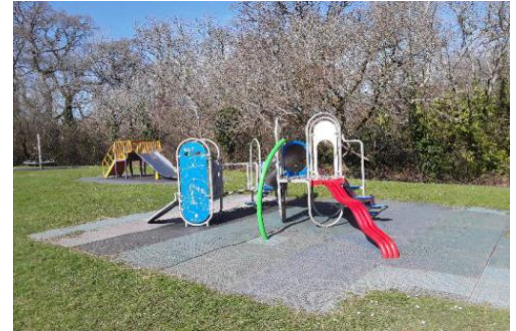
Item: Multi Play (Toddler)
Manufacturer: Wicksteed Playgrounds
Surface Type: Matta
Item Quantity: 1
Equipment Compliance: No
Surface Area Compliance: Yes
Life Expectancy: 5 -10 Years
Total Findings: 6

The green firemans pole has been installed too far away from the structure in contravention of the manufacturers specifications - Monitor, no remedial action is recommended

There is surface corrosion present on the item - Consider treating the item

There is/are finger entrapment/s in the frame and the item fails to meet the requirements of BS EN 1176 Part 1 4.2.7.6 Entrapment of fingers - Monitor - No remedial work recommended

There is or are fixings missing on the item - Replace all missing fixings

There is / are toggle entrapment/s present in contravention of the recommendations set out in BS EN 1176 Part 3 - Monitor - no remedial work recommended

There is/are bolt cap covers missing or damaged on the item - Replace missing or damaged bolt cap covers

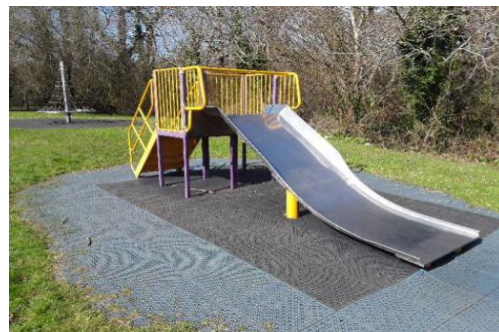
Item: Multi Play (Junior)
Manufacturer: Wicksteed Playgrounds
Surface Type: Matta
Item Quantity: 1
Equipment Compliance: Yes
Surface Area Compliance: Yes
Life Expectancy: 5 -10 Years
Total Findings: 5

There are a number of dents in the slide surface - Monitor for any further deterioration and repair as required

There is/are several inserts missing - Replace missing inserts

There is some minor damage to the surface - Monitor for any further deterioration and repair as required

The weld(s) on this item have failed - Repair item

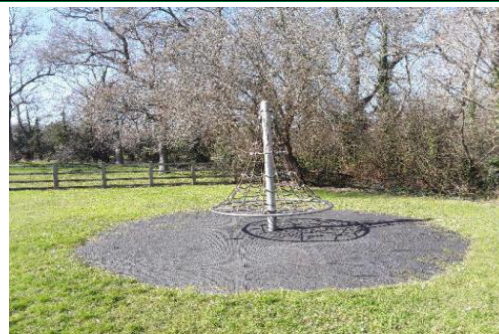
Item: Cone Climber
Manufacturer: Tayplay Ltd
Surface Type: Matta
Item Quantity: 1
Equipment Compliance: Yes
Surface Area Compliance: Yes
Life Expectancy: 5 -10 Years
Total Findings: 3

The ropes on this item have been taped and we are unable to fully assess the condition of the rope, ensure no wire strands are broken beneath the tape - Repair or replace as required

The bearing is showing signs of wear - Monitor for any further deterioration and replace as required

The ropes/nets are worn/damaged in places - Monitor for any further deterioration and repair or replace as required

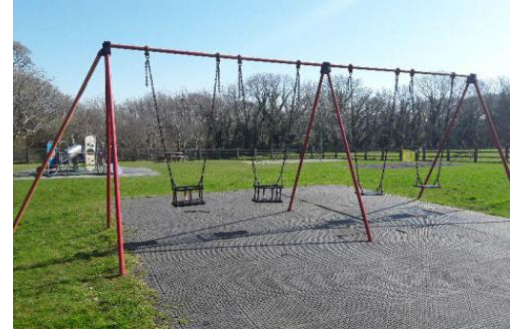
Item: 2 Bay (2 Flat, 2 Cradle)
Manufacturer: Wicksteed Playgrounds
Surface Type: Matta
Item Quantity: 1
Equipment Compliance: No
Surface Area Compliance: Yes
Life Expectancy: 5 -10 Years
Total Findings: 7

The surfacing mats have separated, are not secured and can be lifted creating trip points. The gaps between the mats are also large enough for a small foot to enter - Repair as required to secure the mats

The connecting links are in excess of 8.6mm and less than 12mm and fail the requirements of BS EN 1176 Part 1; clause 4.2.13, Chains - Monitor - No remedial work recommended

There are caps missing from the underside of the seats - Replace missing caps under the seats

There is some wear to the shackles. - Monitor for any further deterioration and replace when 40% worn

The seat has minor damage or wear - Monitor for any further deterioration and replace as required

The chain links are worn in excess of 40% and require renewing - Replace worn chains

The bushes are showing signs of wear - Monitor for any further deterioration and replace as required

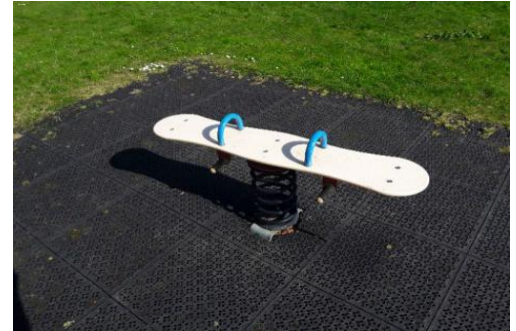
Item: Spring See-Saw
Manufacturer: Not Identified
Surface Type: Matta
Item Quantity: 1
Equipment Compliance: No
Surface Area Compliance: Yes
Life Expectancy: 3 - 5 Years
Total Findings: 3

The paintwork on the spring has been damaged or worn exposing the metal underneath which is rusting - Treat any rusting components and repaint

The fixings have corroded excessively - Replace all corroded fixings

The end of handgrips and/or footrests have a cross section of less than 15cm² and fail to meet the requirements of BS EN 1176 Part 6 - Monitor - No remedial work recommended

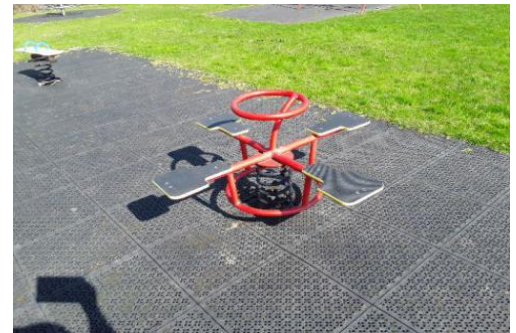
Item: Four Way Springer
Manufacturer: Not Identified
Surface Type: Matta
Item Quantity: 1
Equipment Compliance: Yes
Surface Area Compliance: Yes
Life Expectancy: 3 - 5 Years
Total Findings: 2

The fixings have corroded excessively - Replace all corroded fixings

The paintwork on the spring has been damaged or worn exposing the metal underneath which is rusting - Treat any rusting components and repaint

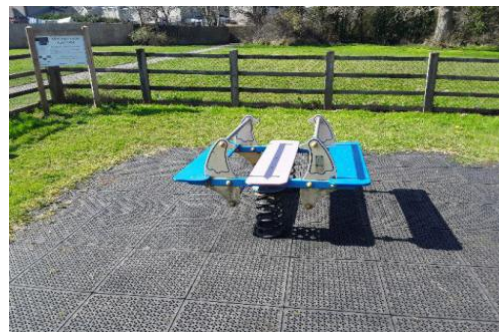
Item: Spring See-Saw
Manufacturer: Wicksteed Playgrounds
Surface Type: Matta
Item Quantity: 1
Equipment Compliance: Yes
Surface Area Compliance: Yes
Life Expectancy: 3 - 5 Years
Total Findings: 3

The weld(s) on this seat bracket have failed - Repair item

The paintwork on this item has been damaged or worn exposing the metal underneath which is rusting - Treat any rusting components and repaint

The paintwork on the spring has been damaged or worn exposing the metal underneath which is rusting - Treat any rusting components and repaint

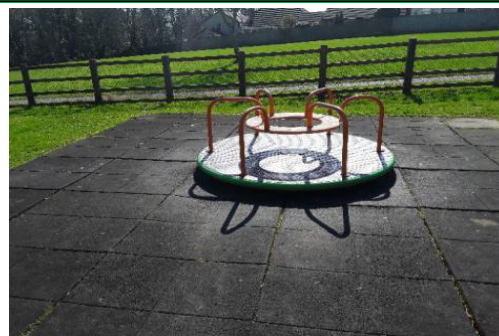
Item: Roundabout
Manufacturer: Wicksteed Playgrounds
Surface Type: Rubber Tiles
Item Quantity: 1
Equipment Compliance: No
Surface Area Compliance: No
Life Expectancy: 5 -10 Years
Total Findings: 4

There are gaps opening in between the tiles - Monitor for any further deterioration and repair as required

There is some minor damage to the surface - Monitor for any further deterioration and repair as required

The surfacing dimensions are short and do not meet with the requirements of the current applicable standard - Monitor - no remedial action recommended

The ground clearance is not maintained under the roundabout for 300mm without deviations as required by BS EN 1176 Part 5 Clause 5.2.3 - Monitor - No remedial work recommended

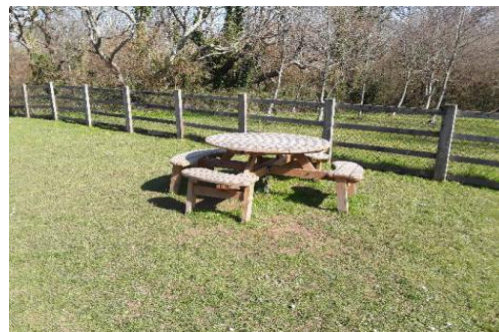
Item:	Bench
Manufacturer:	Owner/Operator
Surface Type:	Grass
Item Part Number:	0
Item Quantity:	1
Equipment Compliance:	N/A
Surface Area Compliance:	N/A
Life Expectancy:	3 - 5 Years
Total Findings:	1

The table is not secured to the ground and there is some potential for the item to be moved within falling spaces of equipment - Secure the item to the ground

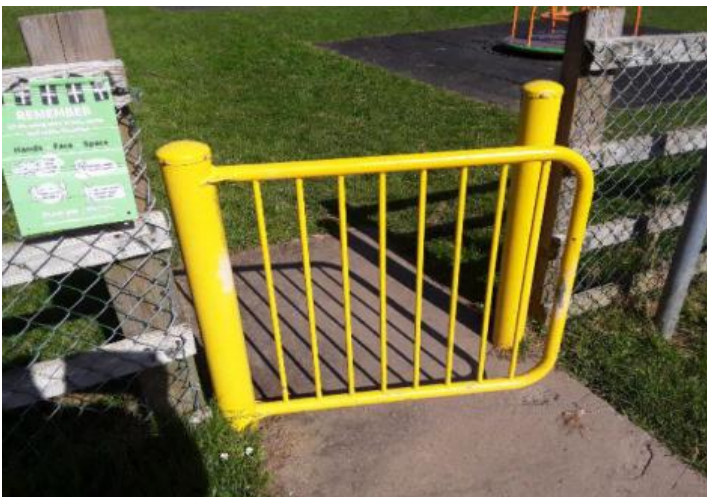
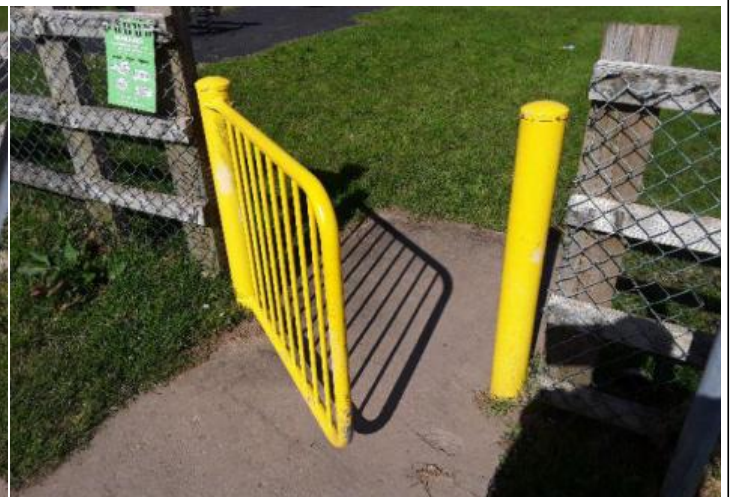
Item: Gates - Gate - Self Closing
Manufacturer: Mono Gate Ltd

Finding: The gate is not operating correctly

Action: Take effective action to ensure the gate closes between 4 and 8 seconds

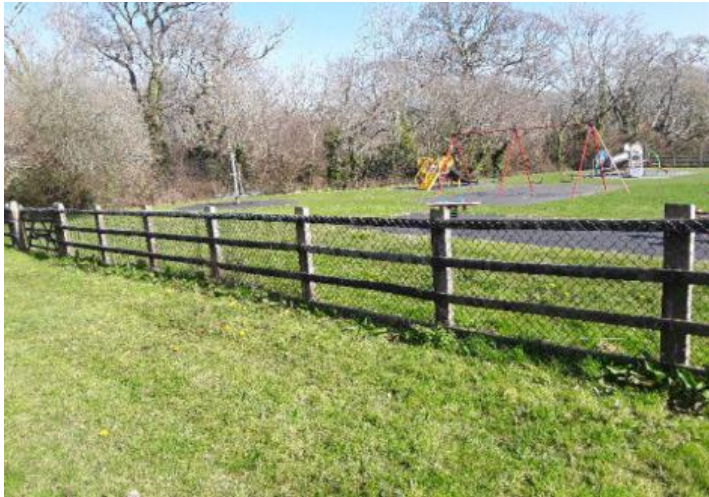
Item: Fences - Fence - Timber & Mesh Infill
Manufacturer: Not Identified

Finding: There is some damage to the fence sections

Action: Monitor for any further deterioration and repair as required

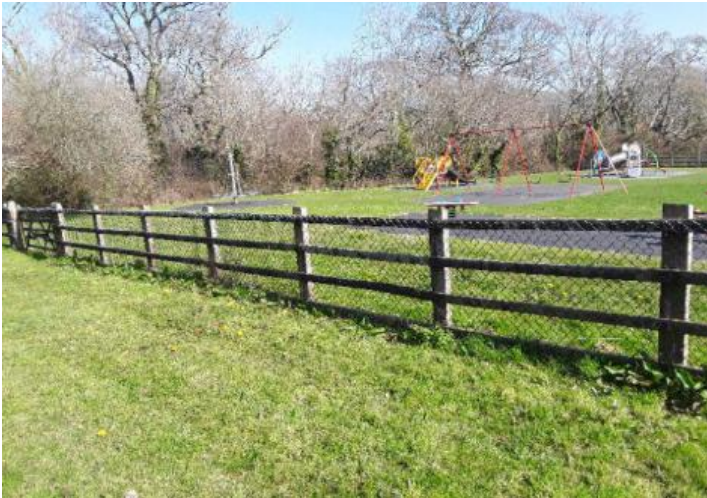
Item: Fences - Fence - Timber & Mesh Infill
Manufacturer: Not Identified

Finding: There are a number of loose posts around the fence

Action: Monitor for any further deterioration and reset as required

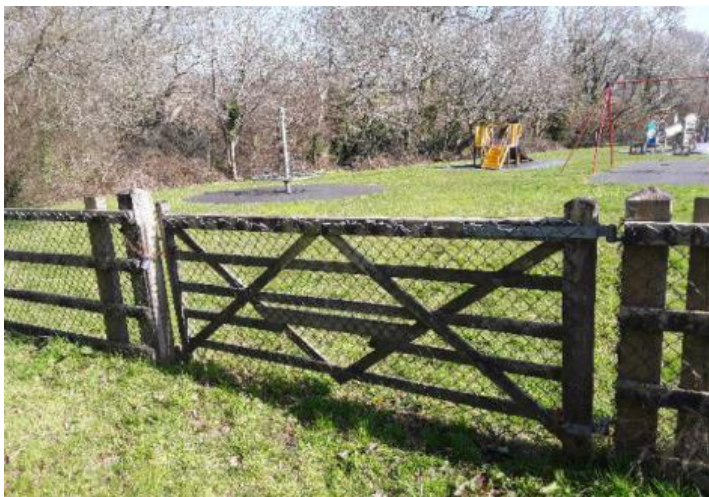
Item: Gates - Gate - Maintenance
Manufacturer: Not Identified

Finding: There are areas or parts of the timber on the structure that have rotted

Action: Replace all affected timbers

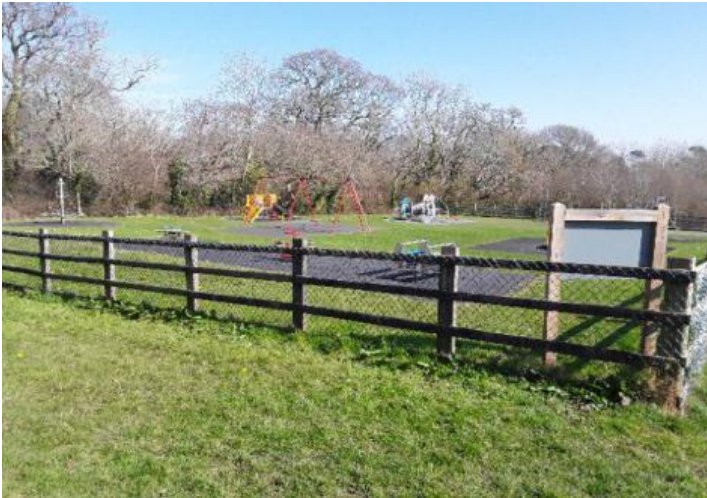
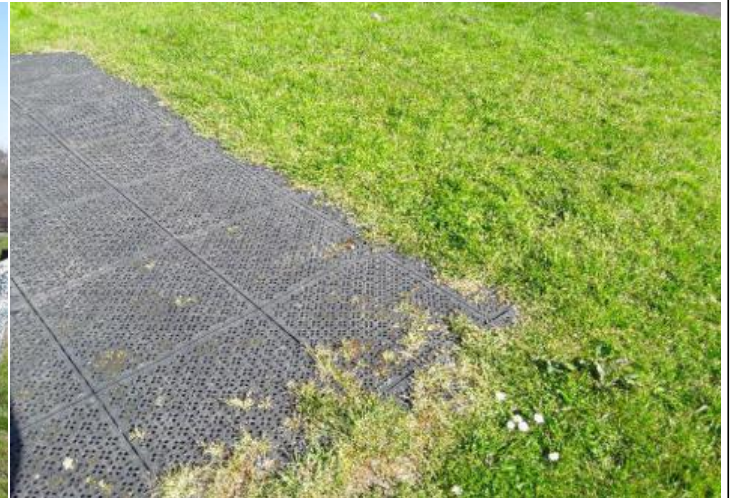
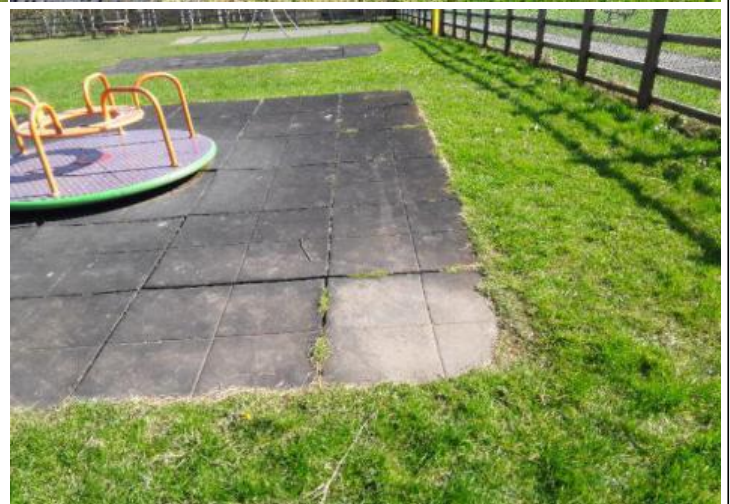
Item: Ancillary Items - Site General
Manufacturer: Owner/Operator

Finding: There is weed / vegetation growth on, between, or around the edges of the surfacing
Action: Remove weed / vegetation growth

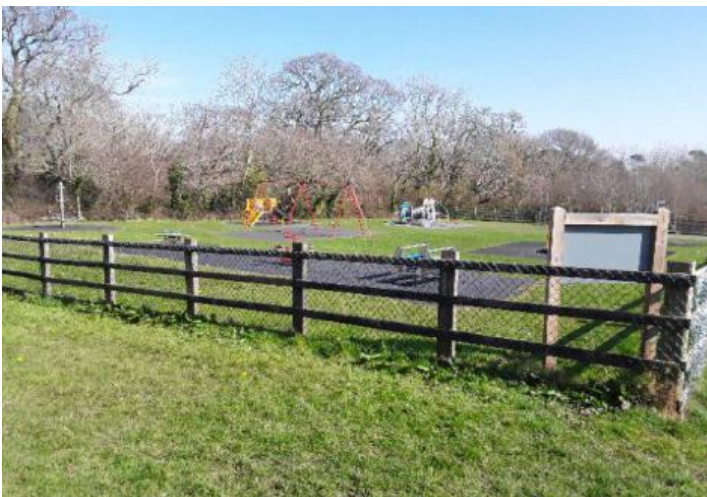
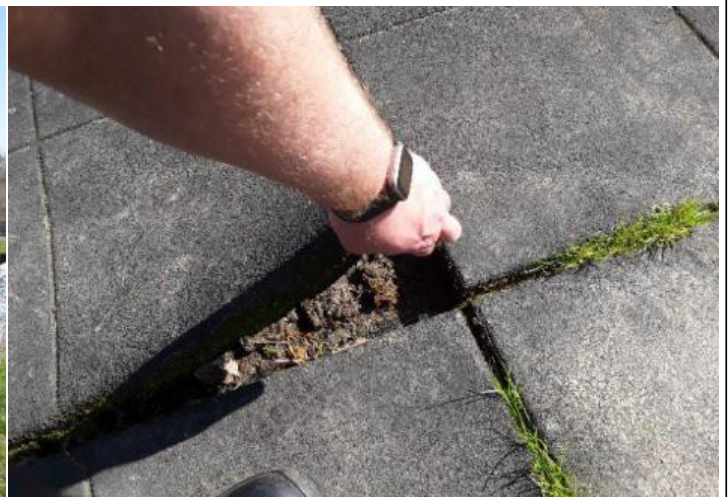
Item: Ancillary Items - Site General
Manufacturer: Owner/Operator

Finding: The tiles can easily be lifted or are lifting along the edges of the area

Action: Lift and re-glue tiles to secure

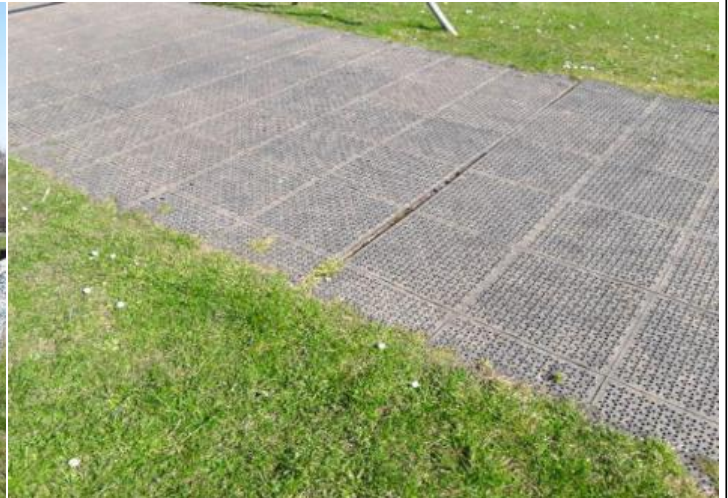
Item: Ancillary Items - Site General
Manufacturer: Owner/Operator

Finding: There are gaps opening between the grass mat tiles

Action: Provide additional ties or secure / reinstate surface

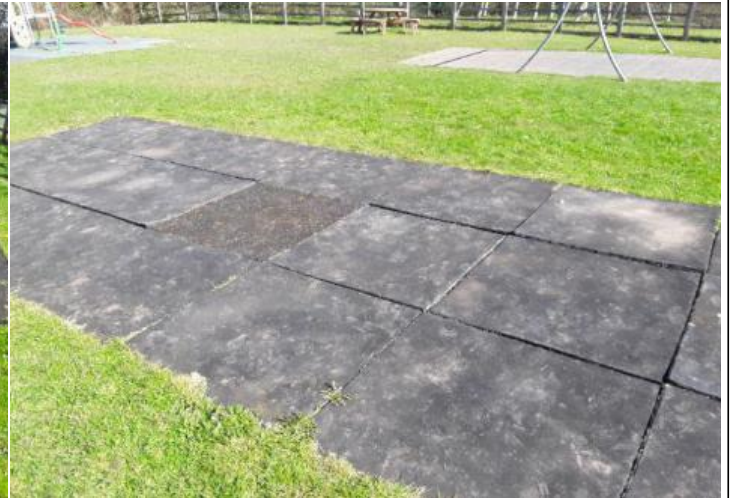
Item: Surface - Rubber Tiles
Manufacturer: Not Identified

Finding: The tiles can easily be lifted or are lifting along the edges of the area
Action: Lift and re-glue tiles to secure

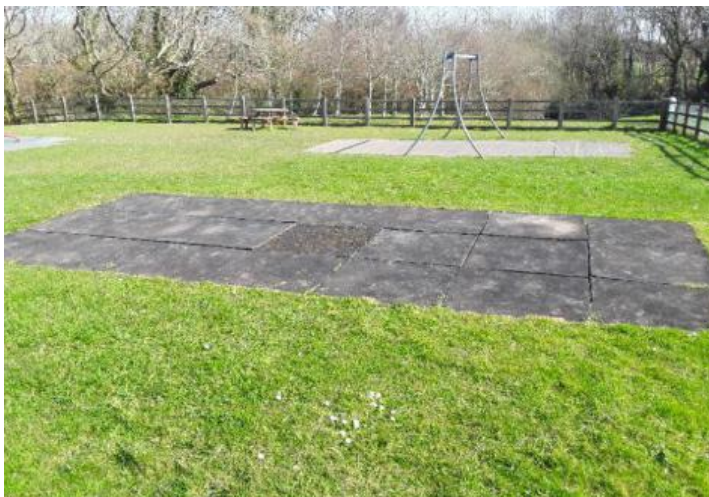
Item: Surface - Rubber Tiles
Manufacturer: Not Identified

Finding: There are gaps opening in between the tiles
Action: Monitor for any further deterioration and repair as required

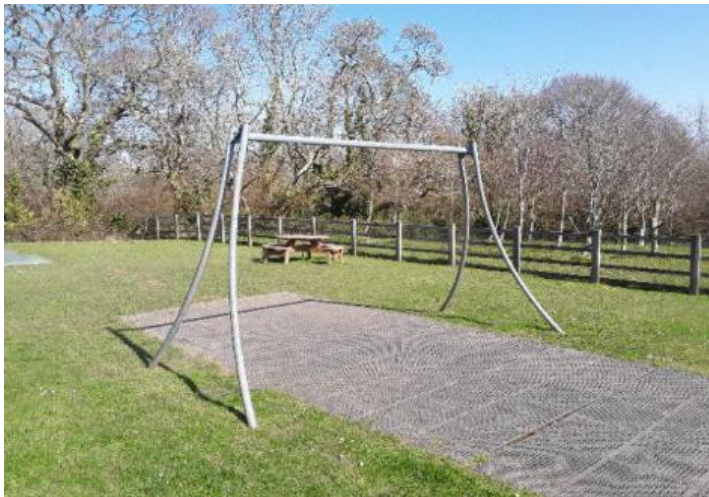
Item: Swings - 1 Bay Swing
Manufacturer: Kompan Ltd

Finding: The seat(s) and suspension were missing at the time of inspection and the inspector was unable to make a full compliance assessment

Action: Replace missing seat(s) and suspension

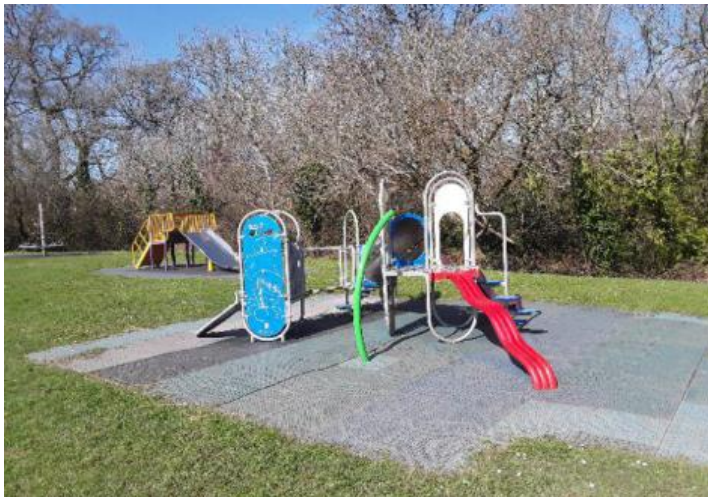
Item: Activity Equipment - Multi Play (Toddler)
Manufacturer: Wicksteed Playgrounds

Finding: There is or are fixings missing on the item

Action: Replace all missing fixings

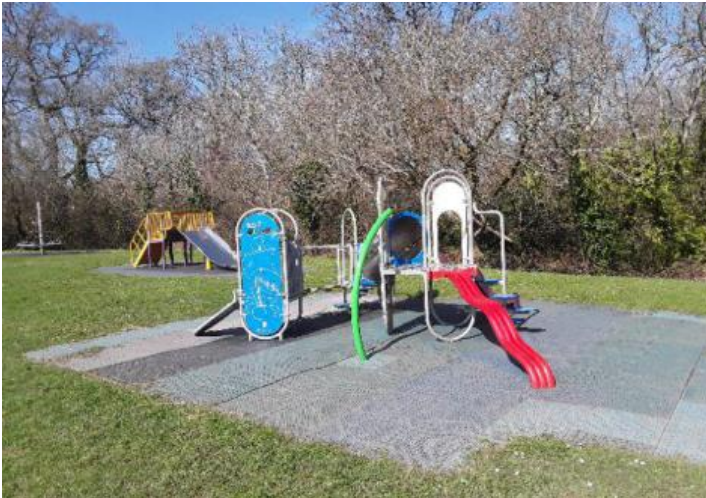
Item: Activity Equipment - Multi Play (Toddler)
Manufacturer: Wicksteed Playgrounds

Finding: There is / are toggle entrapment/s present in contravention of the recommendations set out in BS EN 1176 Part 3

Action: Monitor - no remedial work recommended

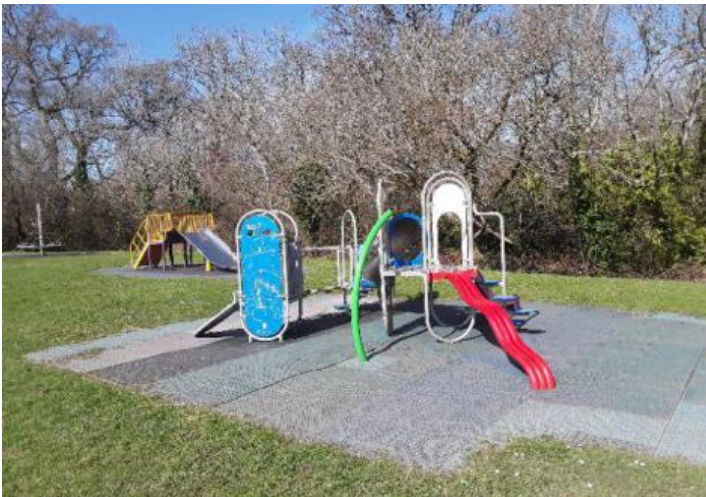
Item: Activity Equipment - Multi Play (Toddler)
Manufacturer: Wicksteed Playgrounds

Finding: There is/are bolt cap covers missing or damaged on the item

Action: Replace missing or damaged bolt cap covers

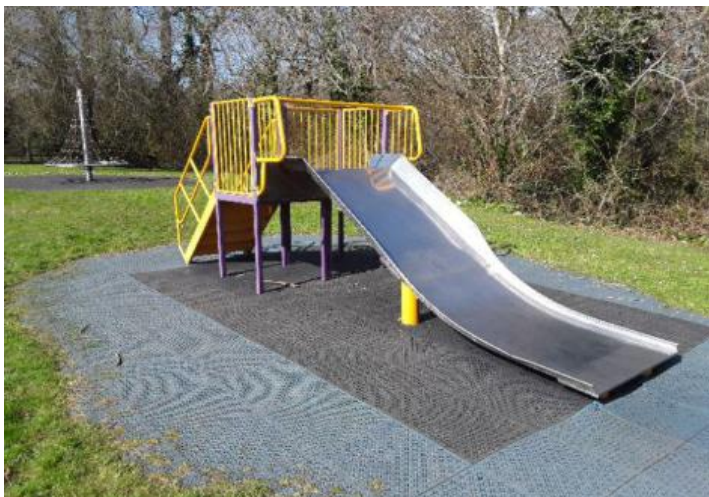
Item: Activity Equipment - Multi Play (Junior)
Manufacturer: Wicksteed Playgrounds

Finding: The weld(s) on this item have failed

Action: Repair item

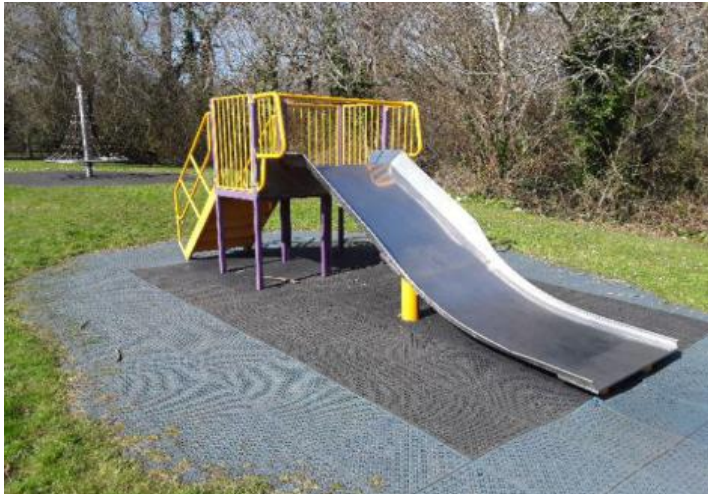
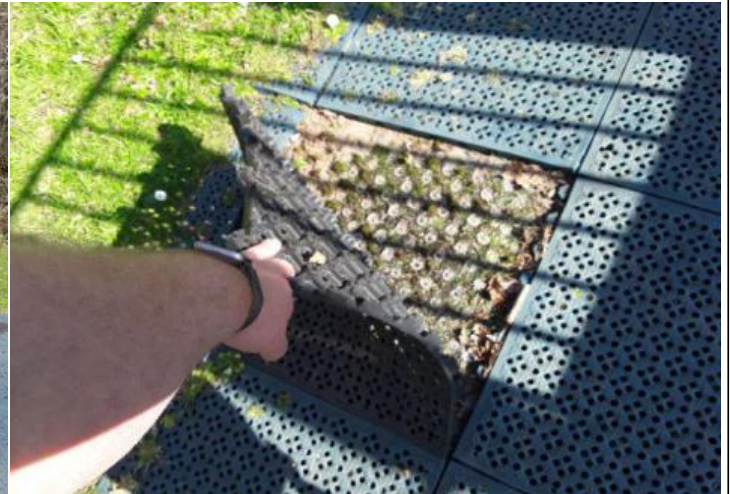
Item: Activity Equipment - Multi Play (Junior)
Manufacturer: Wicksteed Playgrounds

Finding: The tiles can easily be lifted or are lifting along the edges of the area

Action: Lift and re-glue tiles to secure

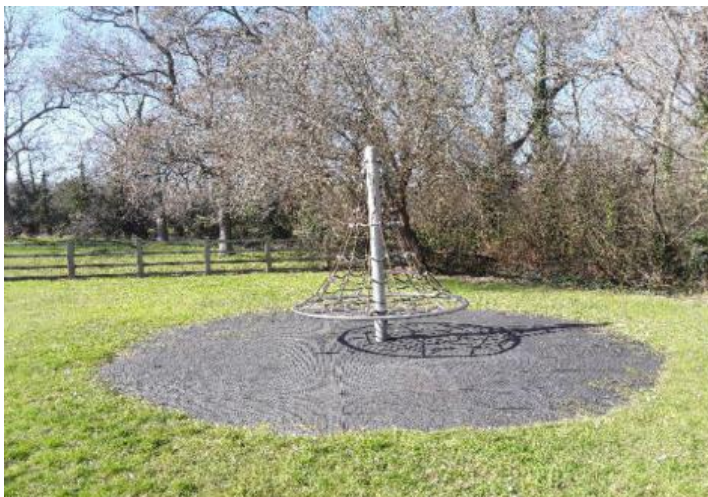
Item: Rotor Play - Cone Climber
Manufacturer: Tayplay Ltd

Finding: The ropes on this item have been taped and we are unable to fully assess the condition of the rope, ensure no wire strands are broken beneath the tape

Action: Repair or replace as required

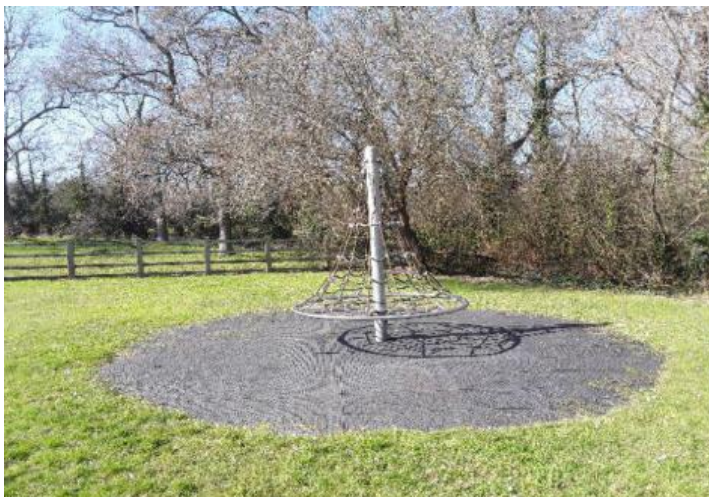
Item: Rotor Play - Cone Climber
Manufacturer: Tayplay Ltd

Finding: The bearing is showing signs of wear

Action: Monitor for any further deterioration and replace as required

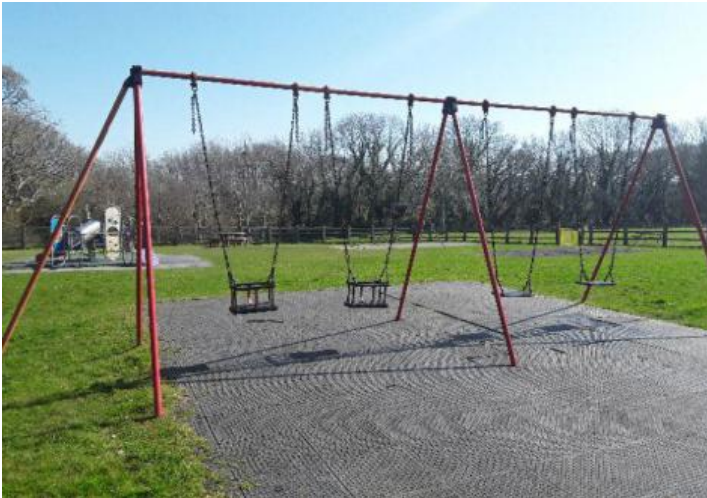
Item: Swings - 2 Bay (2 Flat, 2 Cradle)
Manufacturer: Wicksteed Playgrounds

Finding: The surfacing mats have separated, are not secured and can be lifted creating trip points. The gaps between the mats are also large enough for a small foot to enter

Action: Repair as required to secure the mats

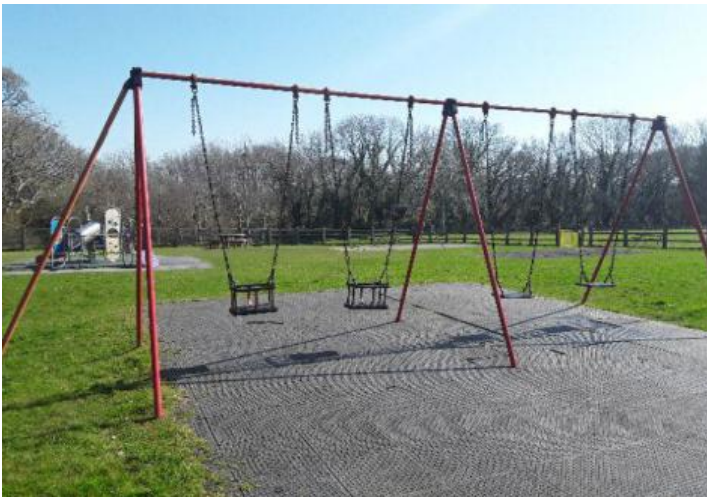
Item: Swings - 2 Bay (2 Flat, 2 Cradle)
Manufacturer: Wicksteed Playgrounds

Finding: The chain links are worn in excess of 40% and require renewing

Action: Replace worn chains

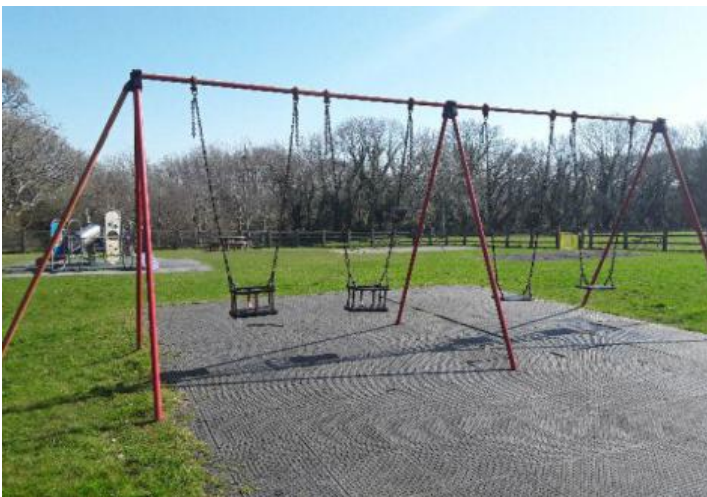
Item: Swings - 2 Bay (2 Flat, 2 Cradle)
Manufacturer: Wicksteed Playgrounds

Finding: The bushes are showing signs of wear

Action: Monitor for any further deterioration and replace as required

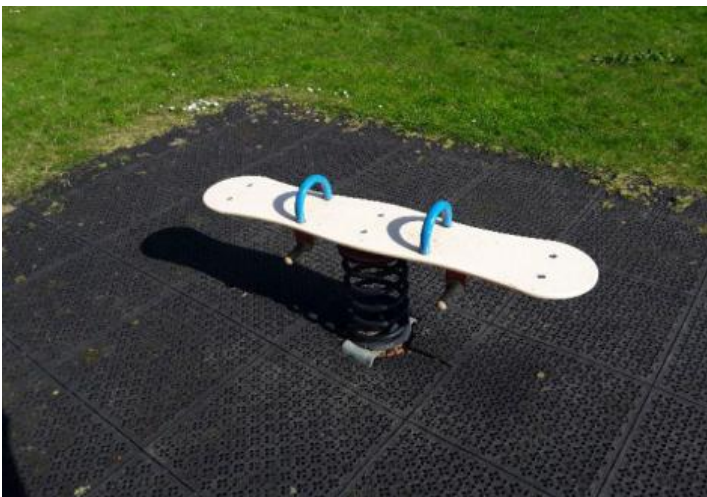
Item: Rocking Equipment - Spring See-Saw
Manufacturer: Not Identified

Finding: The paintwork on the spring has been damaged or worn exposing the metal underneath which is rusting

Action: Treat any rusting components and repaint

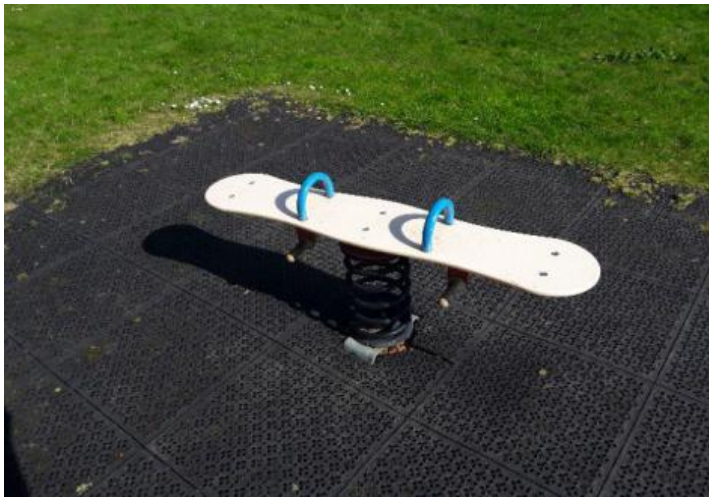
Item: Rocking Equipment - Spring See-Saw
Manufacturer: Not Identified

Finding: The fixings have corroded excessively
Action: Replace all corroded fixings

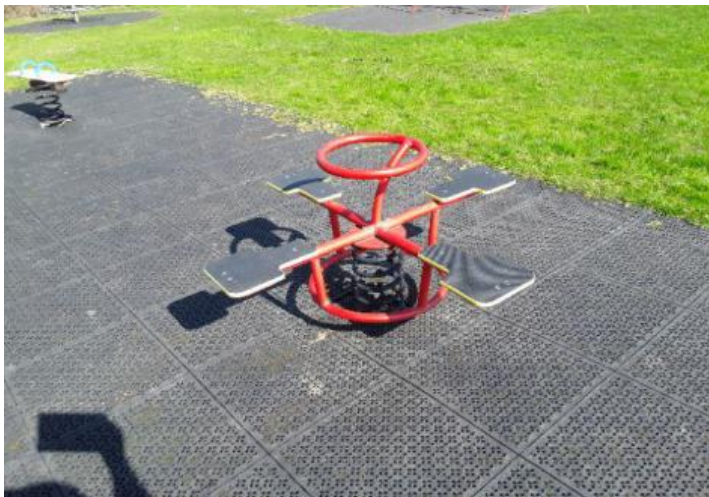
Item: Rocking Equipment - Four Way Springer
Manufacturer: Not Identified

Finding: The paintwork on the spring has been damaged or worn exposing the metal underneath which is rusting

Action: Treat any rusting components and repaint

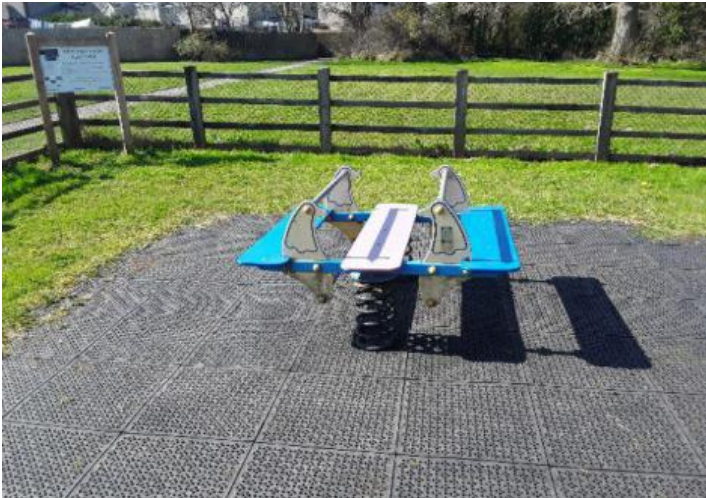
Item: Rocking Equipment - Spring See-Saw
Manufacturer: Wicksteed Playgrounds

Finding: The weld(s) on this seat bracket have failed

Action: Repair item

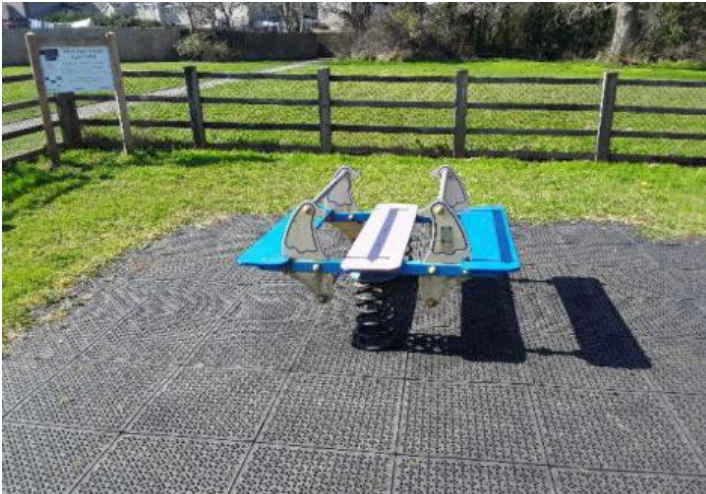
Item: Rocking Equipment - Spring See-Saw
Manufacturer: Wicksteed Playgrounds

Finding: The paintwork on this item has been damaged or worn exposing the metal underneath which is rusting

Action: Treat any rusting components and repaint

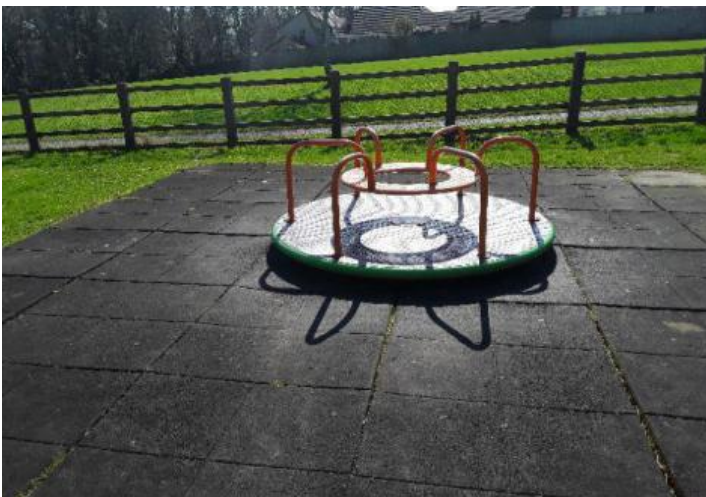
Item: Rotor Play - Roundabout
Manufacturer: Wicksteed Playgrounds

Finding: There are gaps opening in between the tiles
Action: Monitor for any further deterioration and repair as required

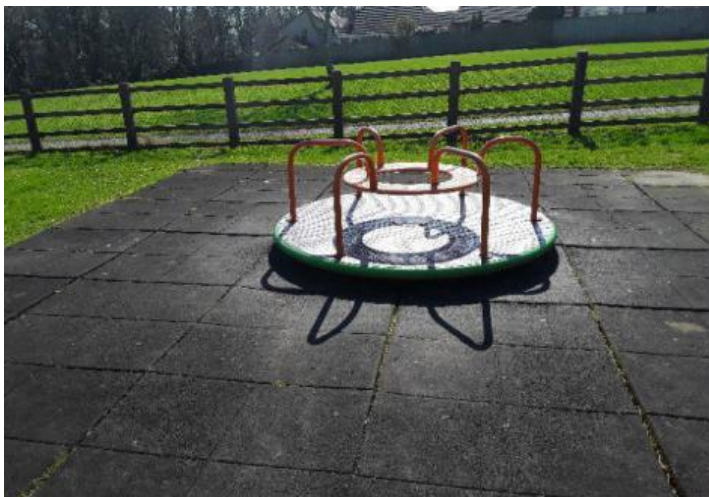
Item: Rotor Play - Roundabout
Manufacturer: Wicksteed Playgrounds

Finding: The surfacing dimensions are short and do not meet with the requirements of the current applicable standard

Action: Monitor - no remedial action recommended

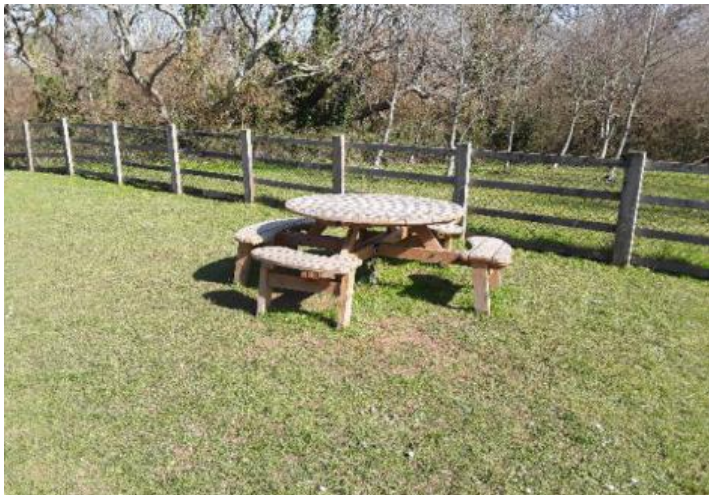
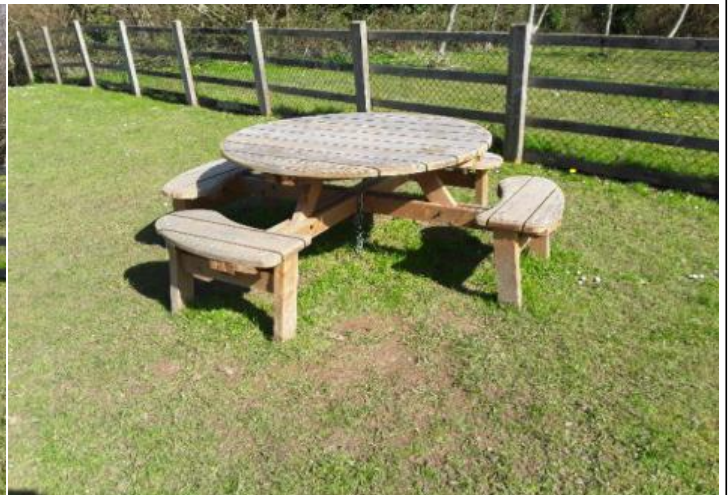
Item: Ancillary Items - Bench
Manufacturer: Owner/Operator

Finding: The table is not secured to the ground and there is some potential for the item to be moved within falling spaces of equipment

Action: Secure the item to the ground
