the **play** inspection company

Annual Inspection

Torpoint Town Council

Chestnut Close, Torpoint, PL11 2NB

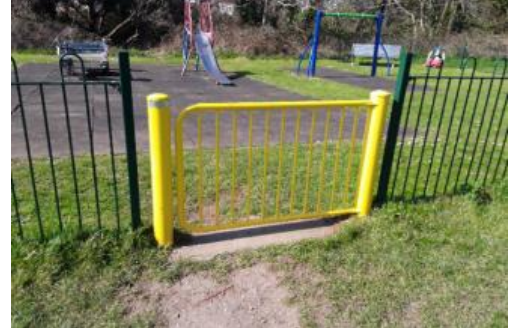
Item: Gate - Self Closing
Manufacturer: Mono Gate Ltd
Surface Type: Concrete
Item Quantity: 2
Equipment Compliance: N/A
Surface Area Compliance: N/A

This item is satisfactory - no work required -

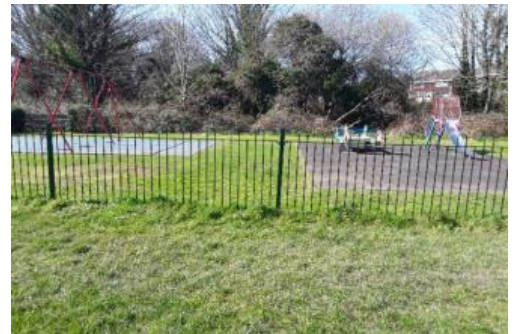
Item: Fence - Bow Top
Manufacturer: Not Identified
Surface Type: Grass
Item Quantity: 1
Equipment Compliance: N/A
Surface Area Compliance: N/A

This item is satisfactory - no work required -

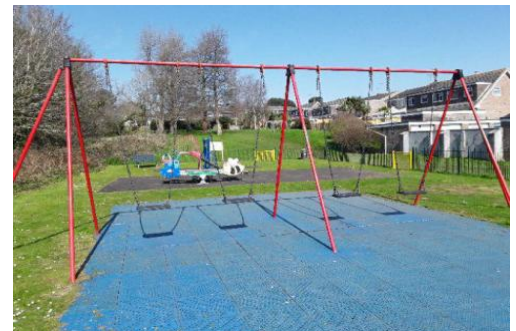
Item: 2 Bay 4 Seat (Flat)
Manufacturer: Record RSS
Surface Type: Matta
Item Quantity: 1
Equipment Compliance: No
Surface Area Compliance: Yes
Life Expectancy: 5 -10 Years
Total Findings: 6

There are gaps opening between the grass mat tiles - Provide additional ties or secure / reinstate surface

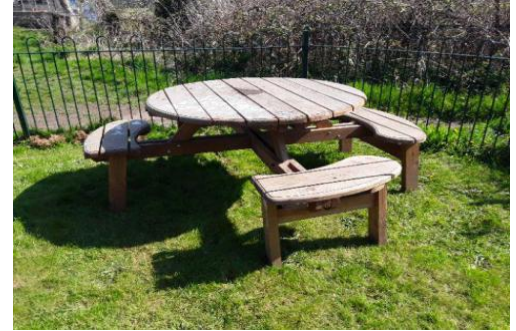
Item: Bench
Manufacturer: Owner/Operator
Surface Type: Grass
Item Part Number: 1
Item Quantity: 1
Equipment Compliance: N/A
Surface Area Compliance: N/A
Life Expectancy: 1 - 3 Years
Total Findings: 2

The table is not secured to the ground and there is some potential for the item to be moved within falling spaces of equipment - Secure the item to the ground

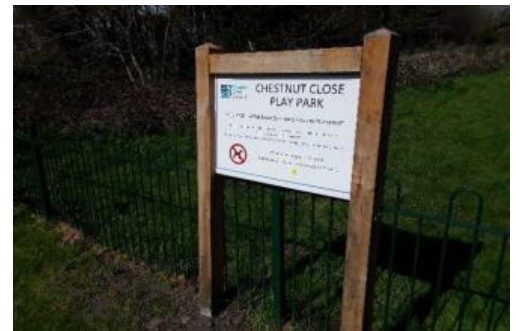
Item: Playground Sign
Manufacturer: Owner/Operator
Surface Type: Grass
Item Quantity: 1
Equipment Compliance: N/A
Surface Area Compliance: N/A
Life Expectancy: 3 - 5 Years
Total Findings: 1

This item is satisfactory - no work required -
